A STUDY ON THE CAUSES OF SOME ROCK SLOPE
FAILURES ALONG HIGHWAYS IN TAIWAN

Moh and Associates, Inc.

*Proceedings, Third Conference of the
Road Engineering Association of Asia and
Australasia, Taipei, 20-24 April, 1981, Vol. 1, pp. 761-777*

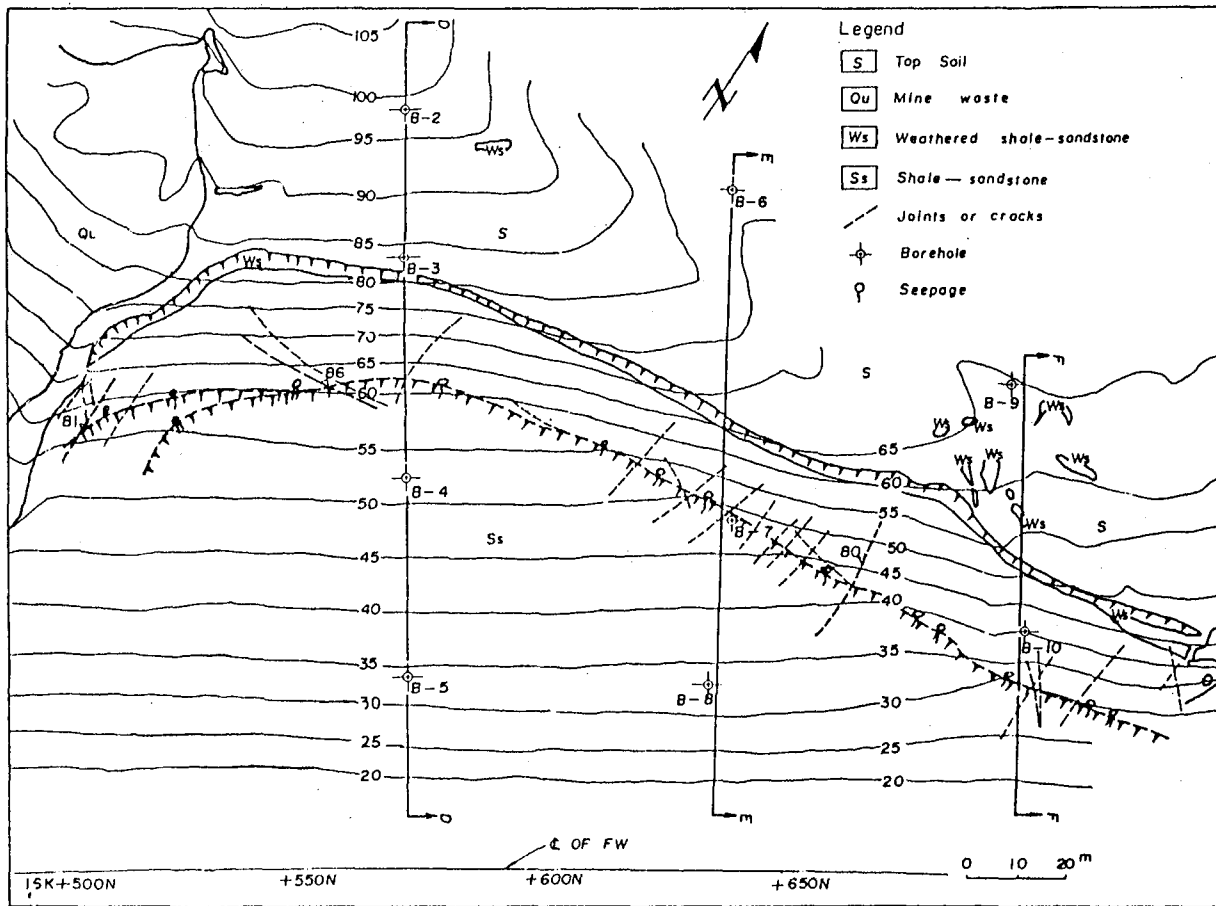
Fig. 5 Geological Map of 16 KN

The rock formation in this area is composed of interstratified gray fine-grained sandstone and clayey shale. The direction of the rock formation is at strike N58°E with dip angle of 25°E. This means that the dip of the bedding plane is towards the Freeway. Sliding of the rock mass occurred along these bedding planes. The original slope in this area was about 25° which is parallel to the bedding planes. Due to construction of the Freeway, the slope was cut back to 45°. The slope failed during the first rainy season after the construction. As shown in Fig. 5, there were two sets of

joints intersecting at right angles with each other present near the failure surface. These joints have dip angle between 80° to 85° nearly perpendicular to the horizontal surface. It was also found that groundwater continuously seeped out along the bedding planes in the zone between the remaining slope and the failure surface. In consideration of the overall safety of the entire slope, a thorough investigation was undertaken to delineate the causes of the slide and to determine the necessary remedial actions. A total of 10 vertical boreholes was drilled to depths varying from 10 m to 40 m. Triple-tube core barrels were used to recover the rock samples. After completion of drilling, hydraulic type piezometers were installed at different depth to monitor the underground pore water pressures. In addition, an engineering geological map was prepared which gave detailed description of the surface geology of the entire slope including rock formation types, patterns, joints, fractures and etc. Two types of laboratory tests were carried out on the rock cores. They were shear strength test along the bedding planes of the rock and water affinity tests. The latter included slaking tests, water adsorption and permeability tests. Results of field exploration and laboratory tests show that in this area seepage water flows much more easier along the bedding planes of the rock formation. The sandstone-shale is sensitive to water. It adsorbs water easily and develops surface cracks which tend to disintegrate. Swelling of this type of rock can amount to 5 - 15% of the total volume. From these information, it can be easily concluded that the rock formation in this area cannot be allowed to be exposed. They must be properly protected from weathering.

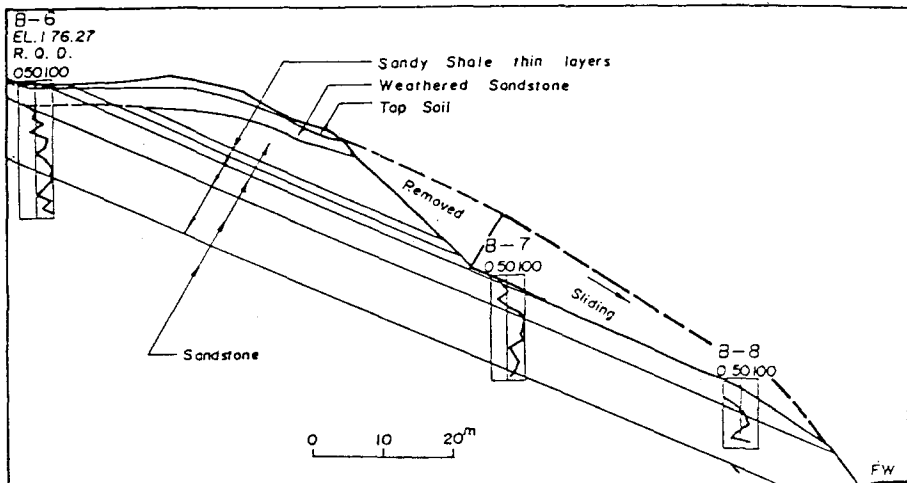
Fig. 6 A Cross-Section of Failure Slope at 16 KN

Figure 6 shows a cross-section of the failure surface. Assuming that the pore water pressure acting on the failure surface at time of failure is equivalent to $2/3$ of the height of the slope, it can be back figured that the strength parameters of the rock formations at time of failure were $c = 0.1 \text{ kg/cm}^2$ and $\phi_r = 32^{\circ}$. By using the in-situ measured pore water pressure values, it was found that the factor of safety of the remaining slope was less than 1.5 in most of the sections. It was thus concluded that the remedial stabilizing measure should include two aspects. They were: reducing the pore water pressure in the rock by installing underground drains, and the use of rock anchors to stabilize the rock formation.

Underground drains were essentially perforated pipes installed deep into the rock formation for the purpose of intercepting seepage water trapped between bedding planes. Prestressed cables were used as rock anchors. The anchors were fixed on 60 cm x 60 cm reinforced concrete cross beams placed on the rock slope. As discussed in the previous paragraphs, the rock formation in this area is sensitive to weathering and erosion, the exposed slope must therefore be properly protected. After cleaning to the fresh rock surface, shotcrete, 5 cm in thickness, was sprayed onto the exposed surface. In order to reduce tension cracks, steel wire mesh was placed in the shotcrete. Figure 7 shows the stabilized slope two years after the construction.

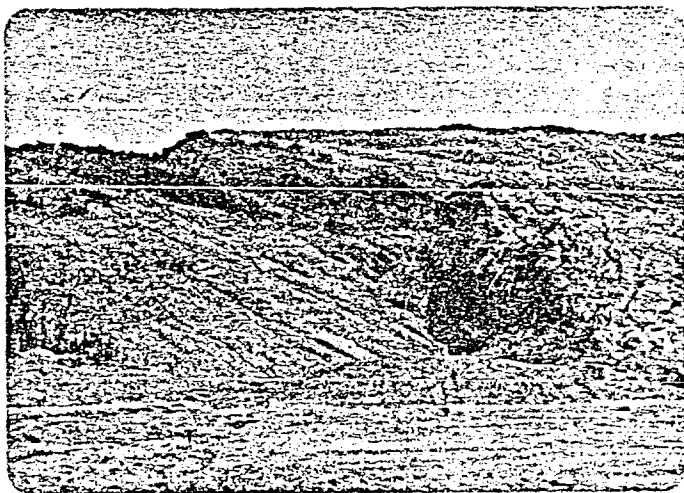
Fig. 8 Slide at Station 128 K

At Station 128K of the N-S Freeway, there is a long cut slope approximately 450 m in length and 85 m high. The slope surface was not protected. Due to exposure to rain water and weathering action, a large slide occurred in 1978. The original slope was at an angle of 20° to the horizontal. After the cut, the 85 m high slope is divided into 10 steps with berms at each step. The height of each step is 8 m with a side slope of 1 on 1.8 except that the top two steps have side slope of 1 on 2. At each berm, horizontal drains and side intercepting drains were constructed. The total amount of material removed from the cut was about 520,000 cu. m. The slide occurred in the middle of the cut area started from the edge of the 9th berm towards the Freeway. The sliding mass was bounded by bedding planes and joint surfaces and was in a wedged shape as shown in Fig. 8. The total amount of sliding mass was about 25,000 cu. m.

The rock formation in this area belongs to the upper strata of the Cholan Formation of the neogene pliocene era. They are mostly alternative layers of sandstone and siltstone-shale. The sandstones are generally loosely cemented and soft which are easily eroded by water. The shale formation is sensitive to water, becomes soft and swellable upon contact with water. Swelling may reach as high as 23%. Upon weathering, the shale will gradually disintegrate in an onion-like shape or form cracks and fractures. The direction of the beddings is generally between $N5^{\circ}W$ to $N25^{\circ}W$ with dip angle of $20^{\circ}SW$. This forms a monocline type of geological structure.

Results of stability analysis according to method proposed by HOEK and BRAY (1977) indicate that the entire slope would have a safety factor about 1.5 under the condition of no pore water pressure. This factor of safety is adequate to maintain stability of the slope. The remedial measure therefore emphasize the installation of adequate underdrainage and surface drainage. furthermore, cement mortar was applied to protect the slope surface from erosion and infiltration.

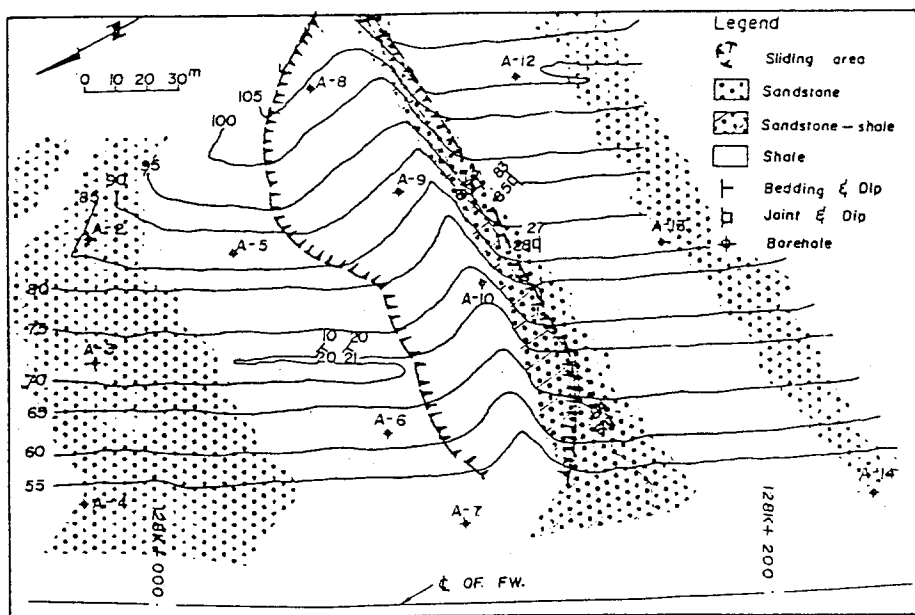
Fig. 9 Geological Map of Station 128 K

and the cut slope according to space geometry, a wedged shape failure was obtained. During the investigation, several sets of joints were discovered on the slope outside the sliding area. These joints have strike at $N83^{\circ}E$ with dip of $53^{\circ}NW$, and the joints extended for 5 to 10 m in length. The directions of these joints are very similar so those found in the sliding area. In areas near the slide, joints with openings of 2 to 3 cm were also found. All these observations indicate that the safety of the entire slope was in question. Figure 9 shows a geological map of the sliding area.

From results of geological study and site exploration, cross-sections were prepared. These sections show that the rock formations in this region crisscross with each other in a parallel pattern which is a clear characteristic of monocline structure. Piezometric data indicate that in certain parts of this region, the underground piezometric pressure is very high, particularly during rainy season. For example, the piezometric pressure head of the piezometer installed in the sandy shale formation at 7 m below the ground surface in Borehole A-14 was 1.2 m higher than the ground surface. Overall speaking, this phenomenon was confined to localized areas. Since the entire surface of the slope concerned was exposed, the rain water would either flow along the surface to drainage ditches which would cause erosion, or permeate through cracks, joints and bedding planes into the rock

formation. These water would stop at the upper boundary of the shale stratum which has rather low permeability and thus form a temporary perched water zone. These perched water zone is a major cause of instability of the slope.

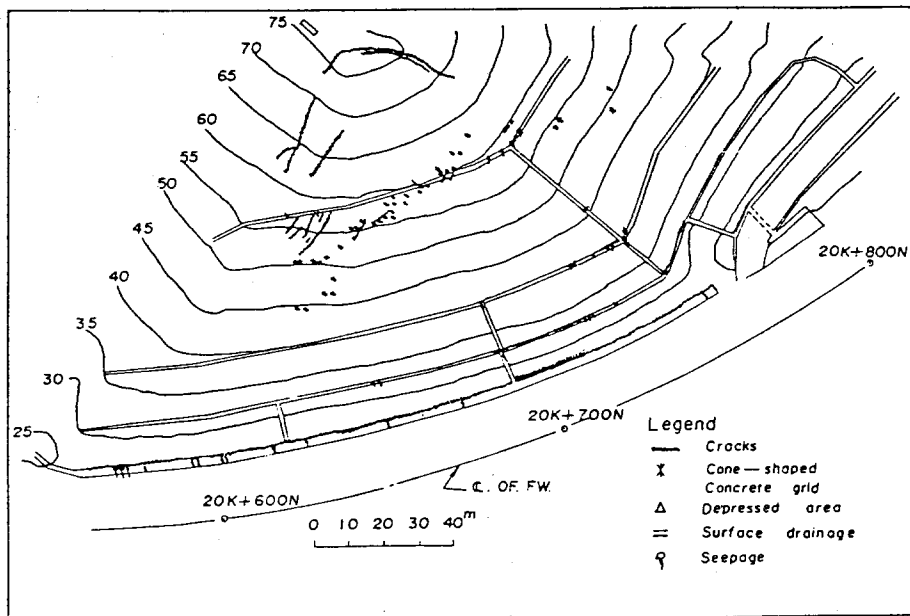
Fig. 10 Geological Map of Station 20 KN

At Station 20k+700N, there is a 50 m high, 250 m long, slope on the north side of the Freeway. The slope faces the highway in a fan-like shape as shown in Fig. 10. Prior to the construction of the Freeway, the original terrain in this area is a cut slope with a dip angle of 20° . The slope was steepened to 26° with localized areas up to 28° for the Freeway. During the construction of the Freeway, some landslips have occurred along the slope. The slope surface was then covered with concrete-grassgrids. In addition, there were three horizontal surface drains connected to a transversal intercepting drain.

A detailed investigation was carried to delineate the causes of the slope instability. It was found that from the surface to a depth of about 21 m, the slope is composed of interstratified layers of sandstone-shale and siltstone. There were three strata of fractured materials interbedded in the formation. The bedding planes of the surface layer dip towards the highway. The piezometric pressure of the groundwater in this area does not appear to be exceptionally high which was even not affected by the Norris Typhoon.

It was found that it is impractical to stabilize a creeping slope with rock anchors or retaining structure. The most efficient way is to reduce the mass of creeping body and to flatten the slope. The main remedial measures adopted for this slope involve the removal of a part of the rock mass in the upper central portion, cutting the upper slope into two steps with side slope of 20°, installing additional surface drains, and protecting the entire slope with grass plants without concrete grids. At the time of preparation of this paper, the design of the remedial measures was completed but construction has not started. In order to ensure long term safety of the slope, a monitoring system including installation of slope indicators, piezometers, and surface measurements was incorporated in the design.

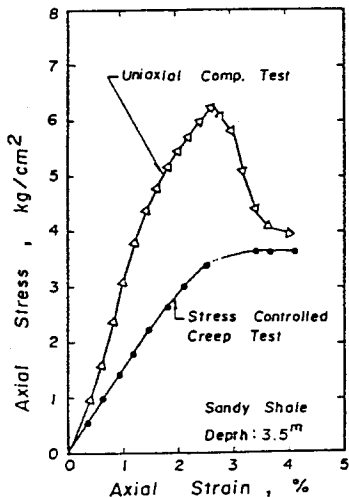
Fig. 12 Creep Test Result of Sandstone-Shale at 20 KN

The sandstone-shale and siltstone formations are composed of fine particles which have high creep potential. Laboratory test results, as illustrated in Fig. 11, indicate that the rock slope in this area would develop significant movement due to creep under constant load. Furthermore, additional creep could develop due to seasonal variations in water content and differential strength characteristics between the various rock strata at the contact surfaces.
