SETTLEMENT OF UNDERPINNED STRUCTURES IN SINGAPORE

by
H. Todo, R.N. Hwang and T. Hulme

Hiroaki Todo, Kiso-Jiban Consultants Co., Ltd., Tokyo
Richard Hwang, Moh and Associates, Taipei
Terry Hulme, Mass Rapid Transit Corporation, Singapore

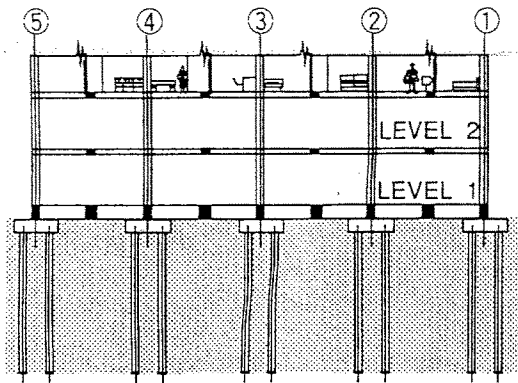
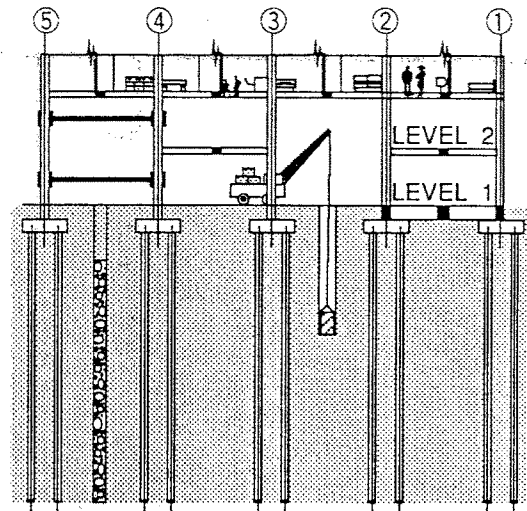
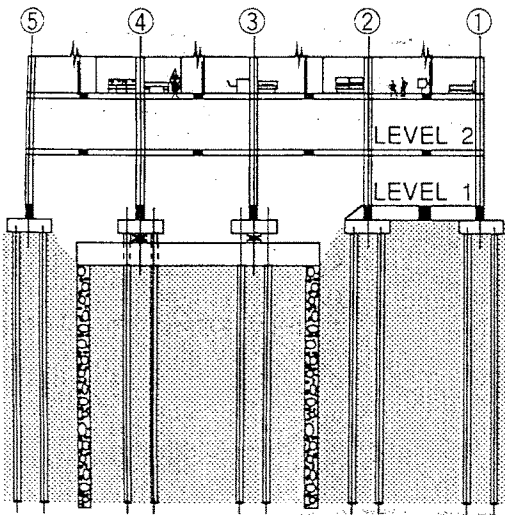
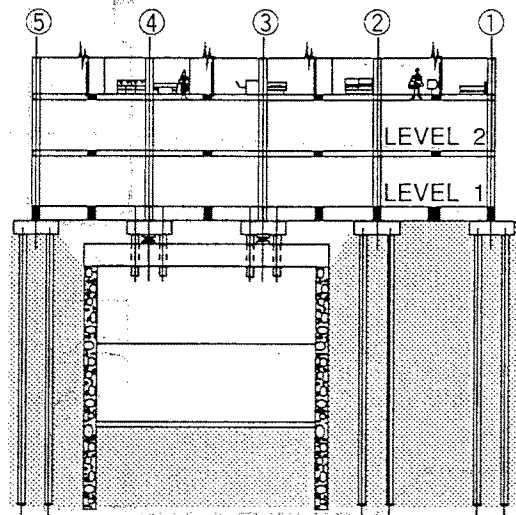
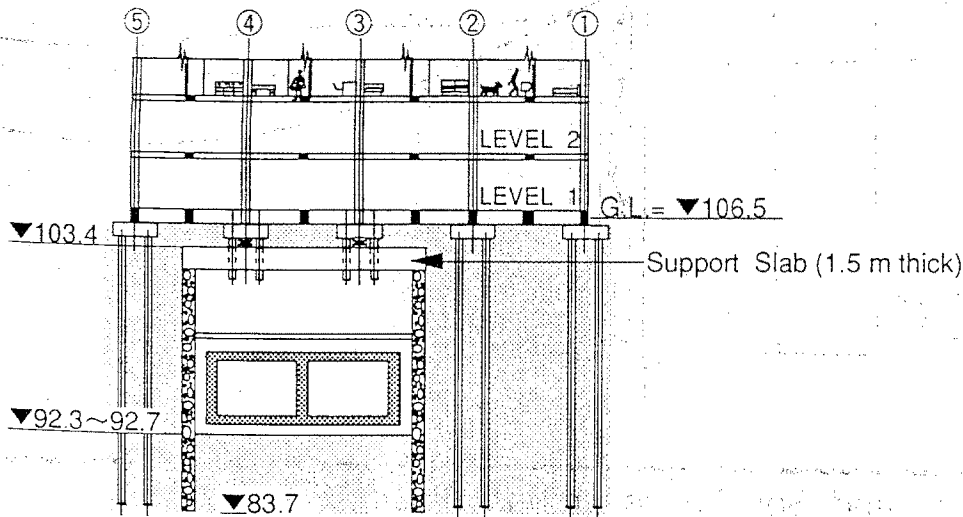
Figure 2 Sequence of Underpinning and Tunnel Construction

Figure 2-(1) shows the condition of the building before the construction work. Settlement monitoring started on May 2, 1984. When the construction of the diaphragm wall started, there was no immediate settlement. Figure 2-(2) shows the construction of the diaphragm wall in progress. The settlement started mid-way through the installation of the diaphragm wall around early to mid-May, 1984. At the completion of the diaphragm wall installation, the

settlements were 1 to 6 mm with an average of 3.2 mm.

Figure 2-(3) shows the excavation at the top of the diaphragm wall and the casting of the support slab. Figure 2-(4) shows the pile cut-off and further excavation. Before the completion of the pile cut-off in early May 1985, some additional settlement occurred as a result of the reduction of shaft friction on piles as the excavation proceeded. The settlements were 4 to 12 mm with an average of 8.3 mm when the cutting of the piles was completed. At this moment, the bottom of excavation was at RL 98 m, giving a total depth of excavation of 8.5 m.

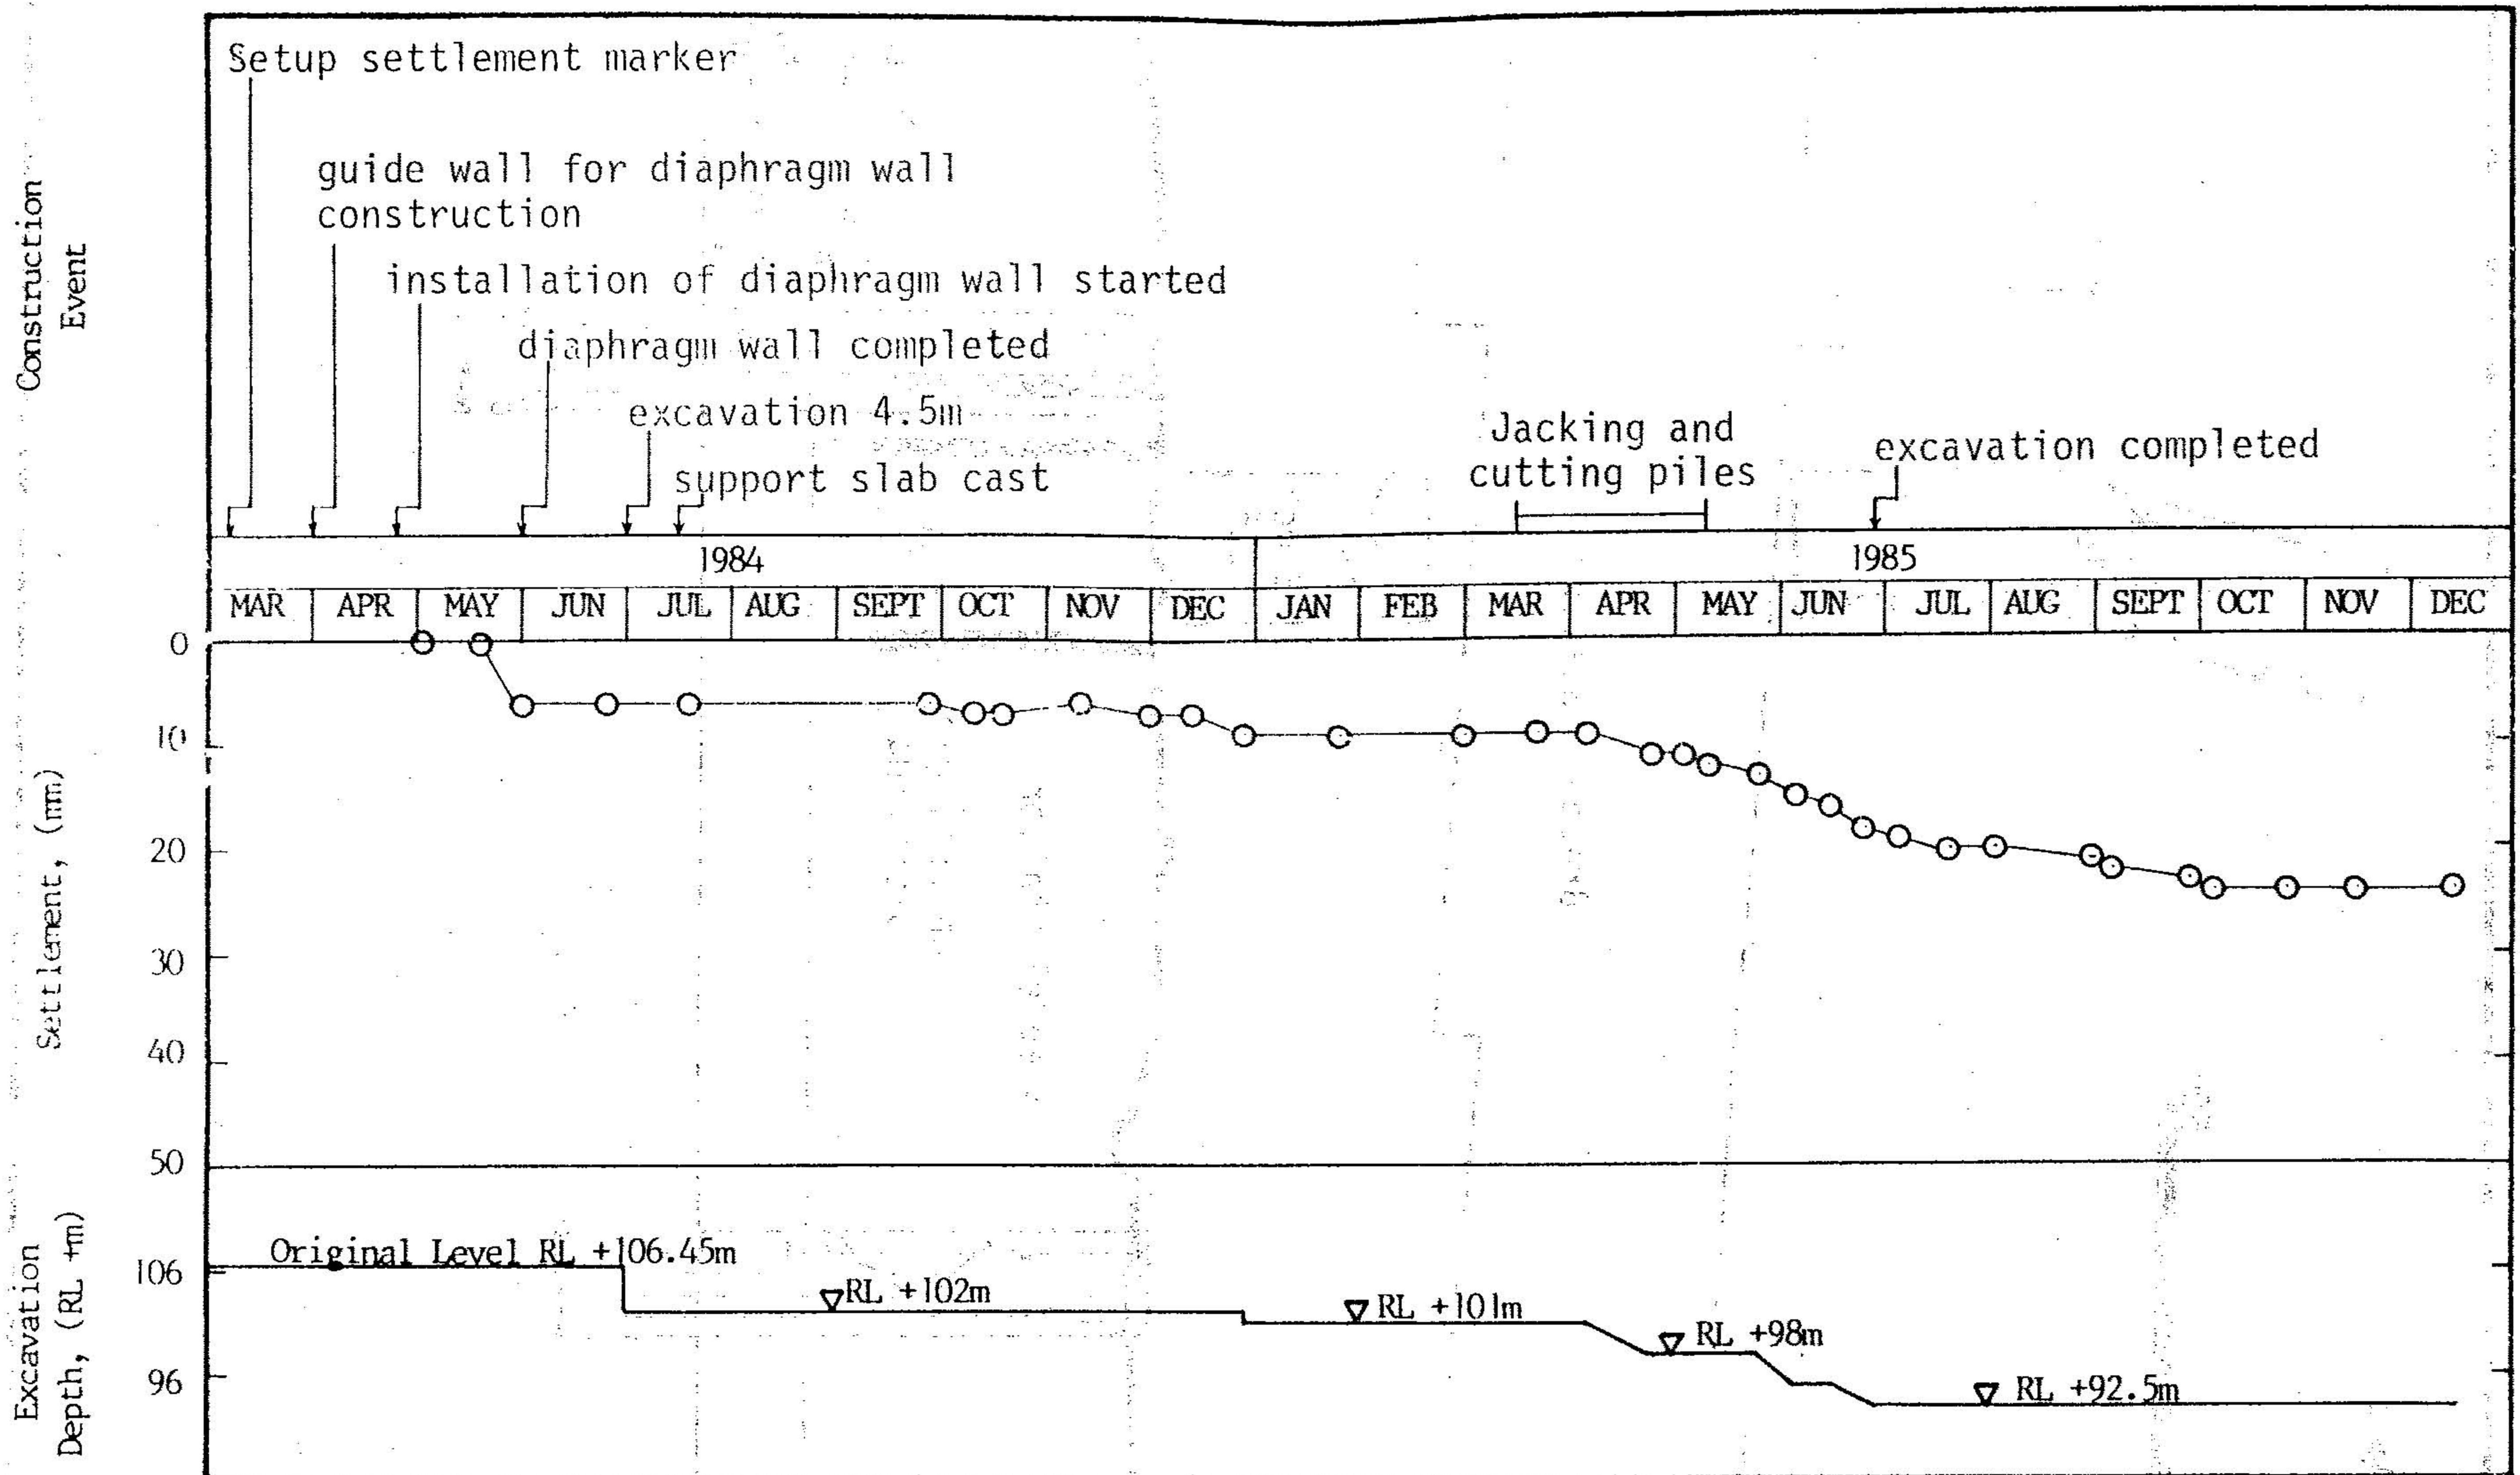
Figure 3 Settlement at Marker 15 at Block 206

All the 17 settlement markers were installed on columns and therefore, registered the settlements of columns. Figure 3 shows time settlement plots for settlement marker No. 15, which registered the maximum settlement among the 17 settlement markers installed. The figure also indicates the construction events and the progress of the excavation.

Major settlement occurred when the excavation proceeded down to RL 92.5 m (additional excavation of 5.5 m) during June 1985. The total settlement was 7 to 18 mm with an average of 13.1 mm when the excavation reached the final level at the end of June 1985. The settlement still continued slightly during the construction of the tunnel box and stabilized in October 1985. The final settlement recorded in December 1985 was 13 to 24 mm with an average of 18.6 mm.

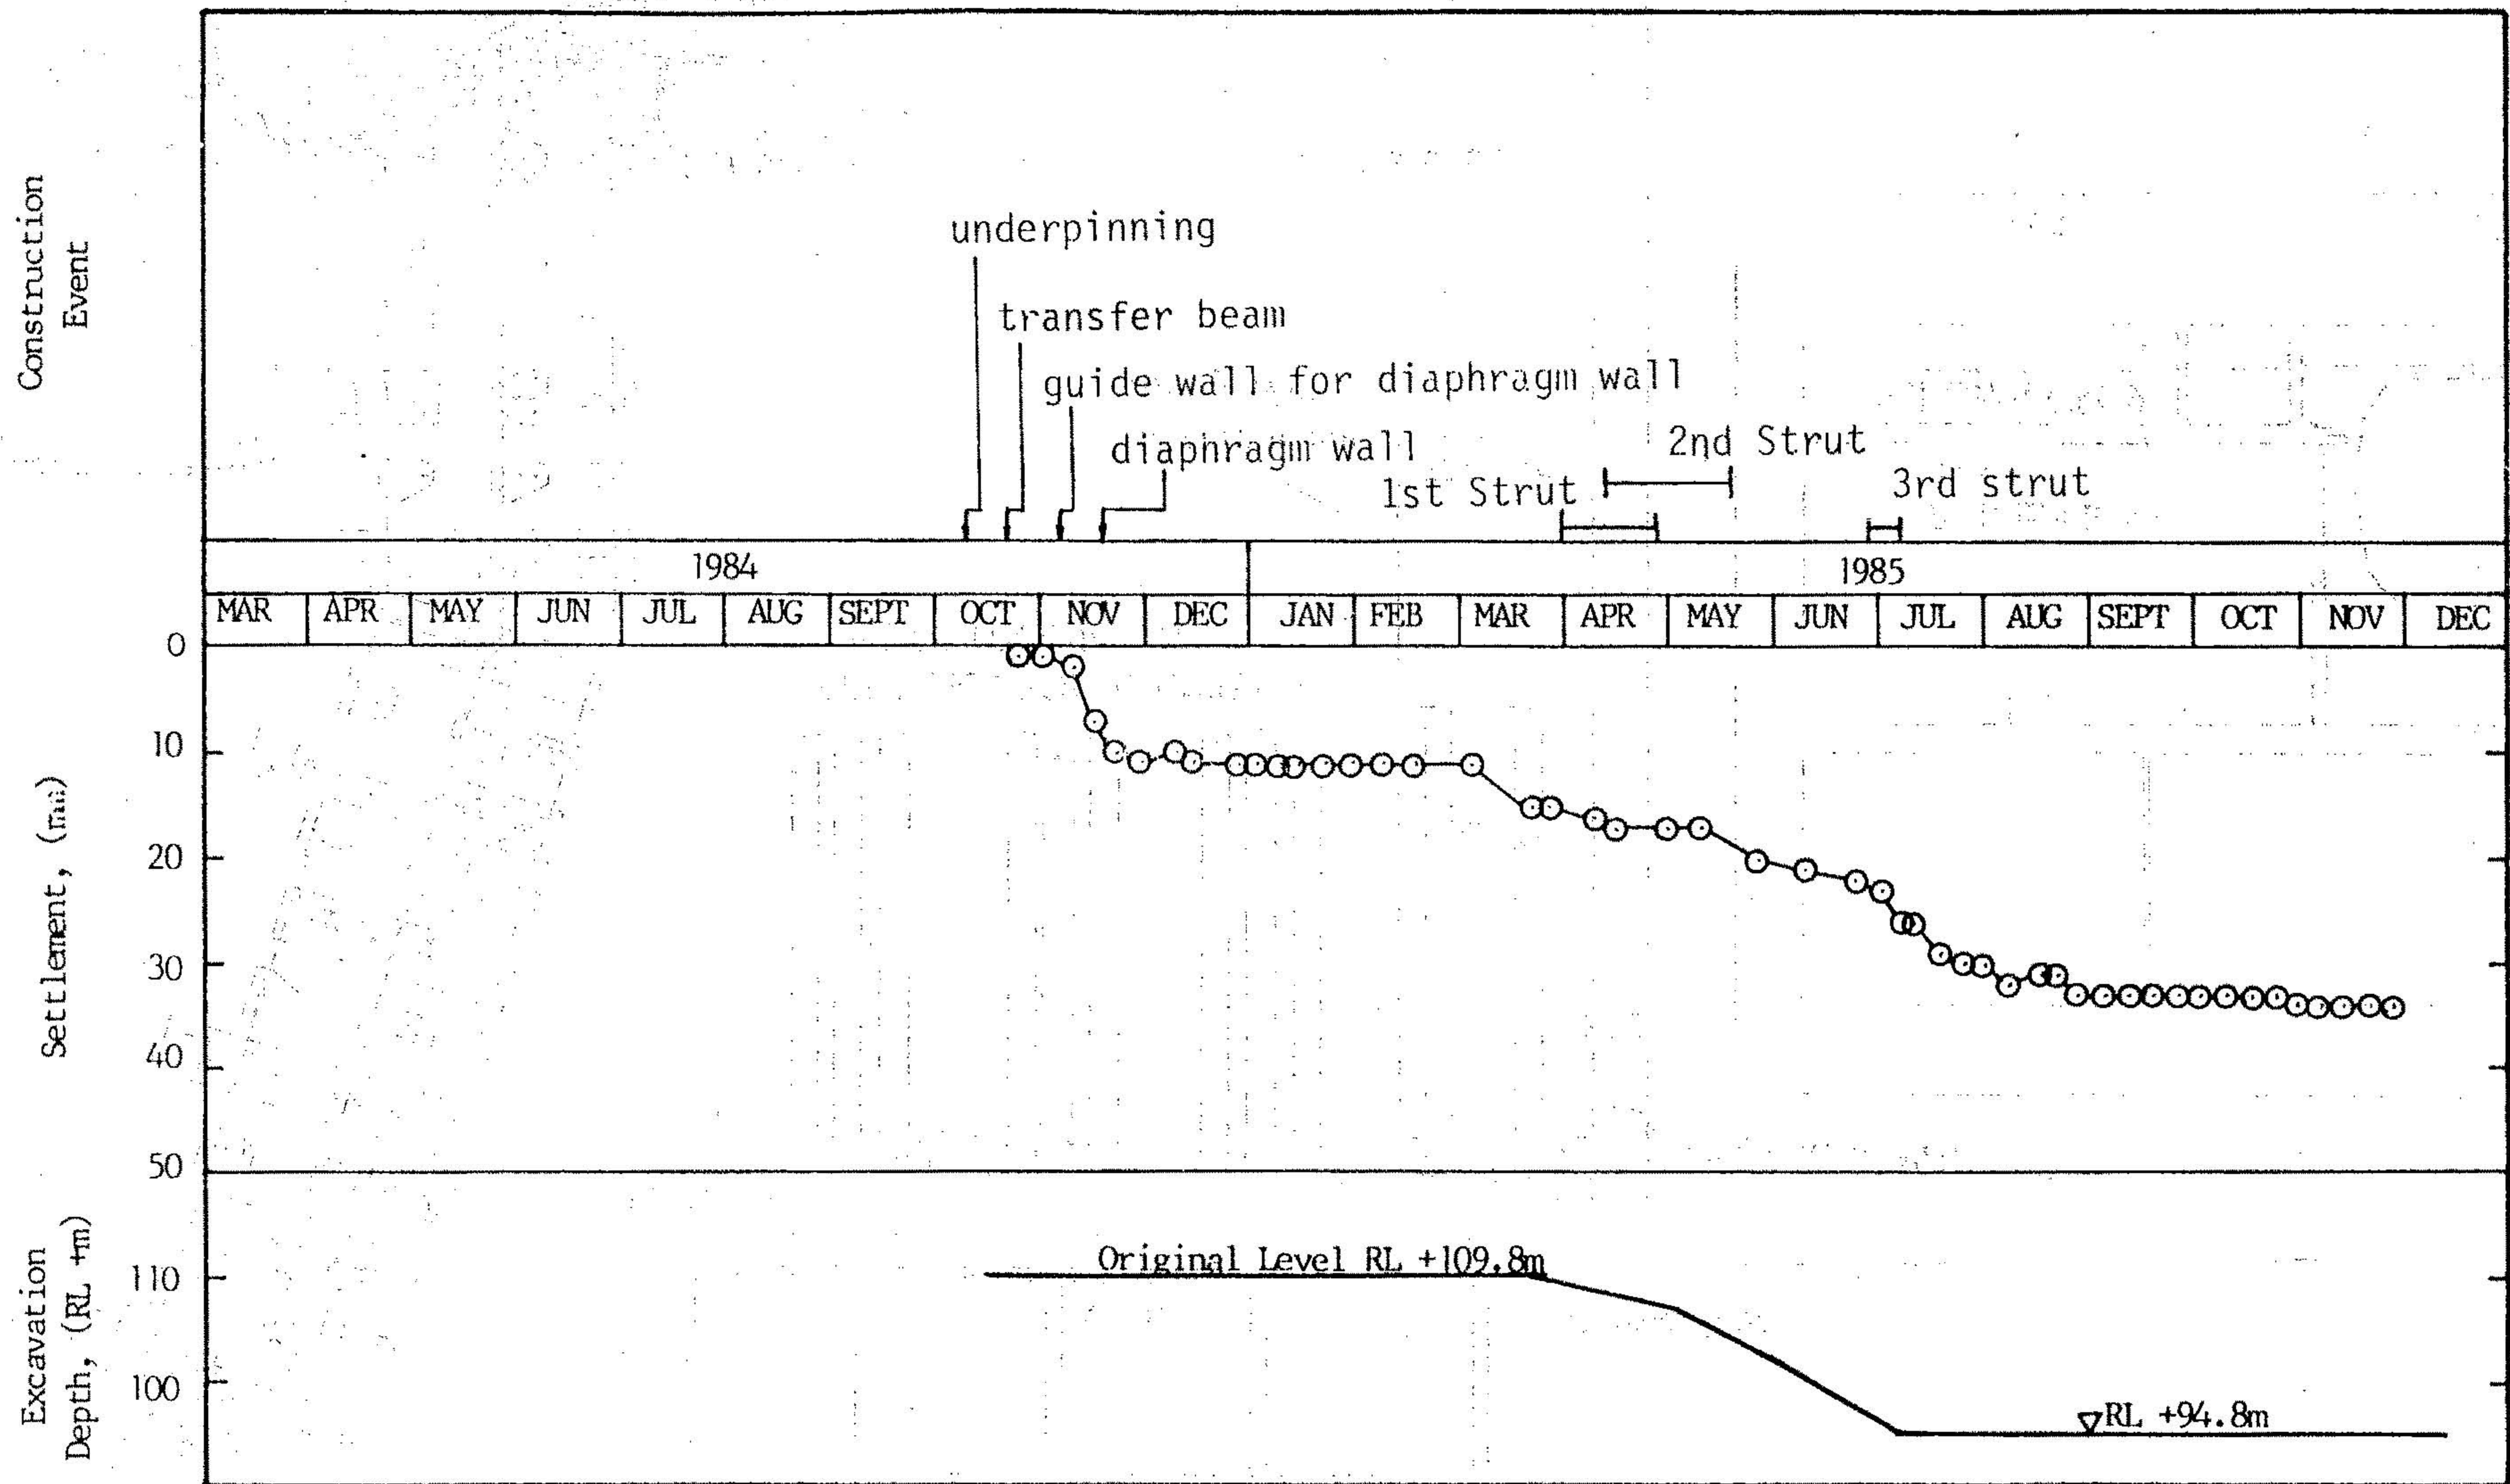
Figure 6 Settlement at Marker 13 at Block 116

The two barrettes were installed in late September, 1984, and station excavation in the vicinity was carried out in the period between early-April and early-July, 1985. Figure 6 shows the time settlement plot for a settlement marker No. 13, which was located at the corner of the building and registered the largest settlement among the 15 settlement markers installed. The maximum settlement

at No. 13 was 34 mm.

During the construction of the underpinning barrettes and transfer beam, there was no recorded settlement. When the construction of the diaphragm wall commenced near the building, settlement started to occur. The recorded settlement at this stage at marker 13 was 11 millimeters. Major settlement occurred when the excavation started in late March 1985 and the settlement continued until shortly after the completion of the excavation.

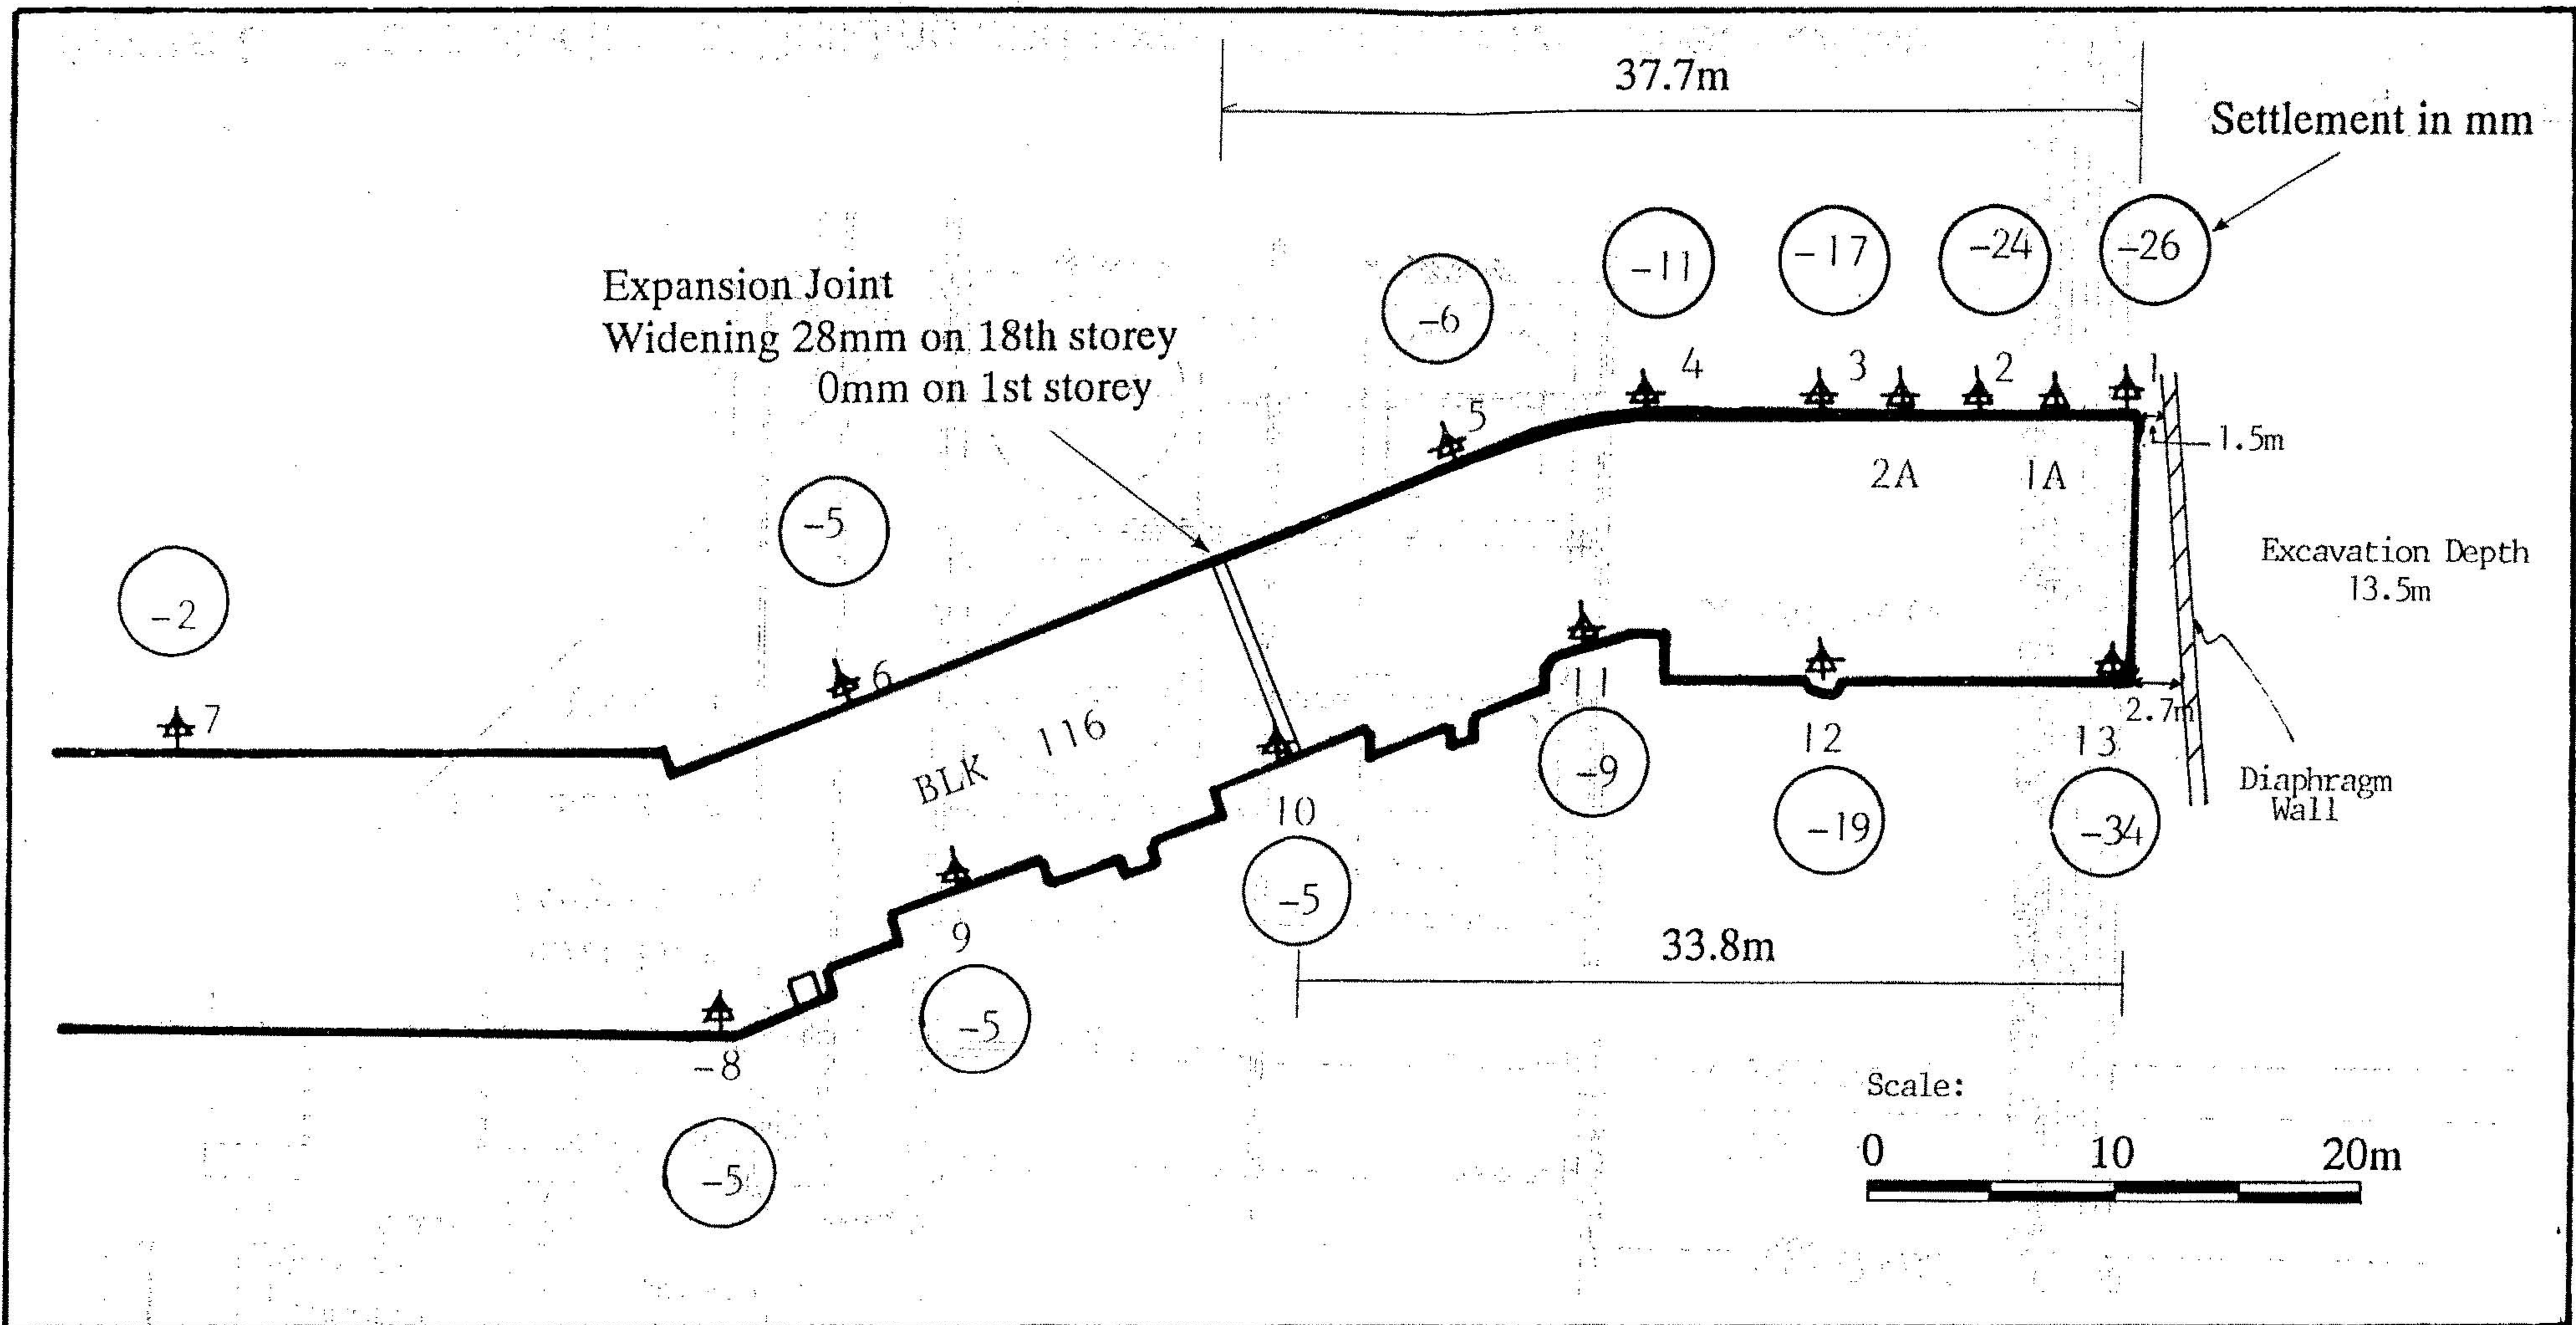
Figure 7 Settlement Readings on 28 November, 1985

Figure 7 illustrates the settlements of the building at the end of the monitoring period. The settlement decreases with the distance from the excavation. The settlement at the edge of the building was 26 to 34 millimeters. There is an expansion joint at 35 to 40 m away from the excavation separating the building structurally into two parts and the settlement at the location of the joint was 6 mm. The expansion joint opened with the width of 28 mm at 18th story. It is surprising that settlement extended to marker No. 7, 80 m away from the edge of the building.

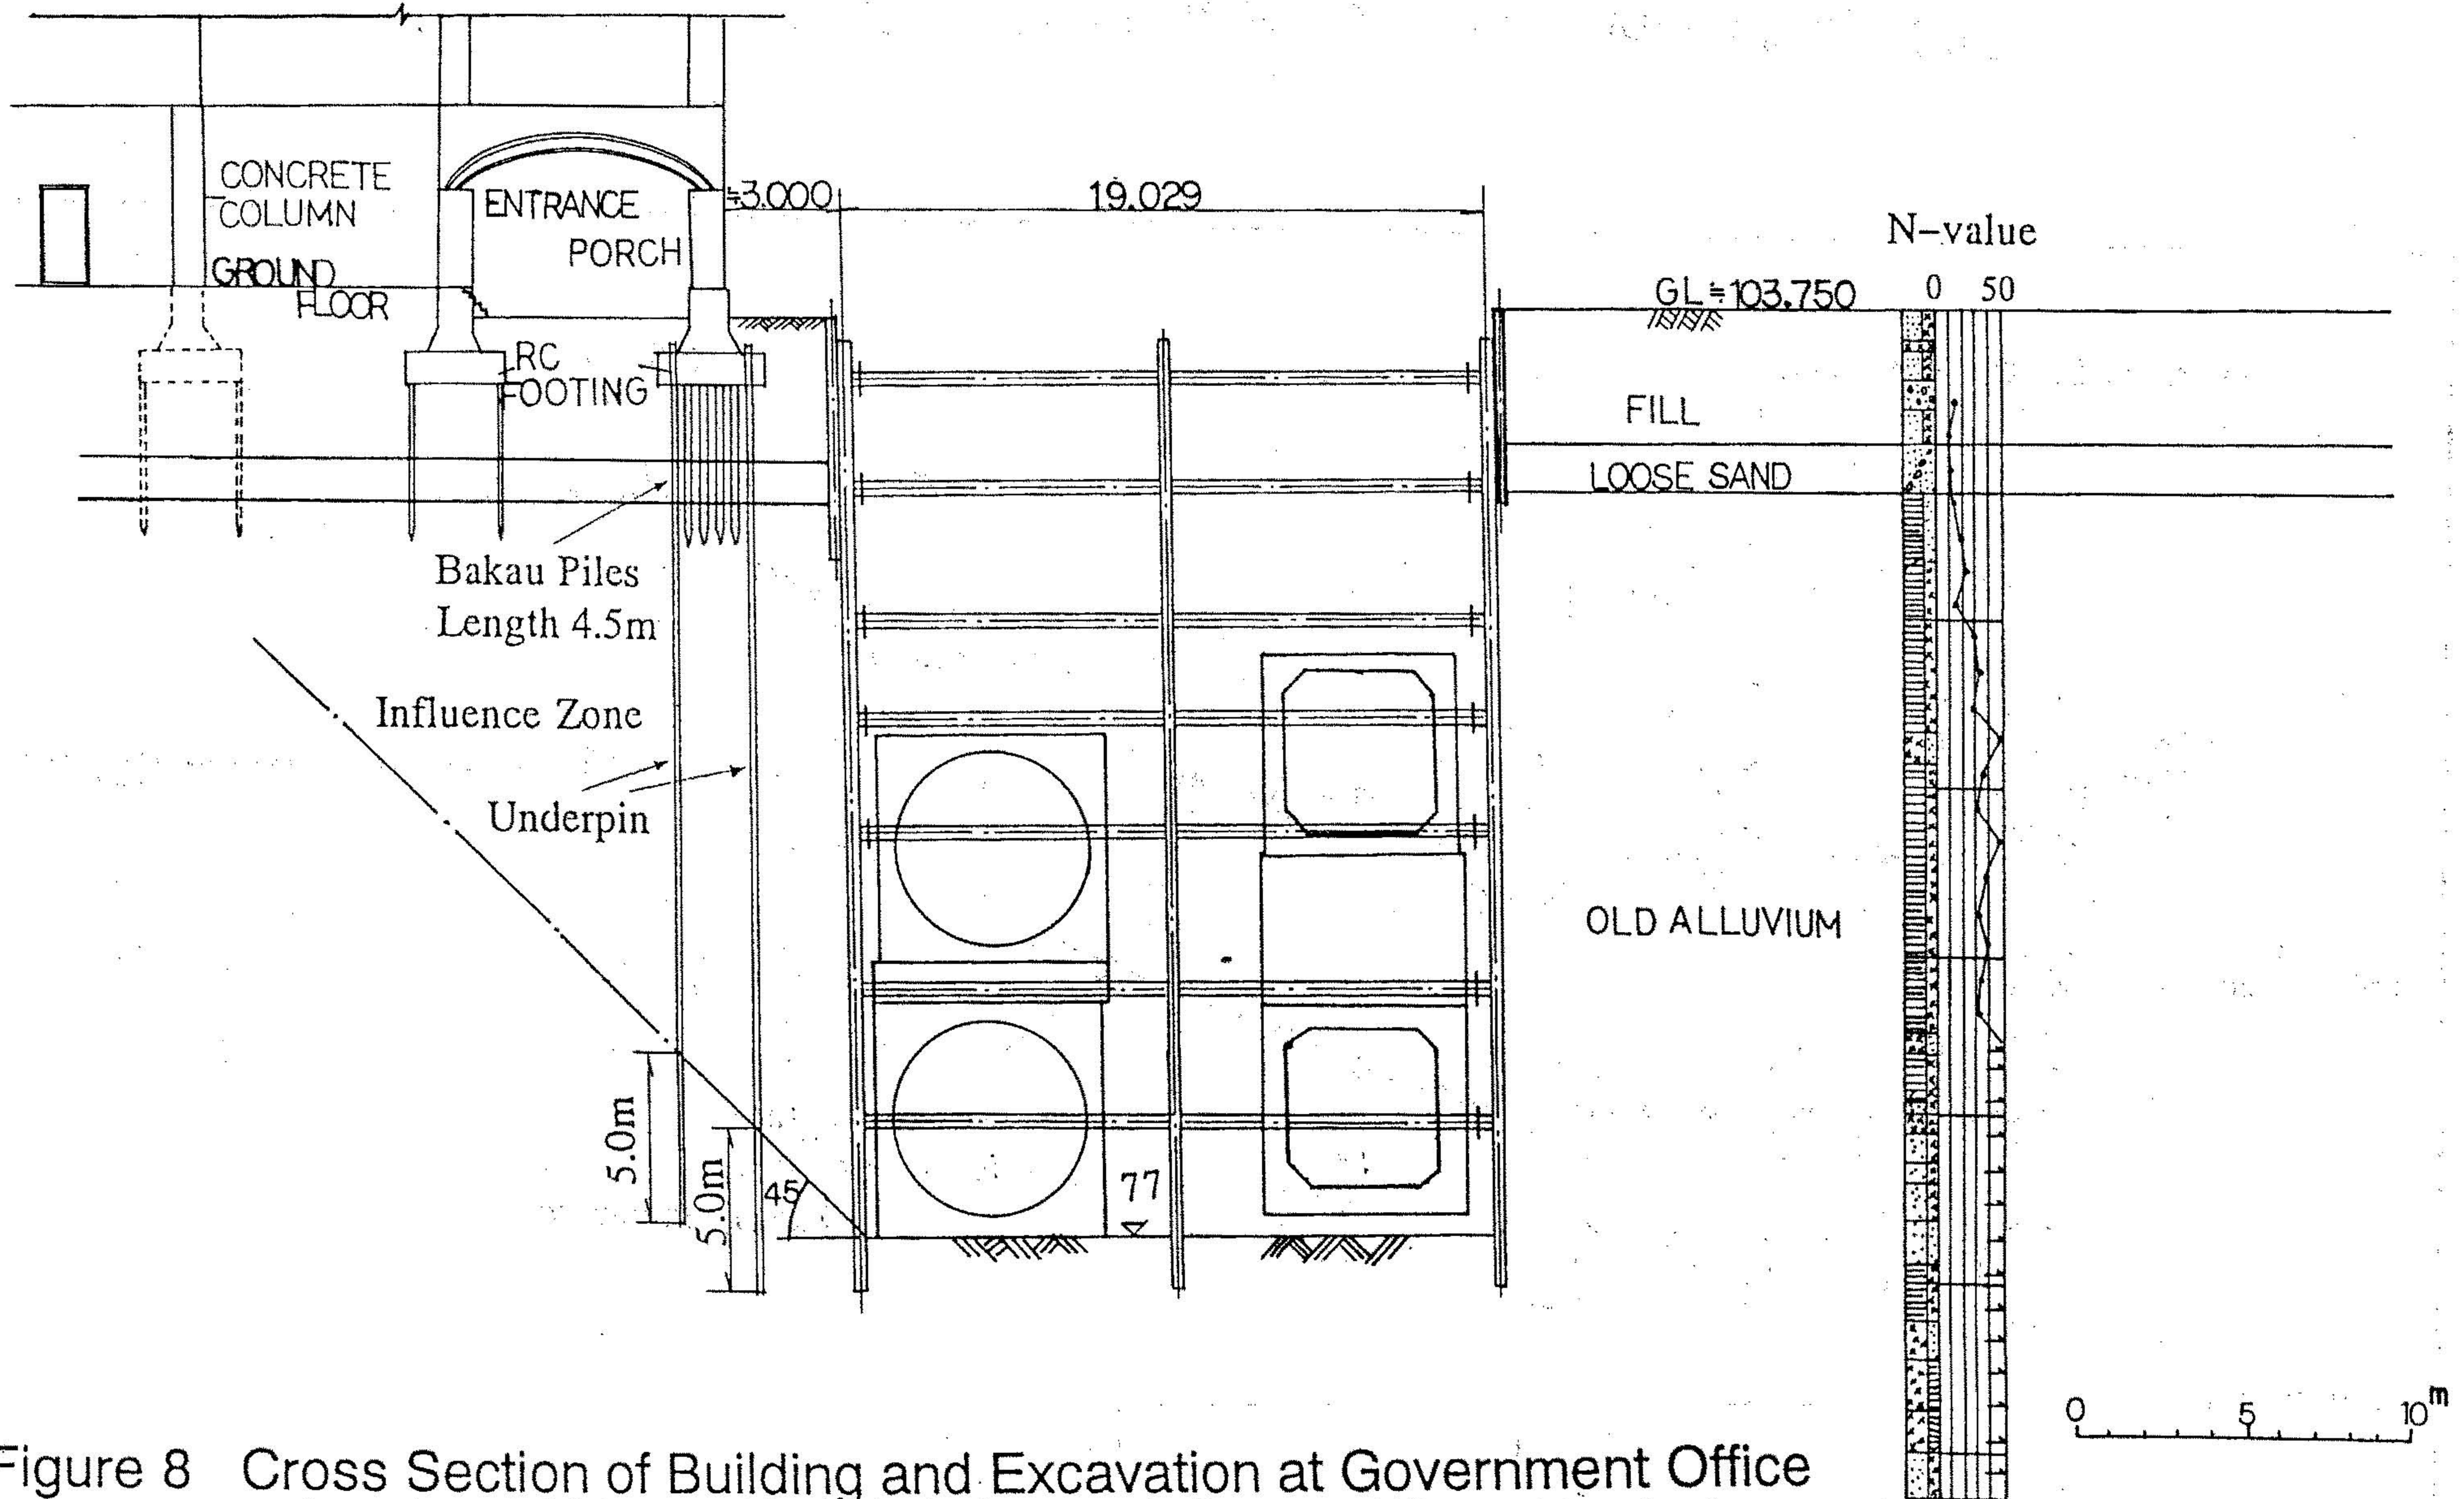
Figure 8 Cross Section of Building and Excavation at Government Office

tunnel, settlement of the building occurred with widespread cracking. The contractor then underpinned the front of the building. However, the cracks continued to widen and the front end of the building was shored by using steel frames as shown in Photo 4. Figure 8 shows a cross section illustrating the building and the excavation.

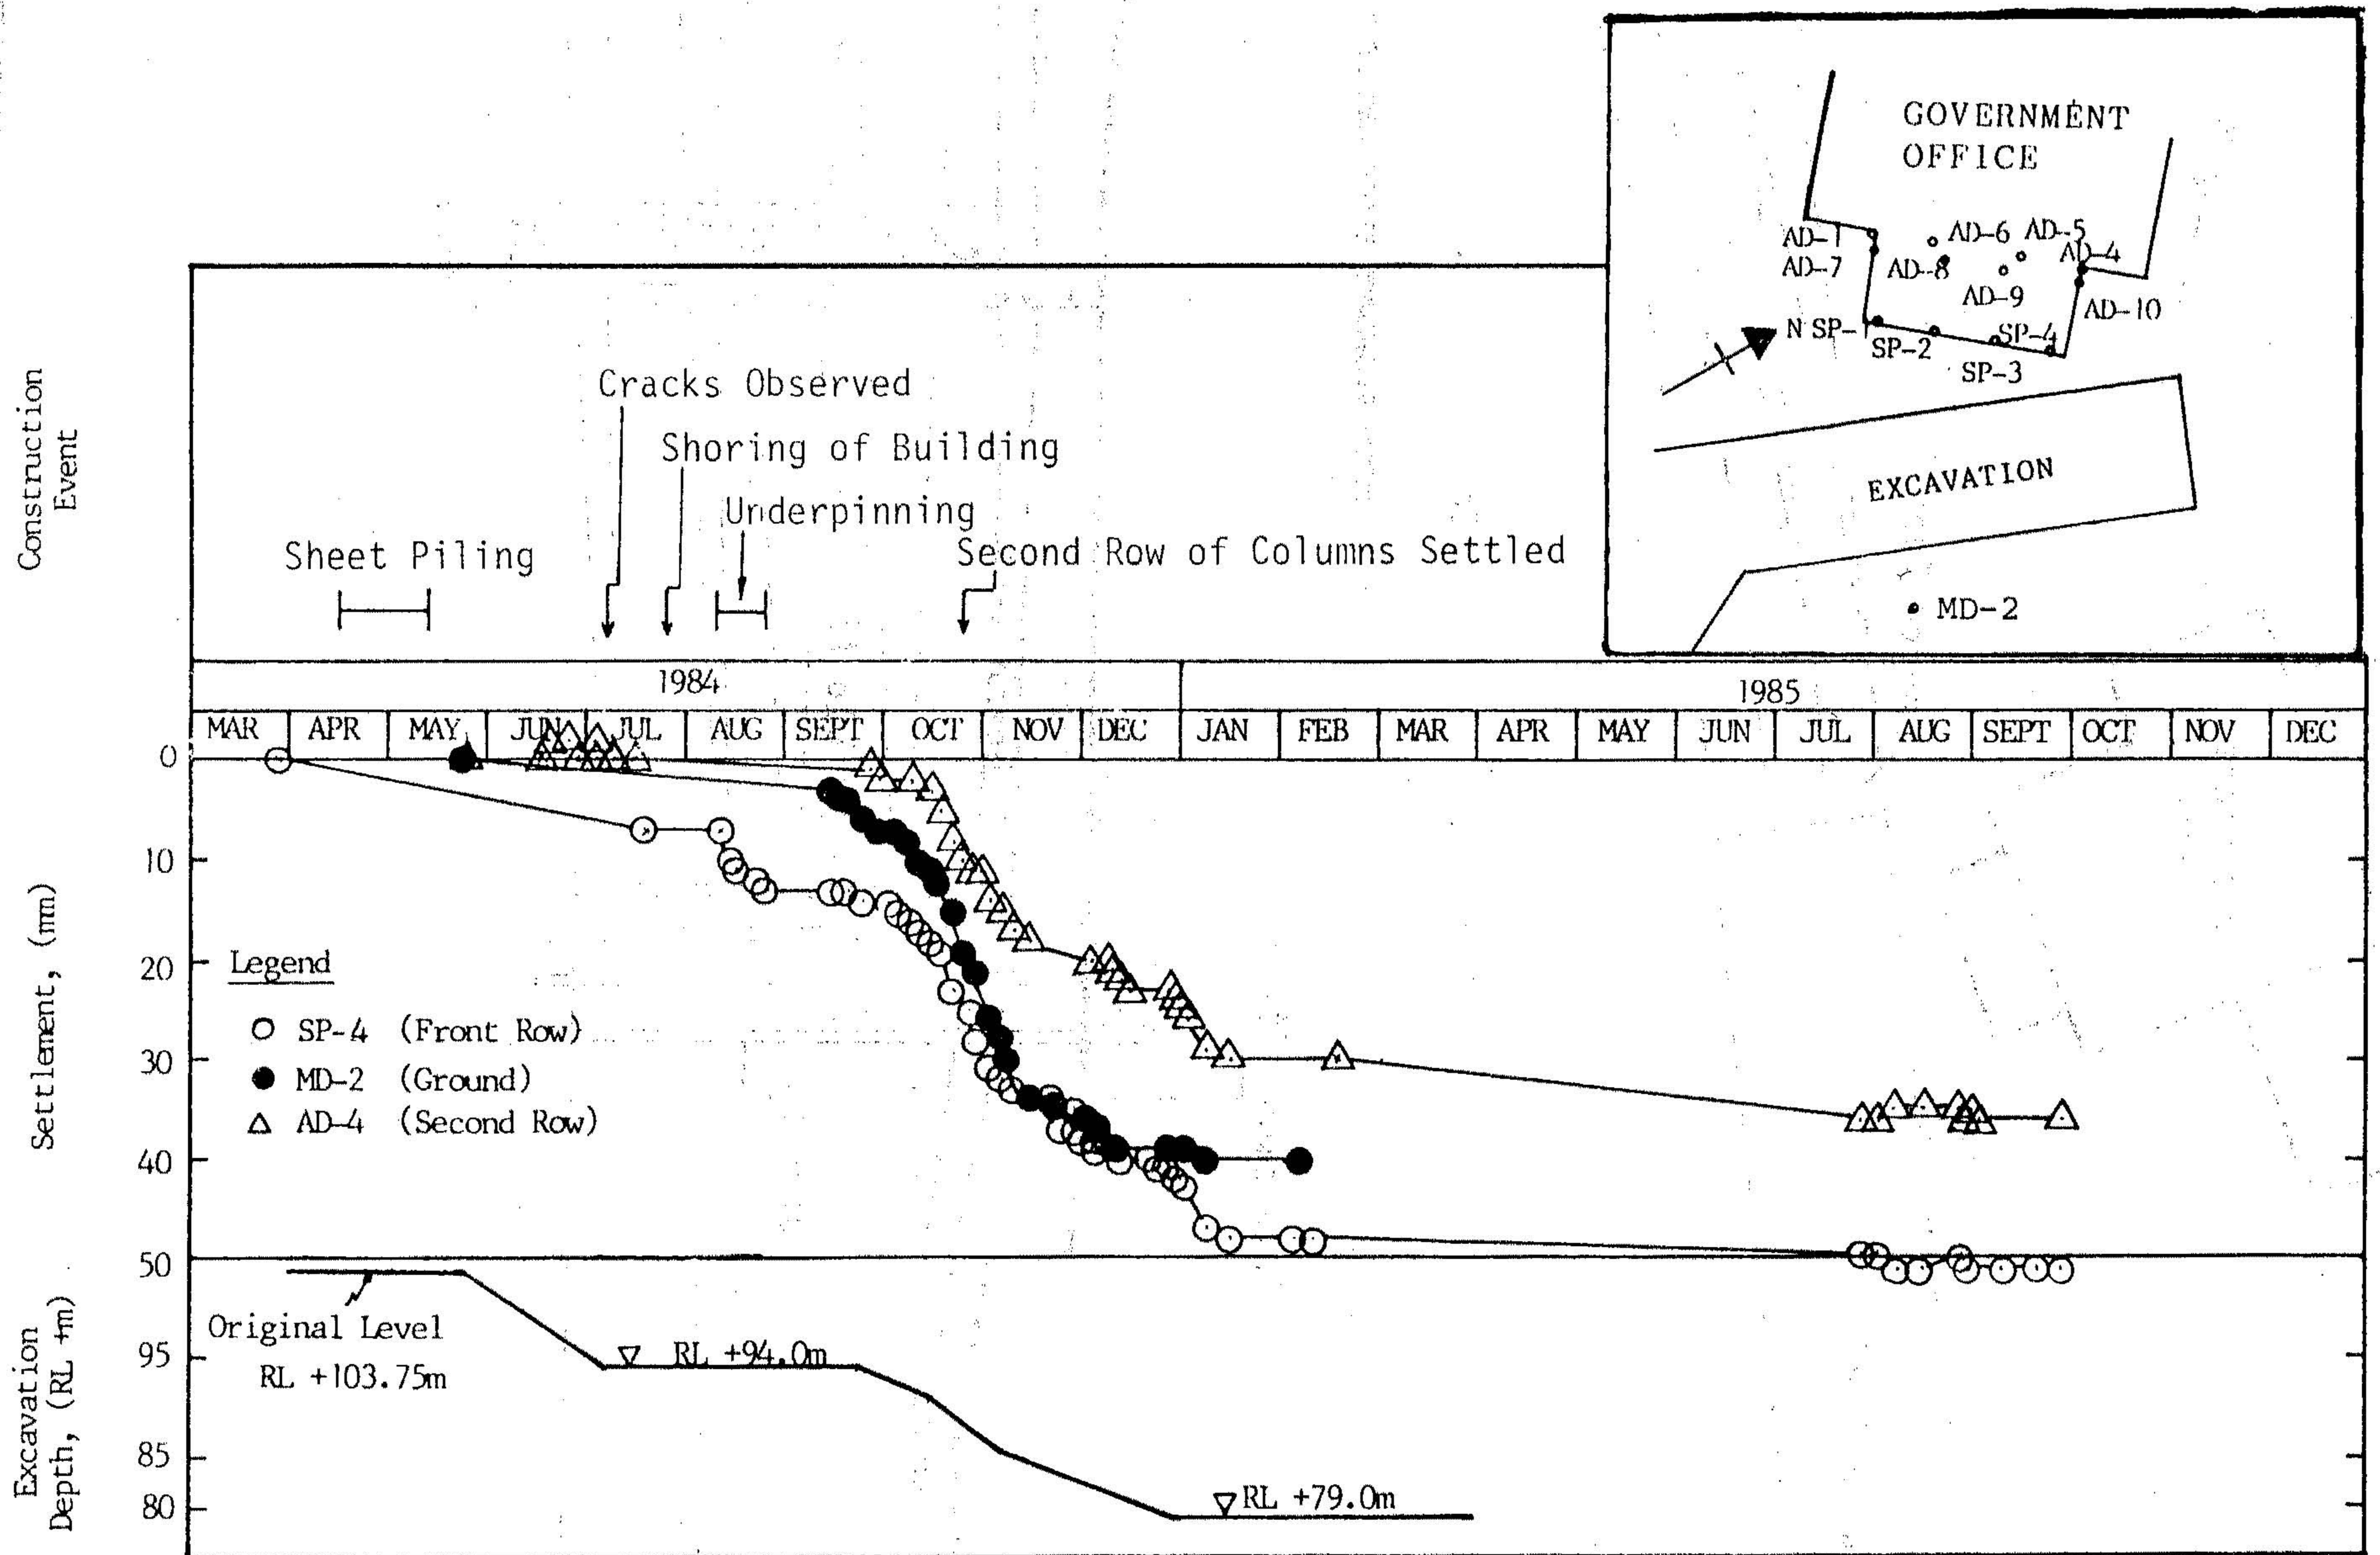
Figure 10 Settlement at Marker SP-4, MD-2 & AD-4 at Government Office

Settlements of the building were monitored from March 25, 1984 to September 30, 1985. Time settlement plots are shown in Figure 10, which indicates the settlement at the front row of the column (underpinned) and second row of the columns (not underpinned) and surrounding ground.

The settlement of the front row columns started when the excavation began in late May 1984. Cracks of the building occurred when the settlement reached 5 mm. Further settlement of 6 mm occurred during the underpinning work. Major settlement started late September when the excavation restarted after the underpinning work. The ground settlement at the opposite side of the excavation and the settlement at the second row of the columns also progressed rapidly. The settlement almost stopped when the excavation reached the final level although a small amount of settlement still continued. The final recorded settlements at the front row of the columns were 37 to 51 mm, which are almost of the same order of the ground settlement as shown in Figure 10. The settlements at the second row of the columns were 30 to 36 mm.
