SETTLEMENT OF UNDERPINNED STRUCTURES IN SINGAPORE

by
H. Todo, R.N. Hwang and T. Hulme

Hiroaki Todo, Kiso-Jiban Consultants Co., Ltd., Tokyo
Richard Hwang, Moh and Associates, Taipei
Terry Hulme, Mass Rapid Transit Corporation, Singapore

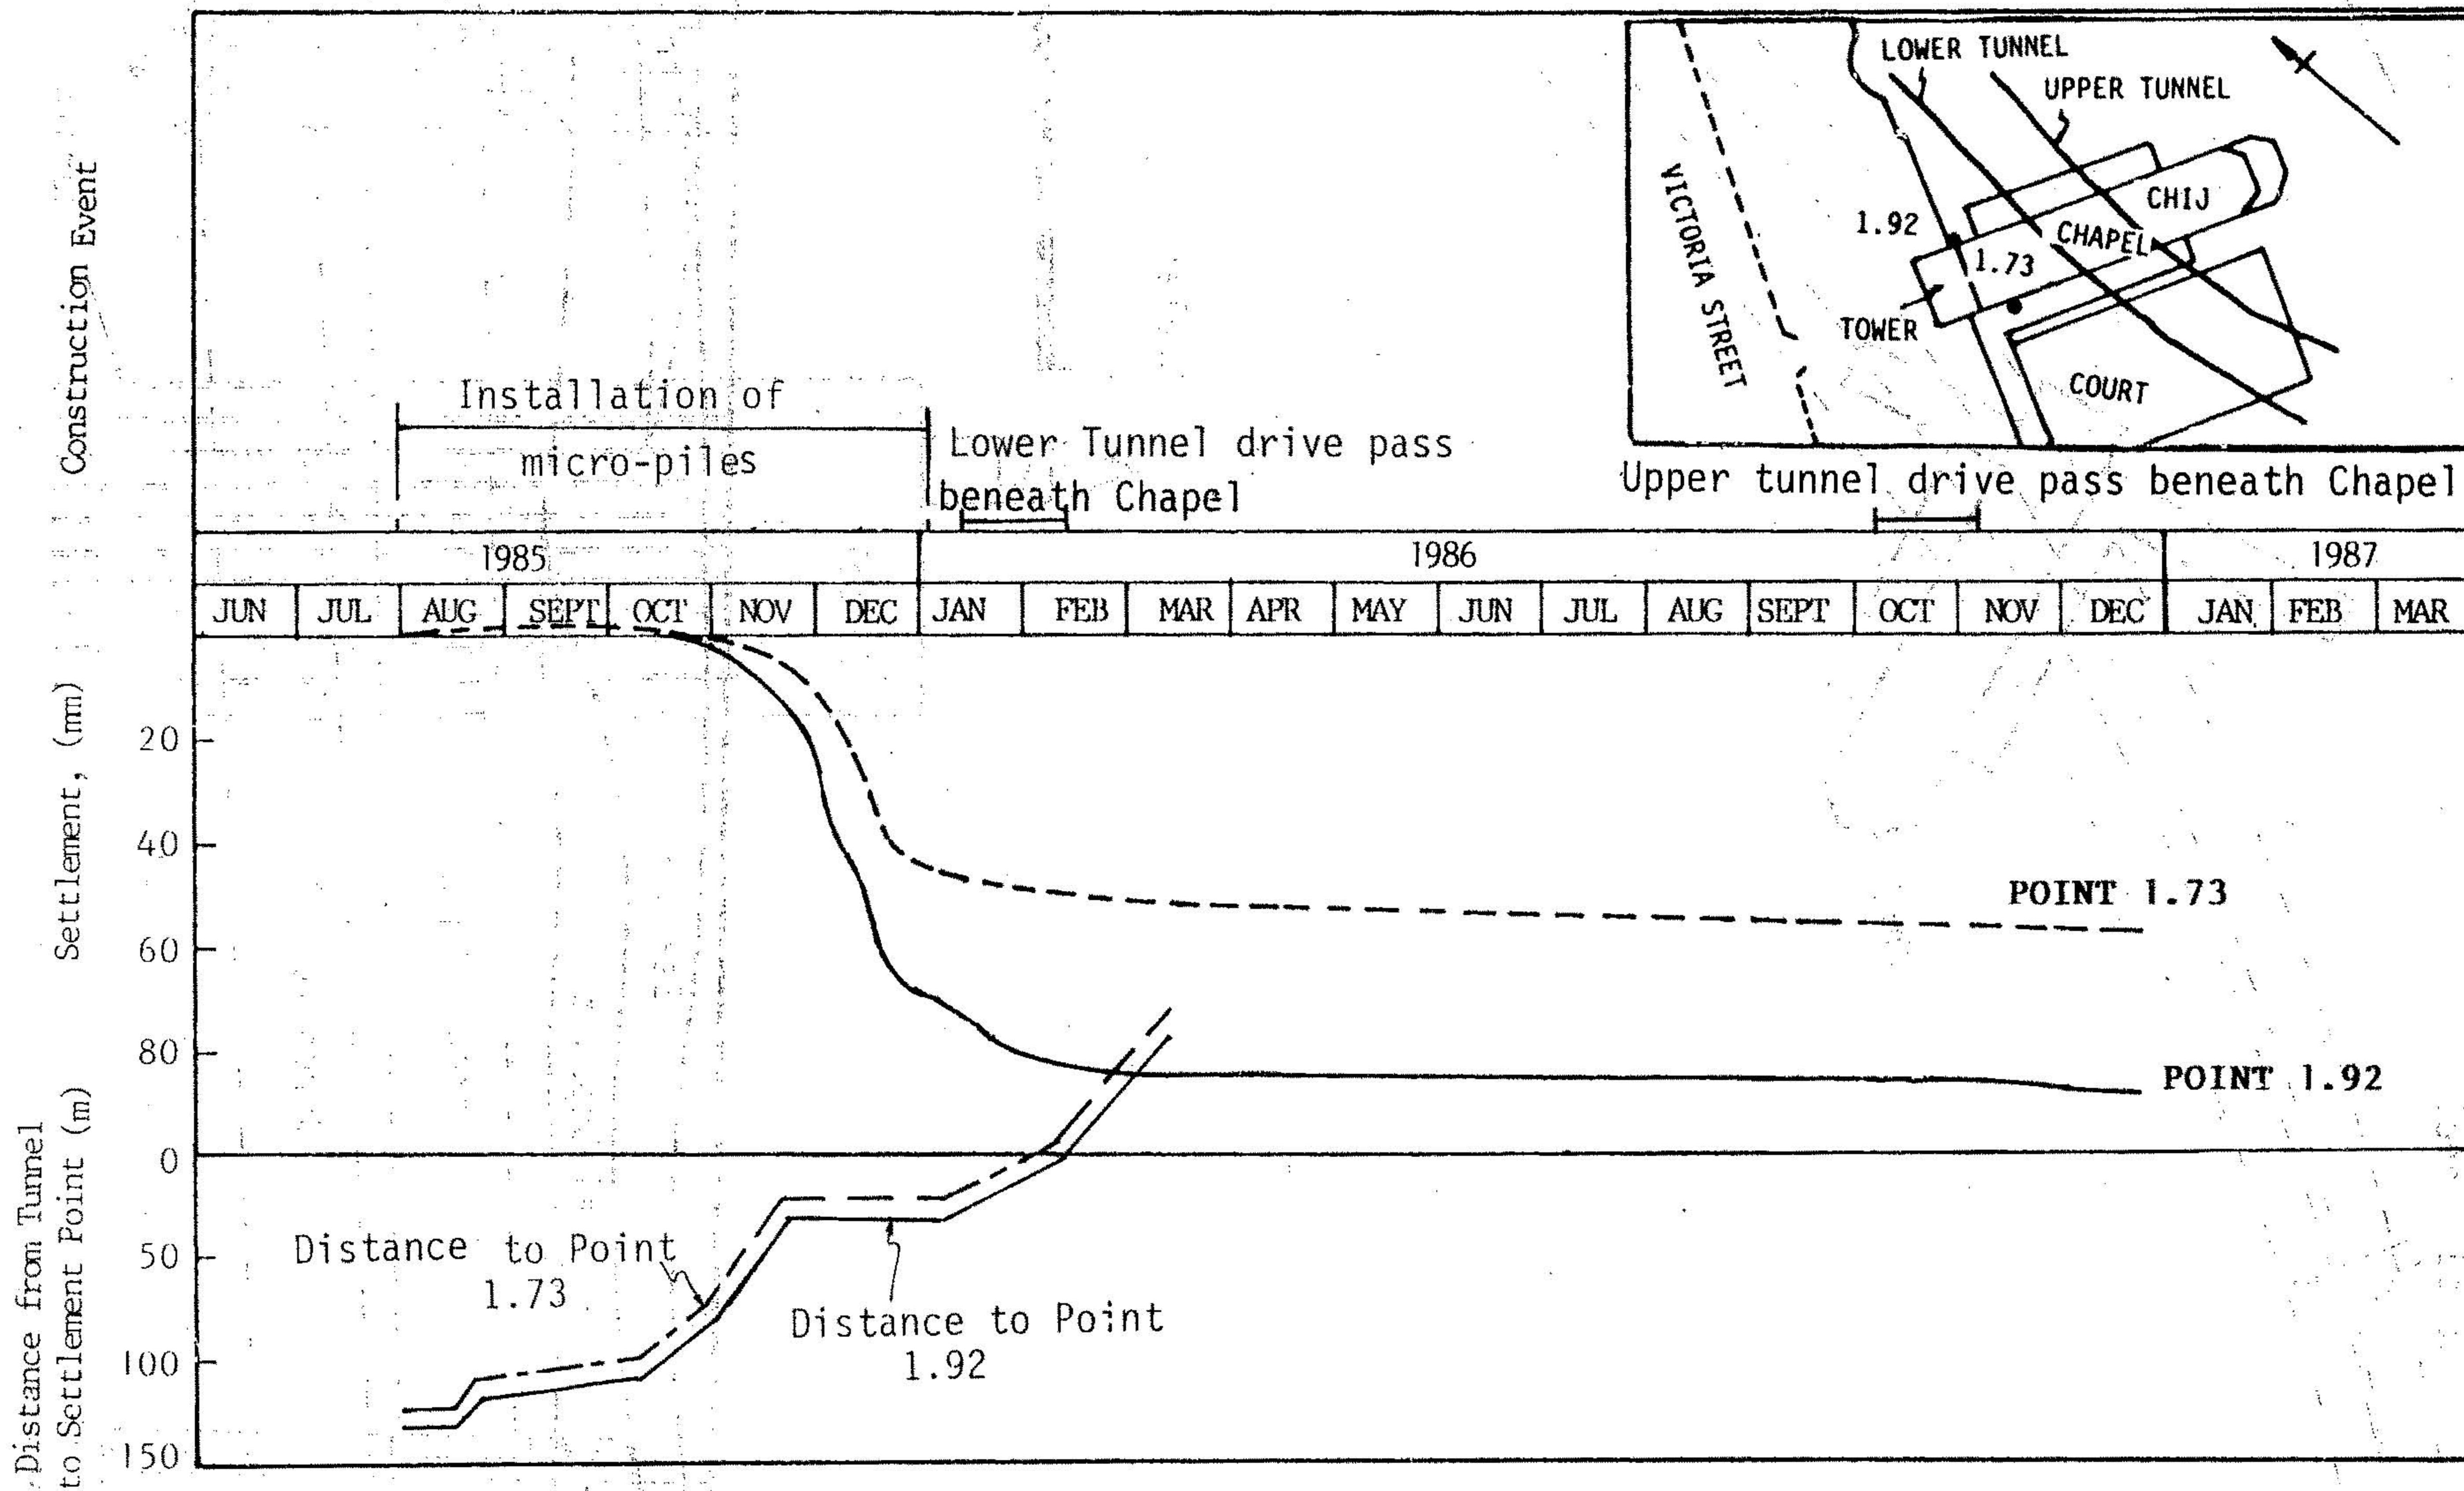
Figure 12 Settlement at Points 1.73 and 1.92 at Chapel

Time settlement plots are shown in Figure 12 for two points, one on the main body of the chapel (supported by the concrete raft) and one on the tower where considerably more movement was registered. The underpinning work started in mid-July, 1985 and continued until early January, 1986. The lower tunnel, started from a nearby shaft in late July, 1985, approached the chapel and stopped in late November, 1985 at a distance away from the building. The tunnel face stayed there until early, 1986.

In this period average settlements of 45 mm and 70 mm occurred on the main building and tower respectively with 50 mm and 90 mm maximum values being recorded. The subsequent tunneling works only increased these values by 7 mm during the passage of the first drive and a further 3 mm due to the second drive.

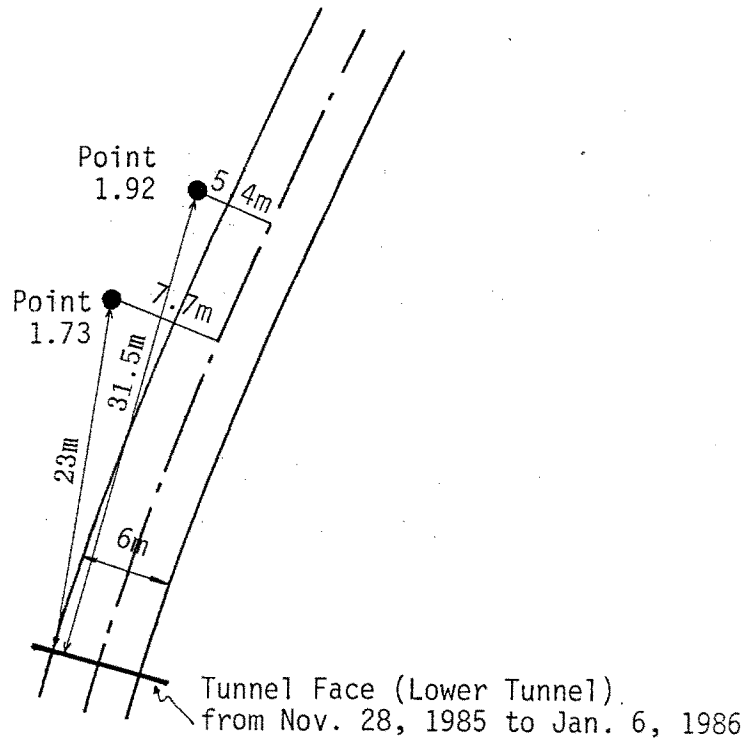
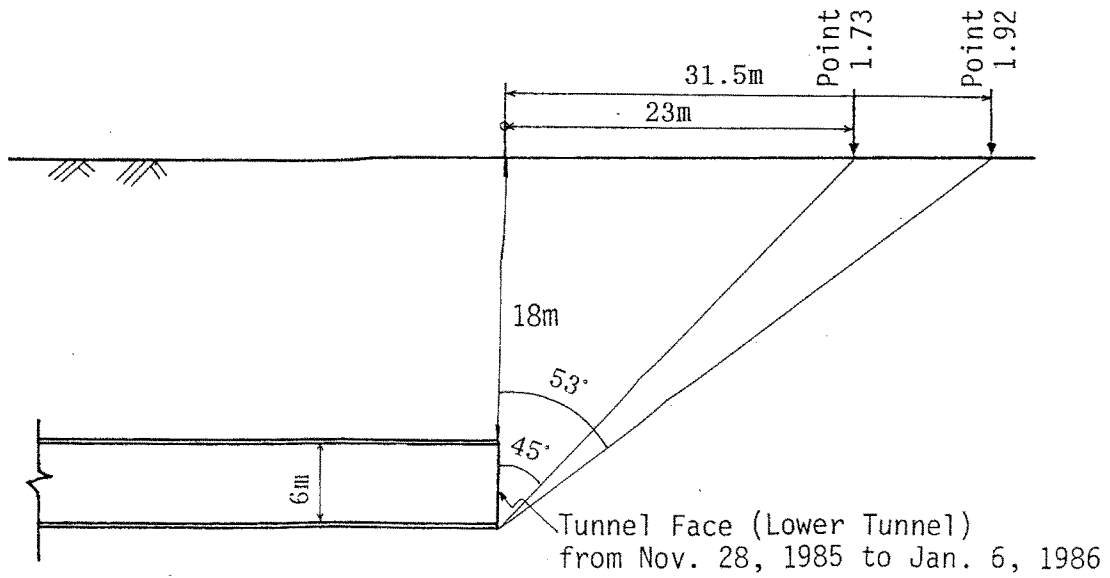
Figure 13 Location of Tunnel Face Relative to Settlement Point 1.73 and 1.92 at Chapel during Underpinning Work

Major settlement occurred in November to December, 1985, which corresponds to second half of the underpinning work period. During this period, the tunnel face approached the building and then stayed at 23 m away from Settlement

Point 1.73 and at 31.5 m from Settlement Point 1.92 as illustrated in Figure 13. The figure shows that these settlement points were located approximately 45 and 53 degree lines extending from the bottom of the tunnel face. The face was sufficiently away from these settlement points.

During November to December, 1985 settlement at Point 1.92 (which was much away from the tunnel face than Point 1.73) was greater and faster than the settlement at Point 1.73, indicating that the approach and staying of the tunnel face did not directly affect the settlement at these points.
