# **GROUND FREEZING FOR RESTORATION OF DAMAGED TUNNEL**

**D. H. Ju, S. W. Duann and H. H. Tsai**

*Reprinted from Proceedings of  
13th Southeast Asian Geotechnical Conference  
Taipei, Taiwan  
November 16~20, 1998, pp.615~620*

**SYNOPSIS :** The presence of an abandoned pumping well led to a serious failure at a tunnel portal when the opening is made on the diaphragm wall of the arrival shaft to prepare for the breakthrough. The well became a path bringing a large quantity of water from an underlying gravelly stratum to spurt at the tunnel invert. A sinkhole of 5,000 cubic meters in volume was made outside the shaft, and as a result, the shaft was flooded and two shield machines were submerged in water. Both of the twin tunnels of the rapid system were seriously damaged. Ground freezing was adopted to seal up the portal so the damaged segments could be replaced. The successful application proves that ground freezing is an effective measure in cases of a similar nature.

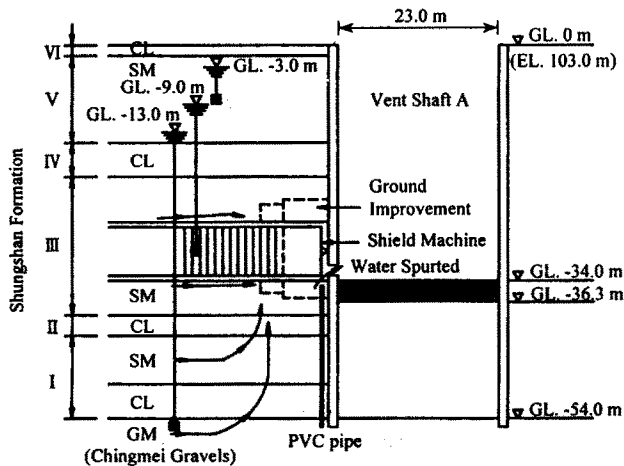
Fig. 2 Soil Profile and Configuration of the Shaft A

The site is located at a distance of about 70m West of the bank of the Hsintien Creek which separates Panchiao from the City of Taipei. A typical soil profile in this area is shown in Fig. 2. The subsoil at the site comprises alluvial deposits, i.e., the so-called Taipei Silts or the Sungshan Formation, to depths varying from 45m to 55m (Woo and Moh, 1990). Underlying the Sungshan Formation is an extremely permeable and water-rich gravelly layer, i.e., the Chingmei Gravels, with hydraulic conductivity ranging from 0.12 m/sec to 0.18 m/sec and storativity ranging from 0.001 to 0.004 (Moh, Chuay and Hwang, 1996). It was once the primary source of water

Layer IV of the Sungshan Formation is an impervious clayey layer which separates the ground water into two aquifers. The twin tunnels are buried in a silty sand layer, i.e., Layer III in the Sungshan Formation. The inverts of the tunnels are located at a depth of 33.6m below the ground surface and the piezometric head at the inverts of the tunnels was about 200 kPa.

As shown in Fig. 2, to ensure the safety during the breakthrough, Column Jet Grouting (CJG) was conducted to treat the soils immediately behind the portals to form two grouted tubes, one for each tunnel, to temporarily shelter the shield machines upon arrival. The primary treatment was 6.3m in length, 11.9m in width and 13.5m in height. This treated zone was extended by 3m by using chemical grouting (CW1) to cover the entire length of the shield machine, which is 7.7m long and 6.2m in diameter.

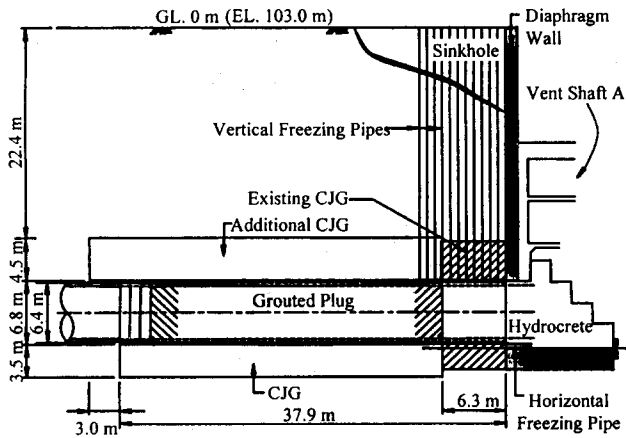
Fig. 3 Remedial Measures

As depicted in Fig. 3, the portal was first sealed by a concrete gravity wall erected in water so the shaft could be drained in preparation of subsequent operations. A plug was formed behind the tail of the shield by grouting the soils which entered the tunnel. A steel bulkhead was erected at a distance of 700m away from the shaft (not shown in the figure). The ground surrounding the section of damaged tunnel was treated by using CJG grouting. With all these measures taken, compressed air with pressures of, upto, 2.1 bars was applied to pressurize the tunnel so the water in the tunnel could be drained and the dirt removed. Subsequently, the damaged segments were replaced in

Freezing was conducted, refer to Fig. 3, to solidify the soils surrounding the shield machine and to seal off the water path so the concrete retaining wall and the grouted plug, which served the purpose of sealing the portal, could be removed and the final connection to the shaft could be made. A total of 66 vertical freezing pipes, refer to Fig. 4 for layout, were installed from the surface. They were double-tube steel pipes of 90mm in diameter and were installed at spacings of 0.8m apart, center to center. The pipes in the middle 8 rows (C to J) stopped at the tunnel crown while the outer 4 rows extended to a depth of 2m below the invert. To complete the enclosure, 11 freezing pipes were installed underneath the invert to a length of 10m, measured from the outer face of the diaphragm wall.

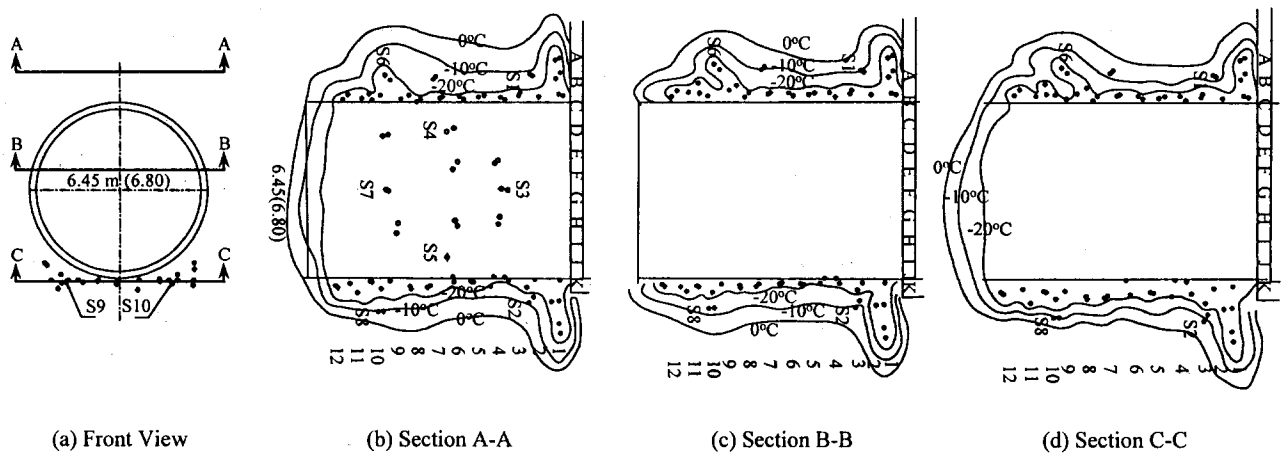
Fig. 5 Temperature Distribution at Horizontal Sections

Installation of the freezing system started in late November, 1995 (about 4 months subsequent to the incident), and freezing started in January, 1996. Figures 5 and 6 show the distribution of temperatures obtained in May. It can be noted that the frozen soil was as much as 3m thick above the crown and 1.5m thick on the two sides and below the invert. The design assumptions appeared to have been satisfied.

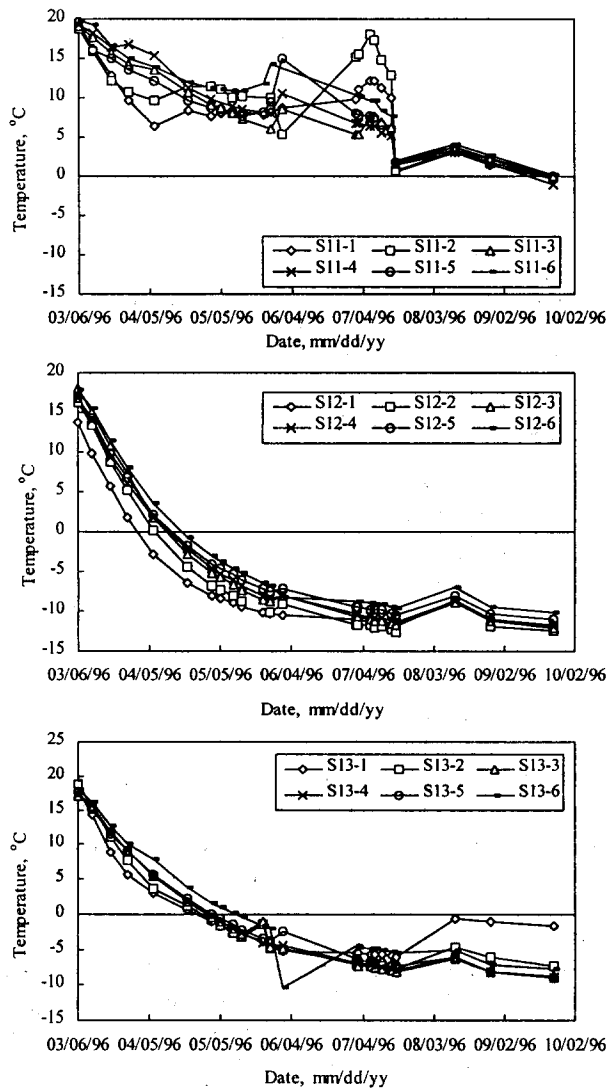
Fig. 8 Time History of Temperature

The readings obtained in these observation holes are shown in Fig. 8. As can be noted that the observation hole S12 registered the fastest rate of freezing while S11 registered the slowest, obviously due to boundary conditions. Another fact worthy of mentioning is that the ground temperatures at the bottom appeared to be a few degrees lower than those recorded at the top. This could be attributed to the fact that the inner rod which carried the

fresh brine supply extended all the way down to the bottom and therefore the temperature of the brine was the lower over there. The brine picked up the heat from the ground on its return and the temperature rose with the height.

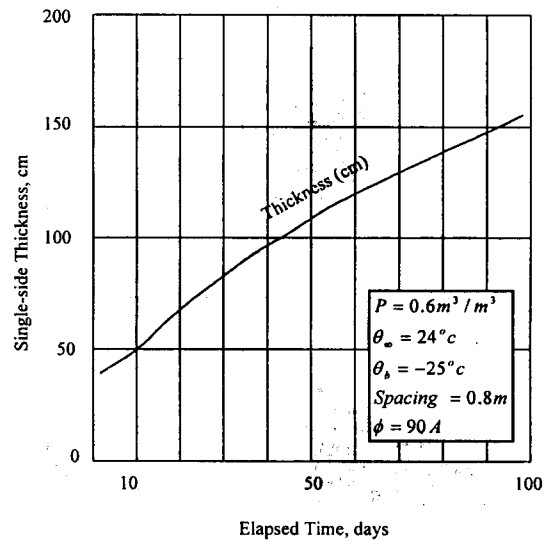
Fig. 9 Estimation of Required Period for Refrigeration

As indicated in Fig. 9, for a water content of  $0.6 \text{ m}^3/\text{m}^3$ , a brine temperature of  $-25^\circ\text{C}$ , an ambient ground temperature of  $24^\circ\text{C}$ , a spacing of  $0.8\text{m}$  between pipes and a pipe diameter of  $90\text{mm}$ , it was expected that the frozen ground would grow into a plate with the design thickness of  $1.6\text{m}$  ( $0.8\text{m}$  on single side of axis in 30 days). As can be observed from Fig. 8 that the soils at the location of S12, which was  $0.8\text{m}$  away from the center of the row, was not frozen till 40 days, or ten days later than what was expected. This could be due to the error in locating the observation hole. A minor error in distance could affect the temperature readings significantly.
