INFLUENCE OF THE CHELUNGPU FAULT ON A HIGHWAY BRIDGE FOUNDATIONS AND COUNTERMEASURE

Tung-Lih Yen
Moh and Associates, Inc.

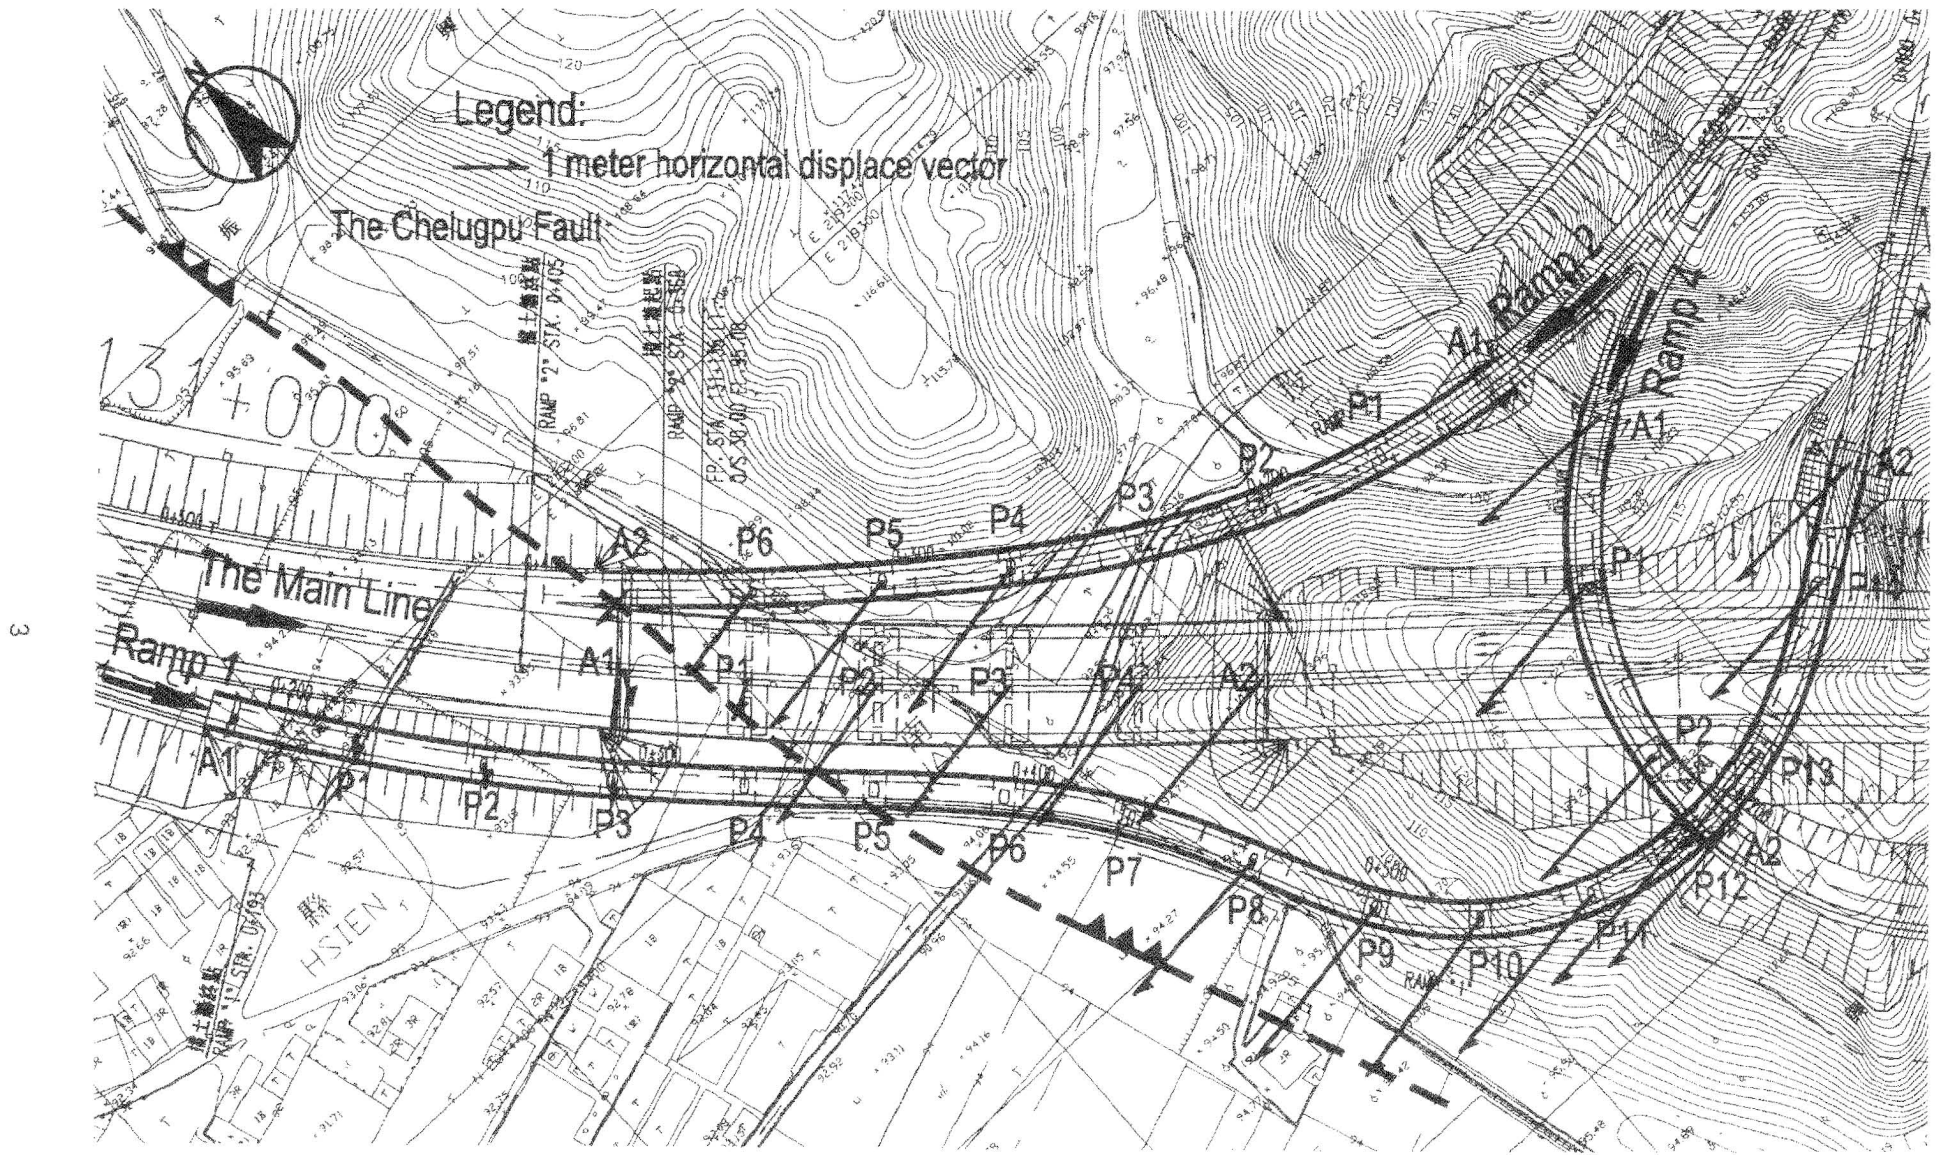
Figure 1 Layout of the 4 Routes and the Horizontal Displacement Vectors at the Piers

After the earthquake, damages to the abutments and piers can be observed. For example, the Pier P5 of Ramp1 was seriously tilted by the movement of the fault. The tilting is as large as 1/11. The abutments of Main line A1 and Ramp2 A2 collided and produced many severe cracks. The ground was also displaced and uplifted in the hanging wall. From the survey of the piers after the earthquake, the horizontal displacement at Ramp1 P11 is as large as 2.71m, and the uplift displacement at Main line P4 is as high as 1.64m. The averaged horizontal displacement vectors of the pier are plotted in Figure 1.

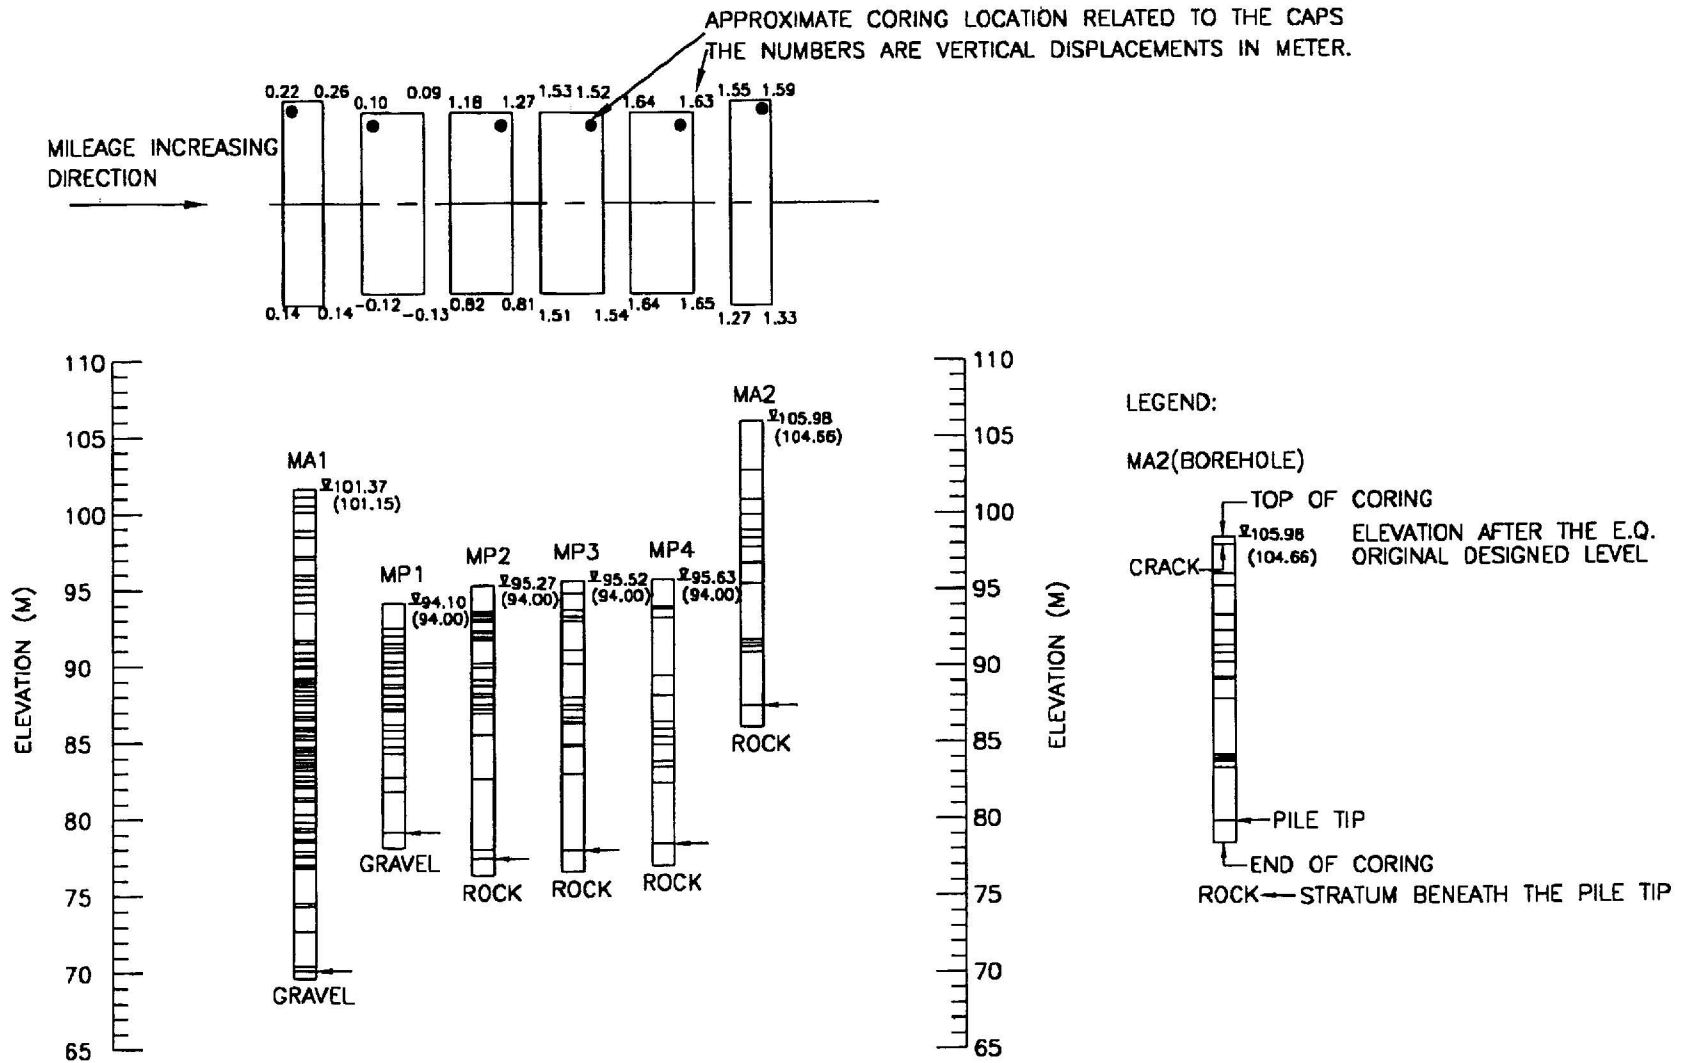
Figure 2 Crack Distribution of the Cored Piles for Main Line

Figure 2 displays that the piles of the Main line were significantly fractured because the fault passes through Main line A1 and P1. Moreover, the caps of the Main line were uplifted and tilted. The cap of MP2 was uplifted 1m in average and had a 0.46m difference in level. When coring at MP2 right passed its pile tip, the advancing rate suddenly increased, the water circulation reduced and recovery of the sample was zero. An aluminous rod was used to explore the gapping phenomenon. Conclusively, a 0.8m gap was inferred at the MP2 pile.

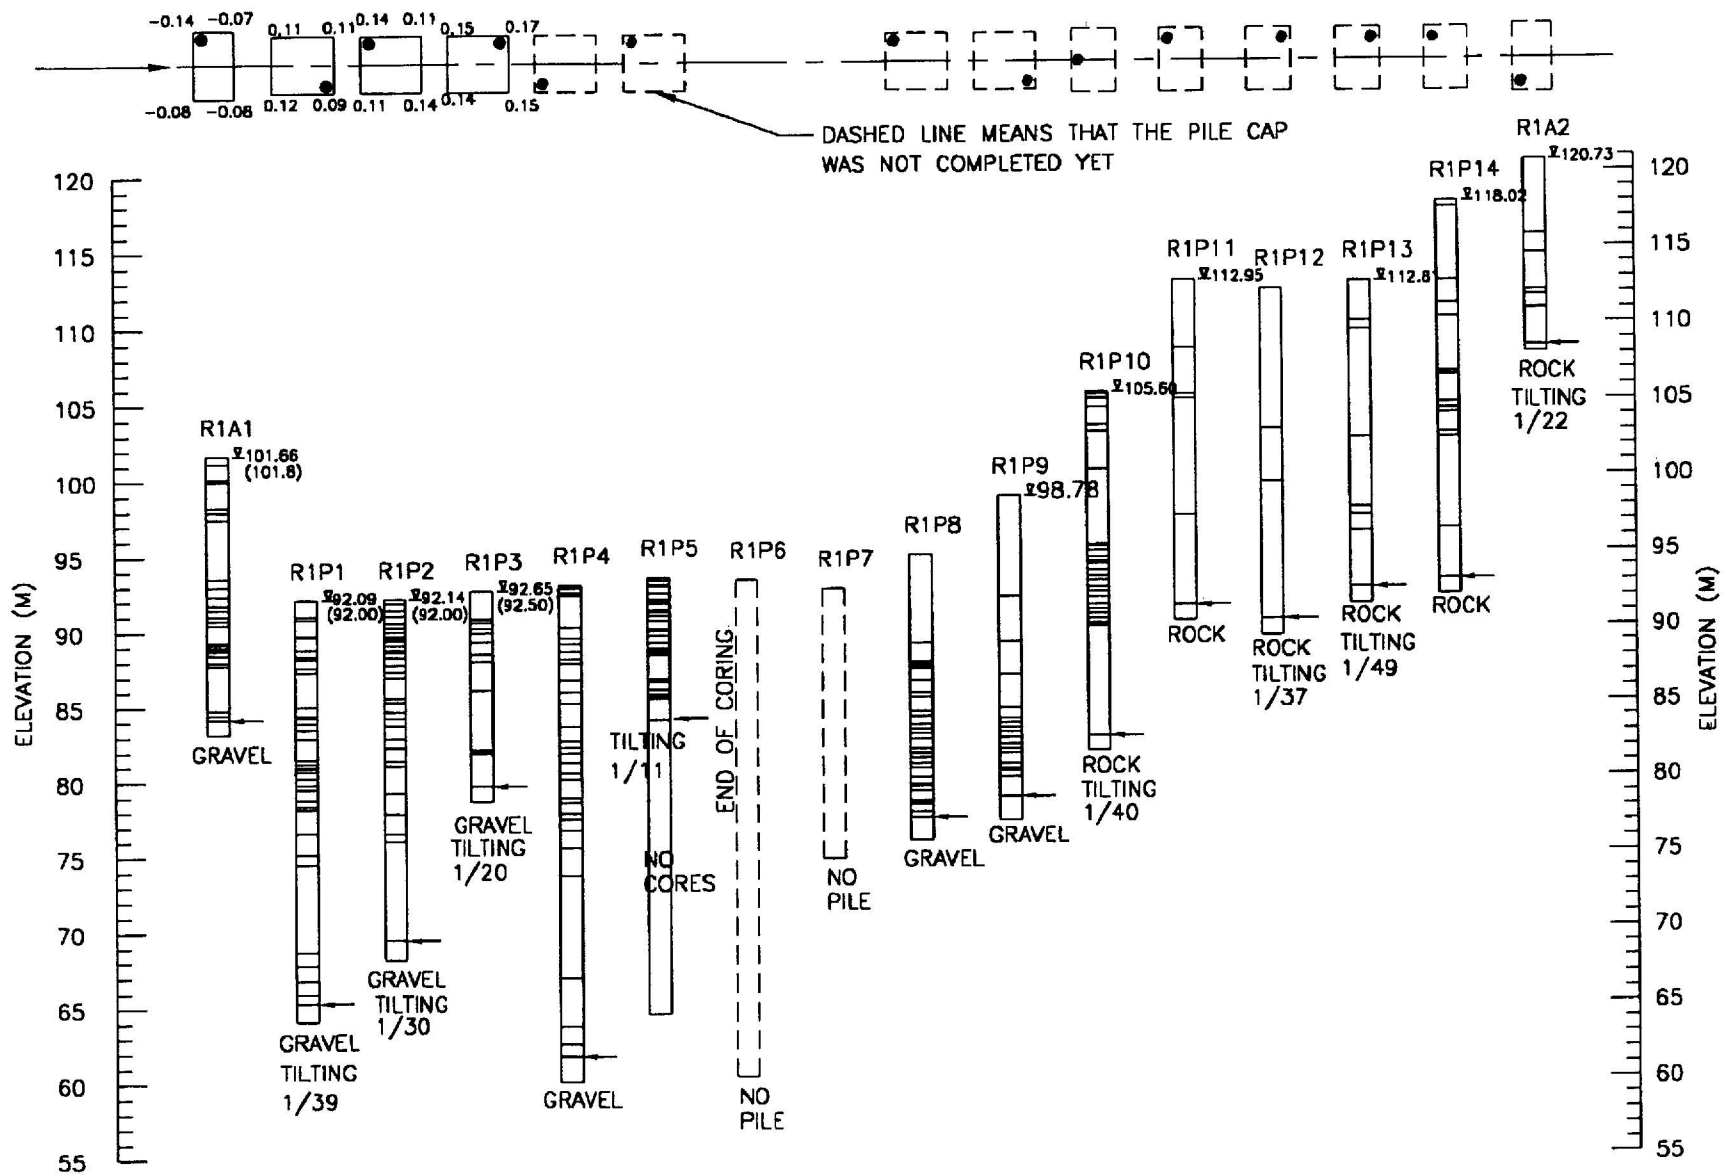
Figure 3 Crack Distribution of the Cored Piles for Ramp1

Figure 3 shows that the crack situation in the piles of Ramp1 is severe. The fault passes through Ramp1 P5 and made it tilted. On both sides of the fault, the piles were seriously fractured. Those piles in the footwall (A1 to P5) have more cracks than those piles in the hanging wall. The possible reason is that the ground of the footwall is softer than that of the hanging wall so the pile-ground interaction was stronger in the footwall. In addition, the restraining of the caps of Ramp1 A1 to Ramp1 P3 may make more cracks near the pile heads. In addition to the cracks, gaps of at least 0.6m beneath the pile tips of R1P10, R1P14, and R1A2 were also encountered.

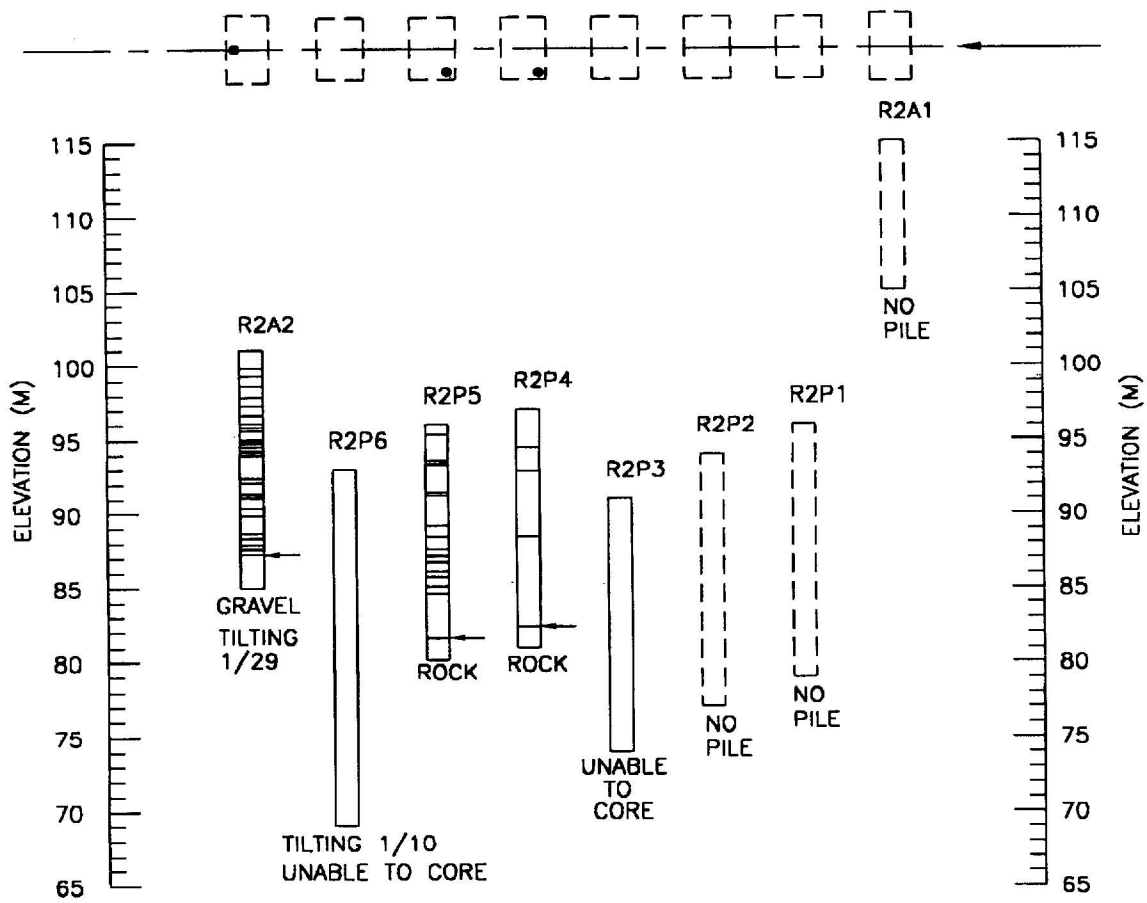
Figure 4 Crack Distribution of the Cored Piles for Ramp2

The fault also passes through Ramp2 A2 abutment. The cracking of R2A2 is serious. Bare eyes can easily observe tilting of R2P6. The crack distribution of Ramp2 can be seen in Figure 4. Cracks appeared to be less in the piles of Ramp4 (Figure 5) whose distance to the fault is greater than those of the other 3 routes. However, R4P1 was tilted and R4P2 has many cracks too. Moreover, a gap of 1.6m was detected beneath the pile tip of R4A2.
