# **A RETROFITTING DESIGN OF YEN-FON BRIDGE IN CENTRAL TAIWAN AFTER CHI-CHI EARTHQUAKE**

## **Retrofit/Bridge Structure**

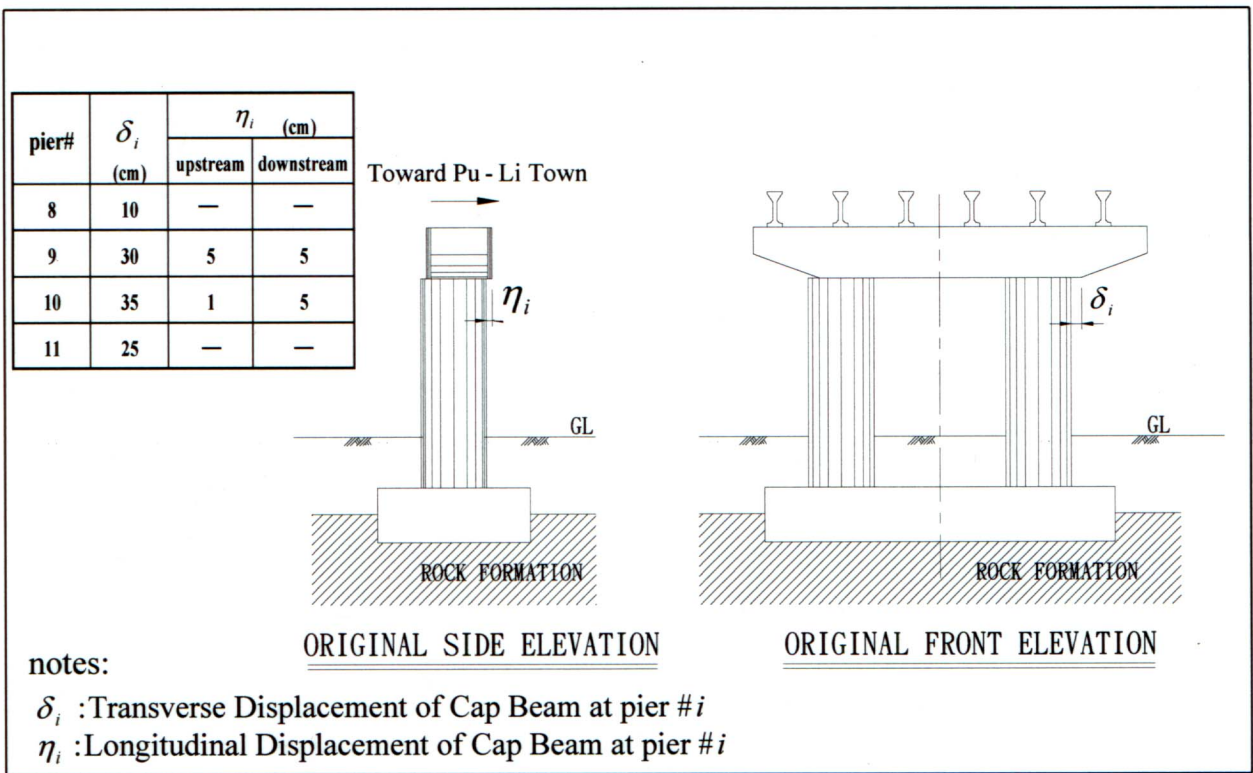
On September 21st 1999, the Chi-Chi earthquake strike central Taiwan and affect almost the whole island. This is the largest earthquake in a century in Taiwan. The Chi-Chi earthquake caused damage to Yen-Fon bridge in the following manner: (i) superstructures of span No. 4~No. 6 and span No. 12 were displaced transversely; and, (ii) except pier No. 6, all pier caps dislocated transversely to some extent and part of their main reinforcing bars were exposed or completely cut (Fig. 2~4). The damage is not catastrophic, however, two out of four lanes remained open to traffic in order to maintain the access to the area where emergency assistance is needed (Fig. 3).

**Fig 2: Dislocation of Cap Beam**

The upper part of formation near bridge is alluvium and the formation below is Pleistocene alternation. The formation displaced from east by south toward west by north during earthquake, which can be judged from dislocation and cracking pattern of damaged cap beams (pier No. 7~ No. 12). The ground acceleration measured at the nearest seismometer station is about 500 gal, which is much larger than the original design value. However, because the direction of formation displacement is perpendicular to the longitudinal direction of the bridge and two-column bent piers provides redundancy, the earthquake only caused minor damage such as dislocation of pier caps and spalling of concrete. Two lanes remains open to traffic after the earthquake.

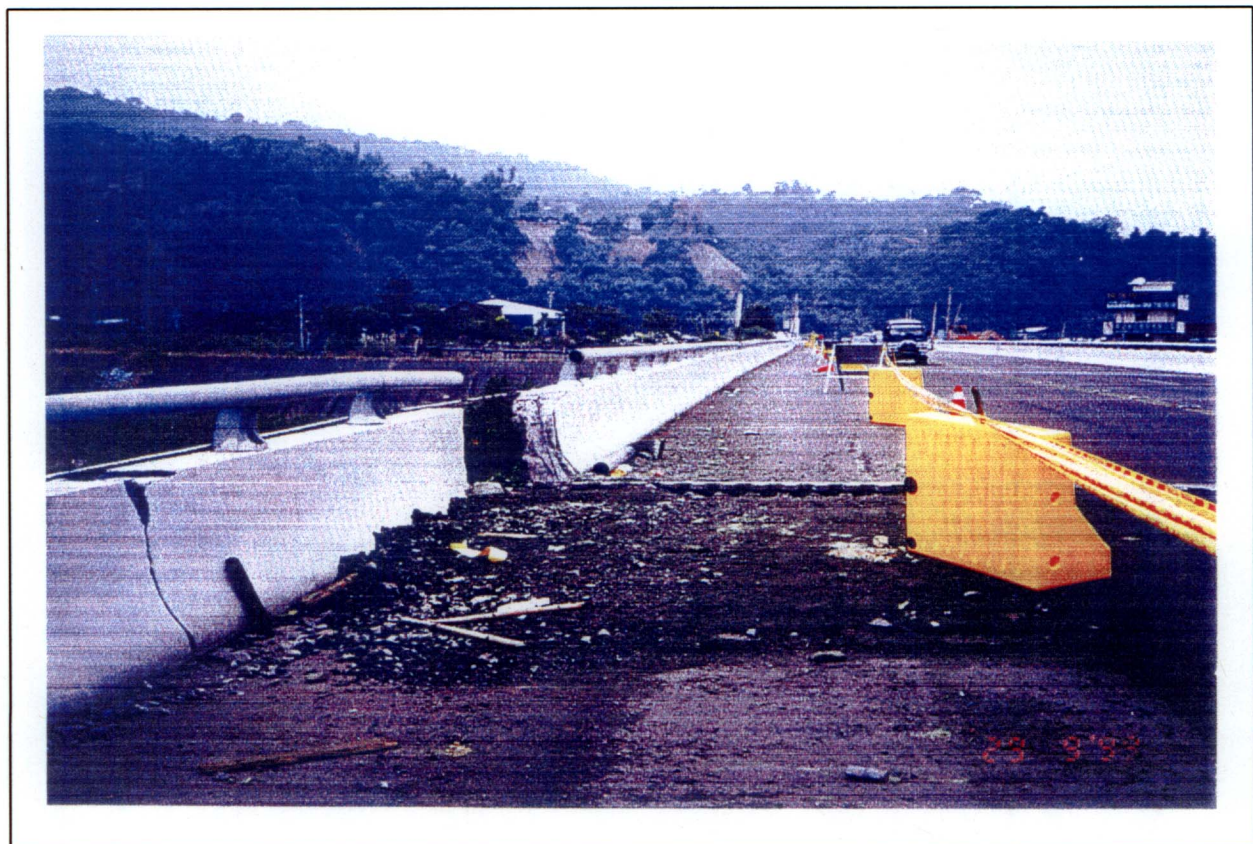
**Fig 3: Conditions of Slab Displacement and Opening to Traffic**

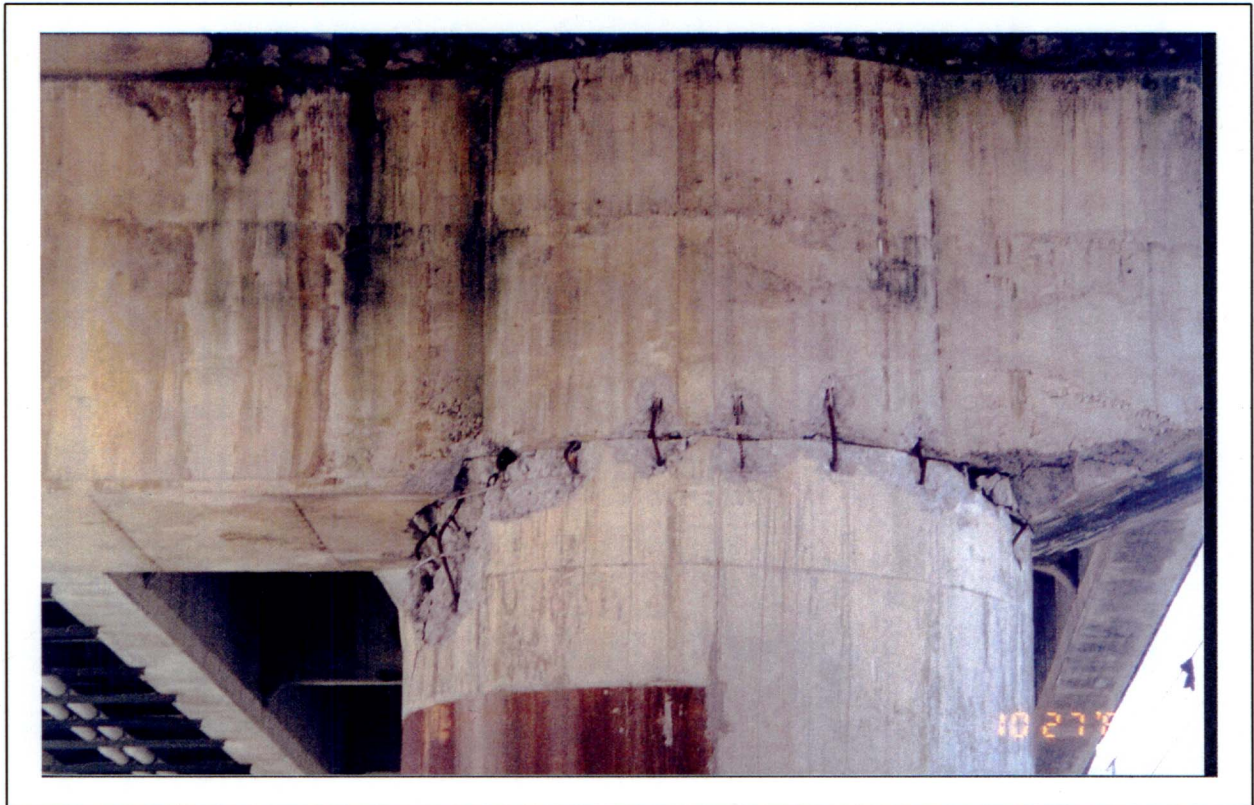
**Fig 4: Conditions of Dislocation and Concrete Spalling at Bottom of Cap Beam**
