# A case study – Stabilization work to unstable crib wall in residual granite

S. K. Kong

Moh and Associates (S) Pte. Ltd., Singapore

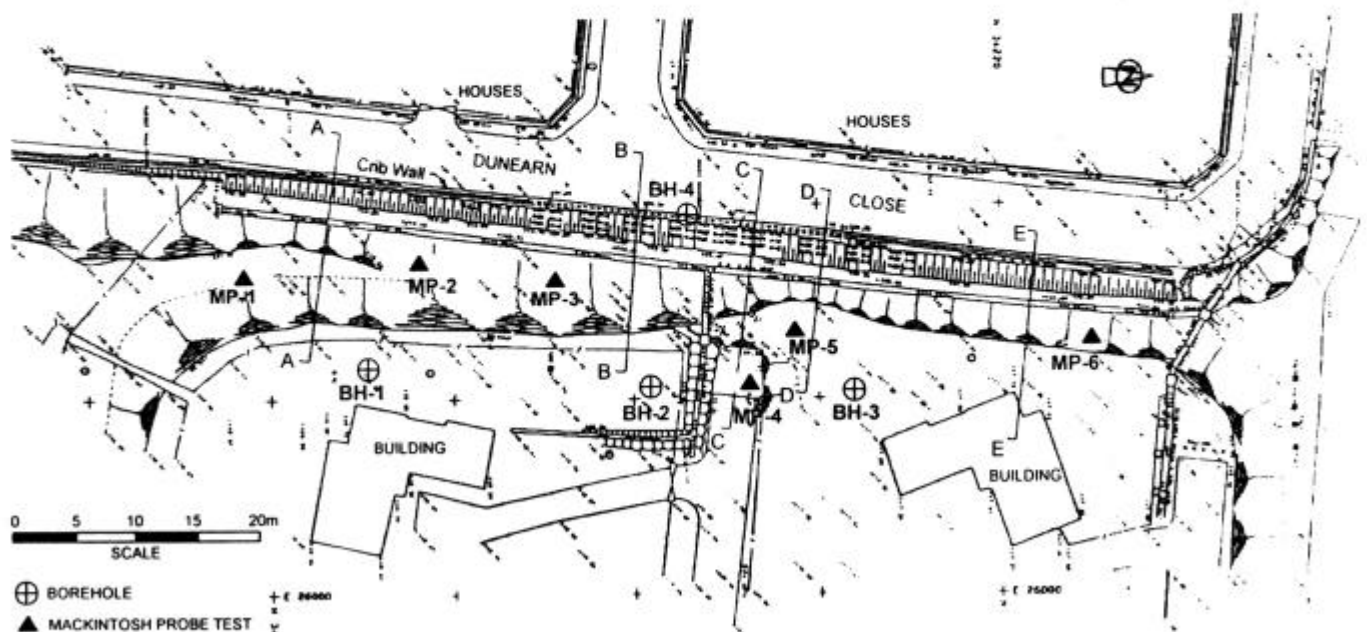
Figure 1. Site and borehole location plan.

A 5 m to 7 m high crib wall supporting a 1V:1.75H cut slope consisting of residual soil from the Bukit Timah Granite formation with an overall height ranging from 8 m to 11 m above the surface of Dunearn Close (Figure 1) was found to be sliding outward during the seasonal prolonged rainfall period in 1996. The sliding of the crib wall had caused dam-

age to the road-side drain at the toe of the wall and tension cracks developed at the top of the slope which posed risk to the residents and road users. The failure surfaces were immediately protected with temporary stabilization measures and detailed geotechnical investigation works were carried out to evaluate the possible causes of failure and to collect the necessary geotechnical parameters for the design of permanent stabilization works. The stability of the affected wall section was closely monitored by instruments prior to execution of the permanent stabilization works.

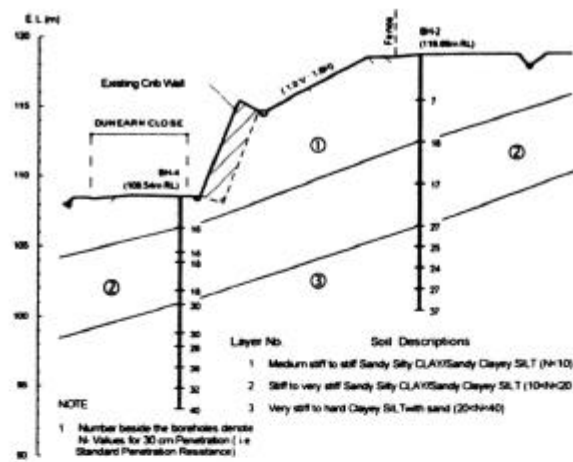
Figure 2. Soil profile.

According to the results of site investigation (MAA 1996), the subsoil condition of the site belongs to the Bukit Timah Granite formation and consists of 2 to 6m thick layer of Silty CLAY (Layer 1,  $N < 10$ ) in medium stiff to stiff condition following by a layer of 3.5 to 7 m thick stiff to very stiff Silty CLAY/Clayey SILT (Layer 2,  $10 < N < 20$ ). The boreholes were terminated in very stiff to hard Clayey SILT with sand (Layer 3,  $20 < N < 40$ ) with sufficient penetration below surface of Dunearn Close (Figure 2). Subsoil retained by the crib wall was found consisting mainly of Layer 1 soil which is of low permeability and sensitive to water. No granular fills

and subsoil drains were provided in the construction of the crib walls. Groundwater level measured in the installed water standpipe was found at level slightly above the surface of Dunearn Close during the site investigation period.

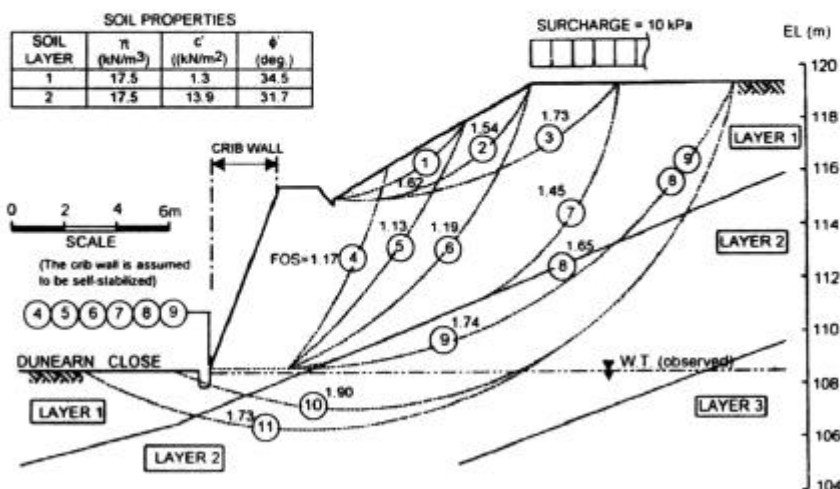
Figure 3. Stability analysis of existing slope (Section C-C).

Detailed stability analysis was conducted on the original wall/slope profiles to evaluate its adequacy for the stabilization works design. The stability of slope was analyzed based on the soil investigation results under the observed groundwater table and an assumed groundwater table at 1/3 the height of the crib wall to evaluate its safety in short and long terms, respectively. The results of stability analysis (Figure 3) indicated that all five selected slope sections were found to have inadequate factor of safety (i.e.  $FOS < 1.5$ ) against slip failure even under the low groundwater table (i.e. at EL108.5 m) observed during the soil investigation period. In view of the above reason and the uncertainties in the integrity of the existing crib wall which long term safety cannot be verified, stabilization measures consisting of restoration/reconfiguration of the slipped ground, re-

According to results of stability analysis and information collected from the site inspection, it can be diagnosed that the failure could be attributed to the poor resistance of Soil Layer 1 and the inadequacy of the surface and subsoil drainage systems which resulted in weakening of the soil near the wall base as observed at site and possible build-up of porewater pressure under the effect of prolonged rainfall. In order to ensure long term safety of the existing slope and crib wall, the following stabilization measures were adopted. The design was carried out based on a minimum factor of safety of 1.5 under an assumed groundwater level at 1/3 the height of the retaining wall.

placement of the unstable crib wall by using suitable retaining system were considered necessary for ensuring the long term safety of the existing slope and adjacent properties.

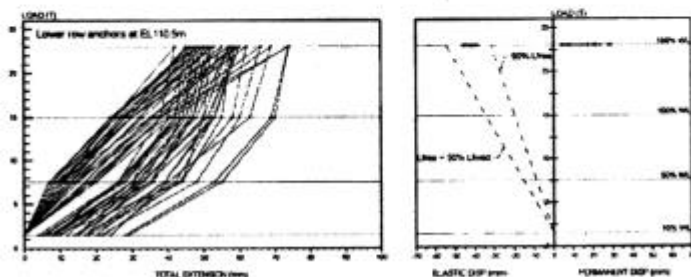
Figure 5. Results of acceptance tests.

Sixty-one nos. of Acceptance Test (or Proof Load Test, 1 cycle), five nos. of Extended Acceptance Test (3 cycles) and three nos. of Suitability Test (7 cycles) were conducted on the installed anchors to verify its carrying capacity and to evaluate its performance. According to the test results as shown in Figure 5, all the installed ground anchors have been successfully stressed up to the maximum test load and passed the performance tests with elastic and permanent displacement varying from 38 mm to 50 mm and 4 mm to 45 mm recorded, respectively. The elastic displacement of anchors recorded in both Acceptance Test and Suitability Tests were found to be well distributed within the elastic limit, i.e. between  $0.9L_{free}$  and  $(L_{free} + 0.5L_{fixed})$  and meet the acceptance criteria (Figure 6). However, larger permanent displacement value was recorded during the Suitability Tests due to the cyclic loading process carried out under the Suitability Test.

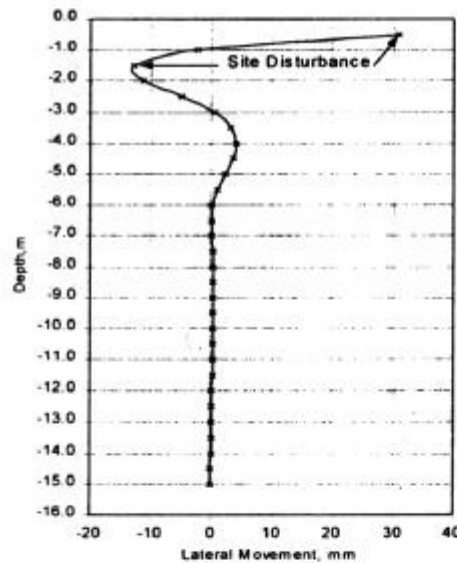
Figure 7. Ground movement profile (I-1).

The performance of the field works have been monitored by instruments, e.g. survey prisms, inclinometers and standpipes during the construction period and for about 7 months after the completion of works. Figure 7 shows the ground movement recorded by the inclinometer with non-critical movement values of 5 mm observed during construction of permanent stabilization works and 32 mm observed since the completion of soil investigation works. The movements of crib wall recorded by the installed survey prisms during the temporary and

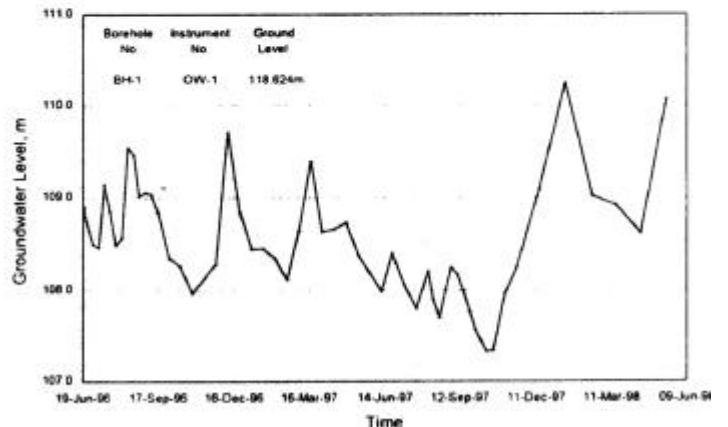
Figure 8. Groundwater table measurements.

permanent stabilization works period were found to be minor (i.e. not exceeding 6 mm). Survey of prisms installed on the completed anchored wall showed satisfactory performance with negligible movement values (i.e.  $\leq 3$  mm) recorded during the maintenance period. Groundwater table observed in the installed standpipe was found to fluctuate between EL107.3 m and EL 110.2 m during the present observation period (Figure 8). The highest groundwater level observed during the rainy season is close to the design level (i.e. 1/3 wall height) adopted in the permanent stabilization work design.
