1999 Chi Chi Earthquake of Taiwan

Za-Chieh Moh and Richard N. Hwang

Moh and Associates Group of Companies, Taipei, Taiwan

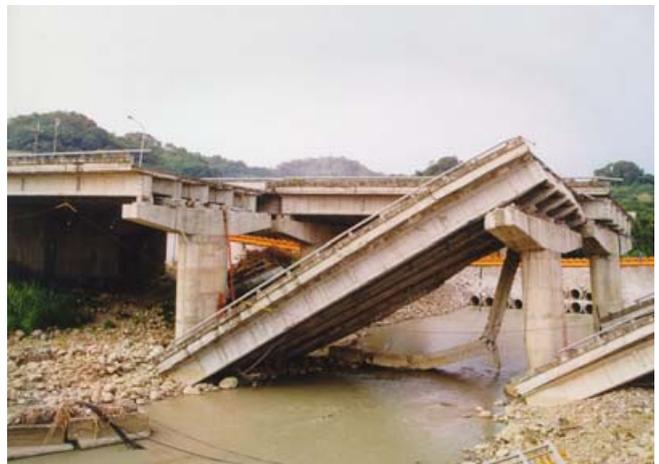
There are approximately 1,000 bridges in the areas with strong shaking and 20% of them suffered damages to certain degrees. Twenty bridges were seriously damaged and required extensive repairs or had to be demolished and rebuilt. Many of them are located on Route 3 which is a major north-south highway running the length of Taiwan from Taipei in the north to Pingtung in the south. There are approximately 65 bridges on this route as it passes through Taichung and Nantou counties. Five of these bridges suffered collapsed spans (Photo 1) or cracked piers (Photo 2). Another five bridges on county and city highways experienced similar distress, including one cable-stayed bridge under construction. All these ten bridges are within 10km of the fault and most are within 5 km. Seven are located directly on the causative fault or on one of its branches. All are considered to be in the near

Photo 1. Bridge with Falling Spans

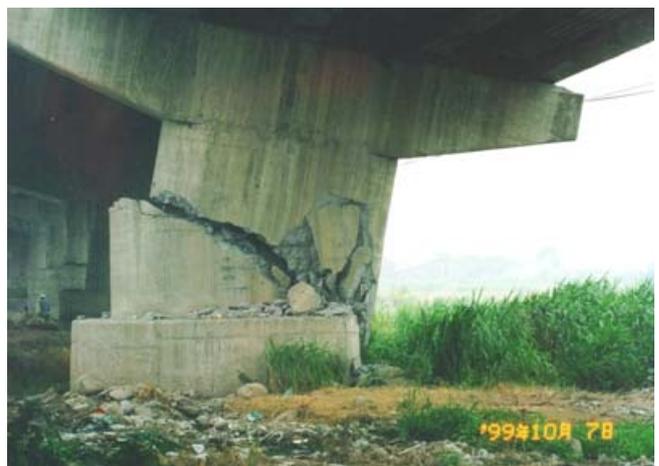
Photo 2. Bridge with Pier Damaged

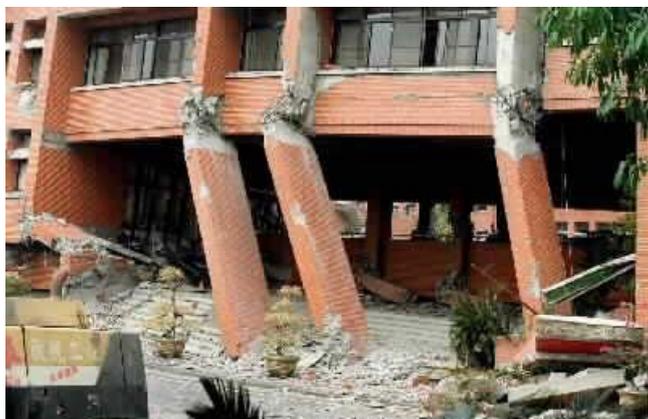
A large percentage of buildings that collapsed were non-engineered one-to-three story reinforced concrete frame structures constructed with brick infill partitions and exterior walls. Many of them had pedestrian corridors and open front at the ground floor (Photo 3). More than two dozen modern high-rise apartment buildings overturned or collapsed (Photo 4) because of inadequate design. Some of the buildings collapsed because of the so-called “short-column effects” as the spaces between columns were partly filled by partition walls (Photo 5). These partition walls trap the columns preventing the development of their normal flexural behavior over their height and allowing them to only deform over their free-height, i.e., the length of the column not surrounded by partitions. As a result, although the shorter length of the trapped column would make it possible to resist higher lateral forces before the flexural strength of the column is reached, the shear strength of a short column is often first reached and typical non-ductile shear failures ensue.

Photo 3. Building with Weak Ground Floor

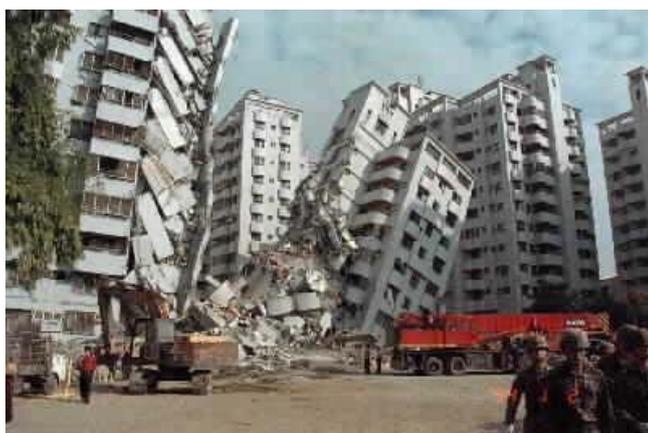
Photo 4. Poorly Designed Modern Highrise Buildings

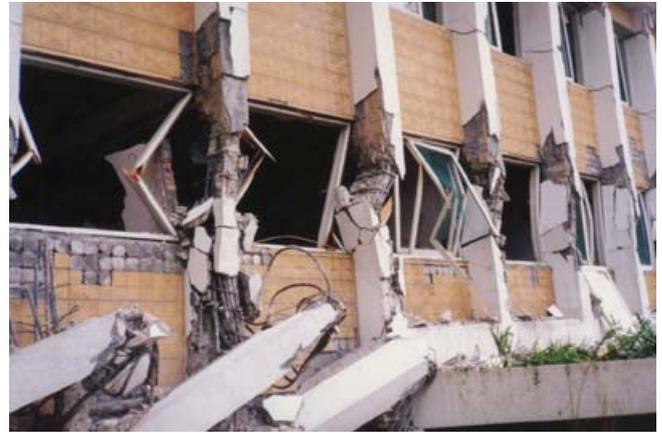
Photo 5. Building Damaged Due to “Short-Column” Effects

Roughly, a total of 786 schools were damaged. Most of them were damaged because of the so called “short-column” effects described in Section 4.2 as the lower part of the space between columns were partially infilled by partition walls leaving the upper part open for windows (Photo 5). This type of damage in these reinforced concrete structures was rather common in the direction parallel to the exterior corridor outside the classrooms. The severity of damage to school buildings exceeded that of other structures due to primarily to the similarity of their design and construction. The eccentricity of most school buildings associated with cantilevered corridors at upper floors made the situation worse.

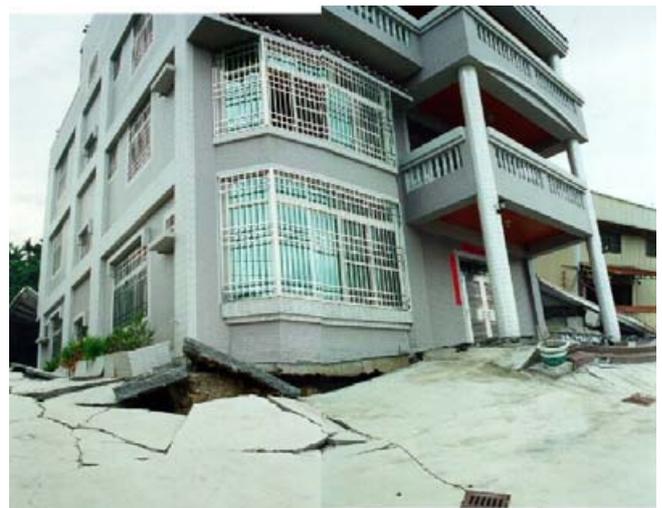
One of the significant features of the Chi-Chi earthquake was its large lateral and vertical displacements at surface. Buildings constructed across faults typically cannot survive the relative displacements that occur at their foundation due to fault movements. This type of failure was commonly seen along the fault (Photo 6).

Photo 6. Building Damaged by Ground Movements

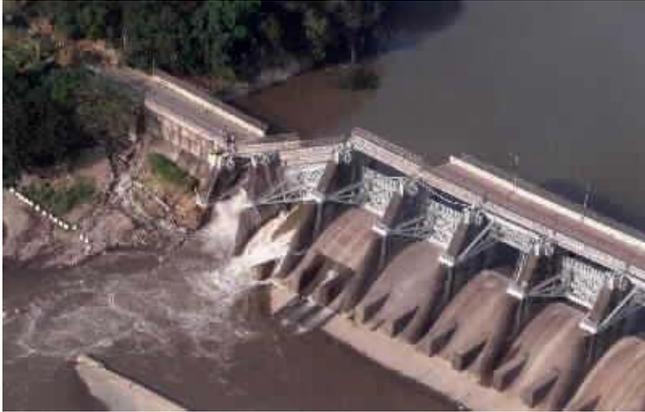
Damages to hydraulic structures were rather light. Of special interest is the Shikung Dam which is a concrete dam and was seriously damaged by ground movements (Photo 7). The fault directly ran through the foundation of the dam. The eastern portion of the dam was jacked up by 9.8m and the western portion of the dam was jacked up by only 2.1m, resulting in a differential movement of 7.7m.

Photo 7. Shikung Dam after Earthquake

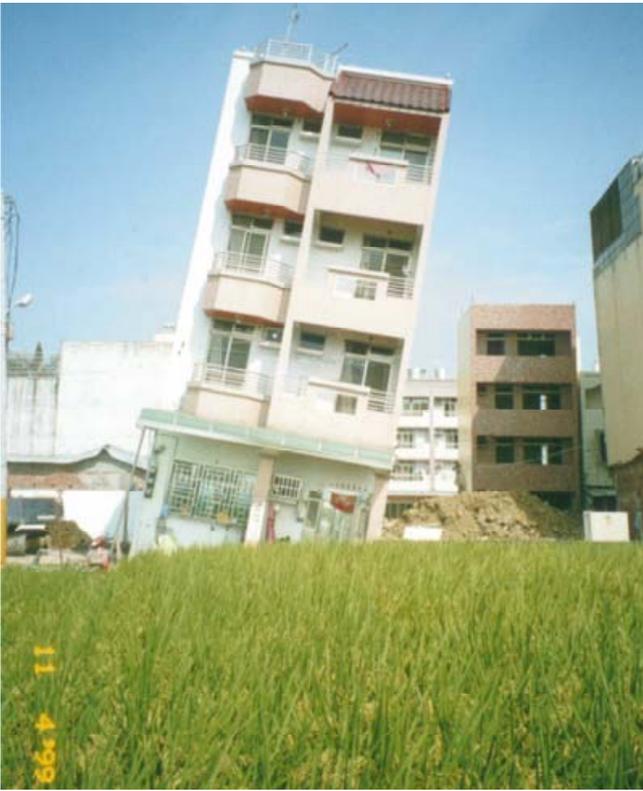
Photo 8. Foundation Failure Due to Liquefaction

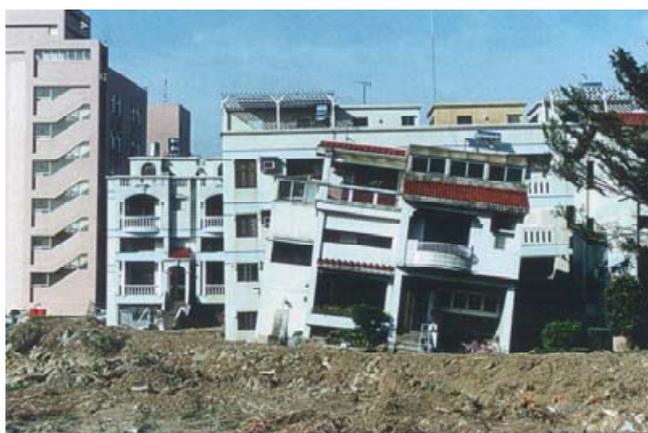
In Wufeng which is within 1 km from the Chelungpu fault., liquefaction resulted in lateral spreading at four locations along the Koniaokeng Creek (Chu, Hsu, Lay and Chang, 2000) and damaged a few low-rise structures (Photo 9). A nearby monitoring station (TCU065) measured peak acceleration of 774 gals in the east-west direction, 563 gal in the north-south direction and 257 gals in the vertical direction.

Photo 9. Building Damaged by Lateral Spreading

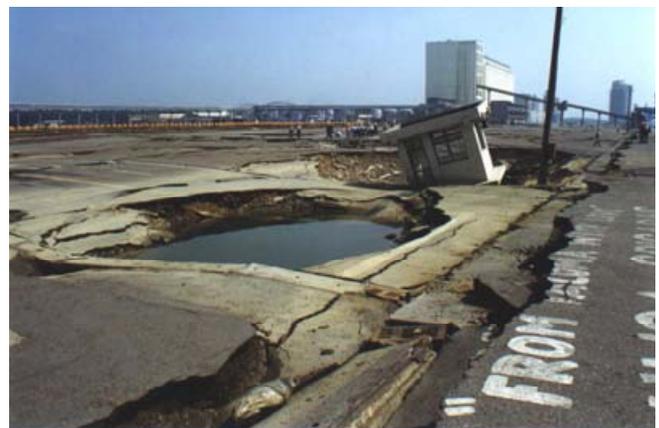
reclaimed land in four stages. The hydraulic fill behind Wharves 1 to 4 are retained by caissons which sit on a thin layer of cobbles and boulders. During the earthquake, the loosely dumped sands behind the caissons were liquefied and sand boils occurred all over the places (Chen and Hwang, 2000). Sands erupted from the ground can be found as far as 150 meters from the waterfront. Due to liquefaction, the caissons moved seaward by 1 meter on an average and the backfill behind these caissons settled by about 70cm. Due to the outward movements of the caissons, gaps were created at the interlocks between caissons and permitted the materials behind the caissons to be washed away by tides resulting in cavities of, up to, 30m in diameter and 4m in depth (Photo 10).

The nearest seismology station located at a distance of 4.7 km southeast of the Port registered a peak acceleration of 165 gals in the east-west direction and 152 gals in the north-south direction. The vertical component of the ground motion was small. Analysis indicates that this magnitude of ground motion would not be able to trigger the sliding of the caissons and the movements of the caissons must be the result of liquefaction of the backfill (Chen and Hwang, 2000). It is worthy of mentioning that the rest of wharves were retained by sheet piles and suffered no damage.

Photo 10. Damage to Taichung Port Due to Liquefaction
