Flooding of A Working Shaft during Construction of Taipei MRT

Za-Chieh Moh and Richard N. Hwang
Moh and Associates, Inc., Taipei

SYNOPSIS : A tunnel was seriously damaged when the portal was enlarged for the installation of the flexible joint. Water spurted at the invert and the flow soon became uncontrollable. The shaft had to be flooded to balance the groundwater pressure. A total of 23 segments of the tunnel lining were damaged and had to be replaced. Freezing was first carried out to seal off the opening so the water in the shaft could be drained and the shaft could be cleaned. Freezing was again carried out to form a tubular shelter to surround the damaged section of tunnel for the segments to be replaced subsequently.

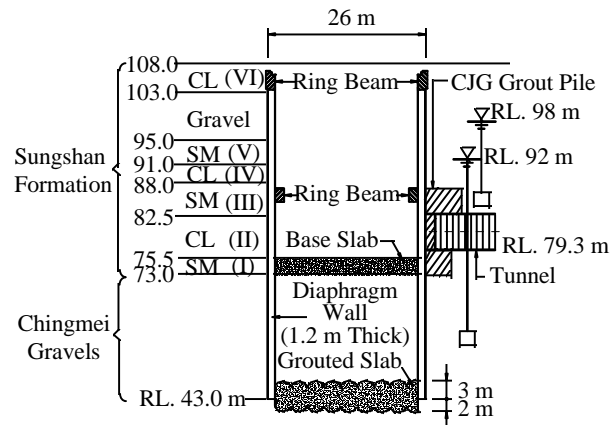
Fig. 2 Ground conditions and configuration of the shaft

Figure 2 shows the soil profile at this site. As can be noted that at the surface there exists a thick layer of Sungshan Formation which is underlain by the so-called Chingmei Gravels at a depth of 35m below the ground surface. A typical CPT (cone penetration test) profile for the central city area of Taipei is given in Fig. 3. There are six sublayers in the Sungshan Formation of which Sublayers VI, IV and II consist of soft silty clays (CL) while Sublayers V, III and I consist of loose to medium sands (SM). The stratigraphy at this site is quite similar to what is shown in Fig. 3 except that there exists a gravelly layer in Sublayer V. Representative properties of the subsoils in the Sungshan Formation are given in Table 1. The Chingmei Gravels underneath the Sungshan Formation contains gravels of various sizes and is extremely permeable. This gravelly layer was the main source of water supply of the City of Taipei till the 60's. Because of its ample storage capacity of groundwater and the extremely high permeability, this Chingmei Formation was responsible for several major failures during the underground construction of TRTS (Lin, Ju and

Sublayers V and III are indeed separated by two aquitards, i.e., Sublayers II and IV, and become independent aquifers with different piezometric levels. However, the piezometric levels in all the sublayers in the Sungshan Formation did move in phase with the piezometric level in the Chingmei Gravels, indicating moderate leakage in these two aquitards (Moh and Hwang, 1997). At this site, the piezometric levels in Sublayers V, III, and I were at RL 101m, 98m and 92m, respectively. The piezometric level in the Chingmei Gravels was practically the same as that in Sublayer I, i.e., at RL 92m.

The diaphragm walls were supported by two ring beams as shown in Fig. 2 without any other types of internal bracing. Lateral deflections of the wall during excavation were within 10mm, which were very small in comparison with the deflections observed for box-shape braced excavations with similar depths of excavation. This indicates that circular shafts out-perform rectangular ones as far as wall deflection is concerned.

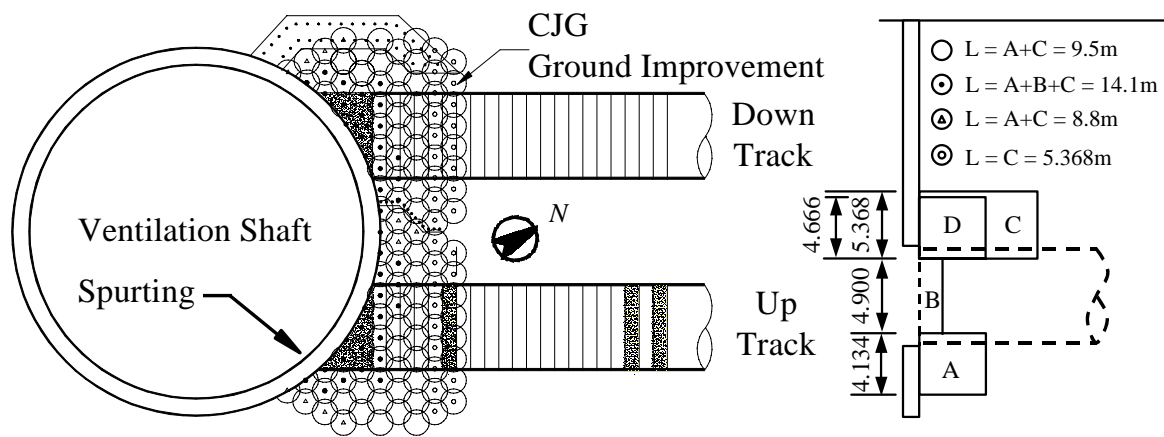
Fig. 4 Ground improvement at portals

As depicted in Figs. 2 and 4, ground treatment was carried out outside the shaft to form a cylindrical shelter at the portal of each of the twin tunnels before launching the shield machine. These two shelters were provided for the shield machines to stay temporarily and to cut off the path of water flowing into the shaft through the fissures surrounding the shield. Each shelter was made of 62 grout piles formed by high pressure grouting using the column jet grouting technique (CJG). All these grout piles were, theoretically, 1.8m in diameter and were installed in a triangular pattern as shown in Fig. 4. The overlaps between neighboring piles were theoretically 240mm maximum.

Because Sublayer II was deemed to be clayey and sufficiently impermeable by the contractor, some of the CJG columns (refer to Fig. 2 for soil stratigraphy and Fig. 4 for CJG columns) did not extend throughout the full thickness of this sublayer.

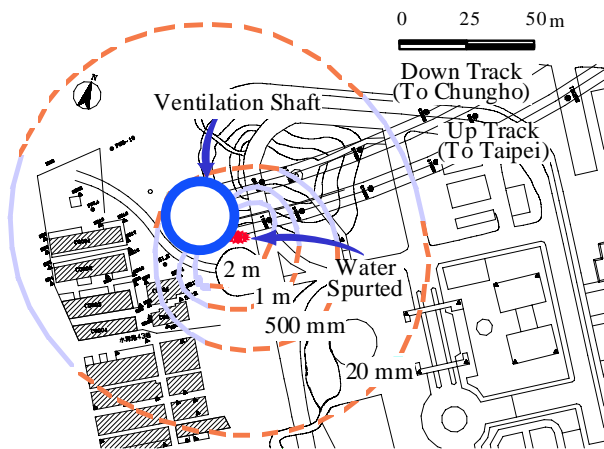
Fig. 5 Ground settlements

The water level inside the shaft rose to RL 92m and became steady in an elapsed time of 48 hours. With the top of the base slab at RL 75.5m, the total quantity of the water running into the shaft was therefore about 7,000 tonnes. The sediments in the shaft reached a thickness of 7m and the top of the sediments was at the same level as the tunnel crown. The water line stretched to a distance of, as far as, 579m from the shaft in the Up-track tunnel while the entire length of 580m of the Down-track tunnel, which has a smaller gradient than the Up-track tunnel, was submerged. Even the recovery shaft next to G10 Station at the other end was flooded with a depth of water of 8m. A sinkhole was created above the tunnel and the maximum ground settlement exceeded 3m. The 20mm settlement contour, refer to Fig. 5, extended to a distance of 80m from the tunnel portal where the leakage occurred. A couple of apartment buildings to the southwest of the shaft were damaged beyond repair and had to be demolished and rebuilt.

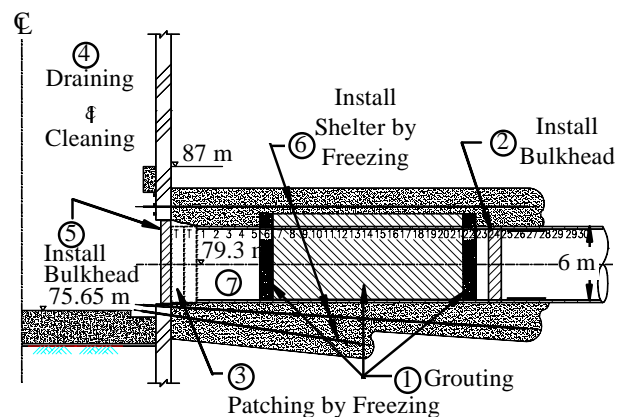
Fig. 6 Sequence of remedial works

The damages to the tunnel segments were investigated by probing the tunnel crowns from the ground surface. It was found that 23 segments in the Up-track tunnel were damaged with a maximum settlement of 1.5m occurring at the 12th ring behind the wall. The Down-track tunnel, however, was unaffected.

It took 3,000 cubic meter of material to backfill the sinkhole. The ground was stabilized by using compensation grouting to fill up cavities. To enable the damaged segments in the Up-track tunnel to be replaced, refer to Fig. 6, the sediments between the 6th ring and the 22nd ring behind the diaphragm wall were grouted to form a plug. The tunnel was drained and cleaned from the other end and a steel bulkhead was installed at the location of the 24th ring. A patching pad was formed by using the freezing technique to seal off the portal from the back of the diaphragm wall. After the water in the shaft was drained and the shaft was cleaned, a steel bulkhead was installed to seal off the portal from the front. The sequence of all these actions is illustrated in Fig. 6 (Aoki/New Asia JV, 1994).

A cylindrical shelter was then formed by using the freezing technique to circumscribe the damaged segments entirely. With this shelter in place, the two bulkheads and the grout plug were removed and the tunnel was cleaned. The damaged segments were dismantled and replaced. The damaged section of the tunnel was fully watertight and the bulkheads at the both ends of the grouted plug were able to be removed without worry. It took nearly two months to demolish the grouted plug and clean up the tunnel (Day 477 to Day 532). The damaged segments were dismantled and replaced by new ones with exactly the same design. The new segments were assembled in the shaft and pulled into the tunnel ring by ring. They were bolted together after their positions were properly adjusted. Once all the rings were in place, the voids outside these rings were grouted. The restoration was completed and refrigeration plants were shut down on October 24, 1995 (Day 571 following the incident).

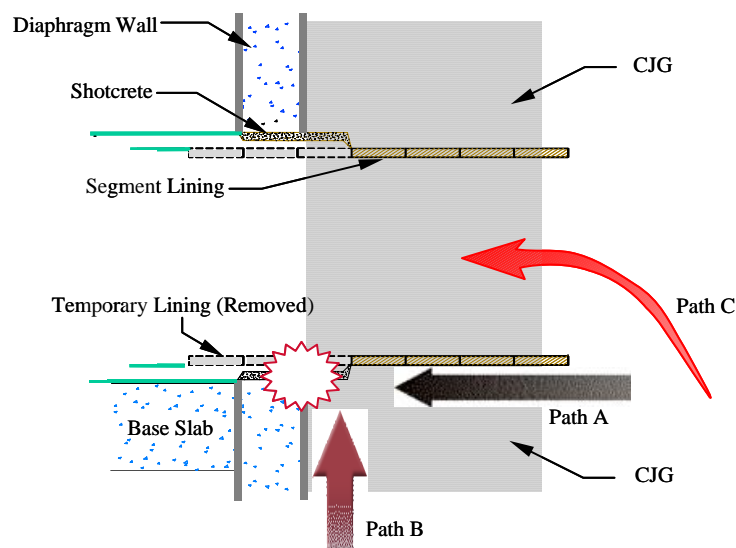
Fig. 7 depicts the 3 possible water paths

To investigate the causes of the incident so the responsibility could be clarified, a committee was appointed by the court in February 1997 with two members representing the contractor of Contract CH221, two members representing the contractor of Contract CC560, and the fifth representing the project owner. After reviewing all the documents and the evidences unveiled during the remedy works and interviewing site staff, the committee members reached the consensus that the water originated from the Chingmei Formation. However, opinions diverged regarding how water was able to get in the shaft. Figure 7 depicts the 3 possible water paths been considered:

Path A—the gap between the tunnel lining and CJG treated ground assuming that it was not properly grouted

Path B—the gaps between CJG columns, or between CJG columns and the diaphragm wall, either due to discrepancies in treatment or due to ground movements

Path C—sand lenses in Sublayer II which was not fully treated

As can be noted from Table 2, although the differences in opinions on the three possibilities were very marginal, Path C was slightly favored. Water was therefore assumed to get into the shaft through sand lenses in Sublayer II and the associated scenario was considered to be the basis for determining the responsibilities. It was reasoned that if all CJG the columns indeed extended into Sublayer II for the full thickness, the incident would not have happened. Accordingly, it was decided that the contractor for Contract CH221 was responsible for the partial omission of CJG
