A STUDY ON THE CAUSES OF SOME ROCK SLOPE
FAILURES ALONG HIGHWAYS IN TAIWAN

Moh and Associates, Inc.

*Proceedings, Third Conference of the
Road Engineering Association of Asia and
Australasia, Taipei, 20-24 April, 1981, Vol. 1, pp. 761-777*

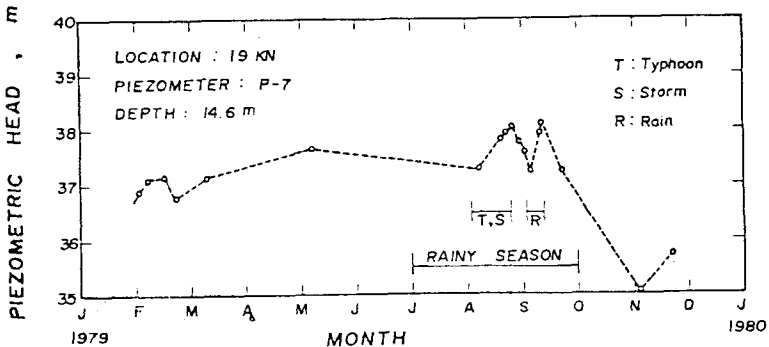
Fig. 3 Variation of Piezometric Head with Time

- (1) increases of the in situ pore water pressure, as illustrated in Fig. 3,
- (2) fill-in of the joints and cracks with water which in turn increases the active force, and
- (3) swelling, weathering and erosion of the slope surfaces due to ad-sorption of water.

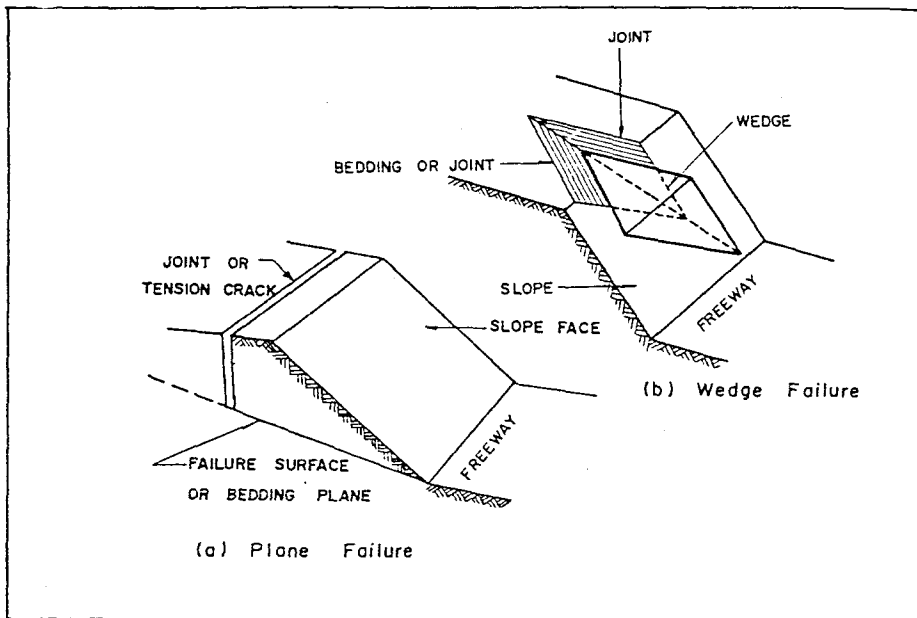
Fig. 4 Modes of Failure in Sandstone-shale Formation

The modes of failure of the interbedded sandstone-shale formation in Taiwan can be classified into two major categories, i.e. plane failure and wedge failure, Figure 4(a), shows the conditions for a plane failure. For a dip slope of interbedded sandstone-shale, if the cut slope at the toe of the dip slope is steeper than the angle of inclination of the dip, the upper rock block has a tendency to slide downward. This tendency of slide must be resisted by the shearing strength along the bedding planes of the rock. If the cut slope is steeper than the angle of shearing resistance and there is no cohesion between the beddings, slide would occur. On the other hand, even if the inclination angle of the cut slope is smaller than the angle of shearing resistance, but there is excess pore water pressure in the joints, slide failure may also occur under the influence of the additional external forces.

When there exists two sets of discontinuous planes, such as joints or beddings, etc., in the sandstone-shale formation, the block above these discontinuous planes may slide along the intersecting planes, as illustrated in Fig. 4(b). This type of failure is the so-called wedge failure. On a cut slope, the necessary condition for a wedge type of slope failure is that the angle of the cut slope must be larger than the angle of intersection of the two discontinuous planes. The weight of the wedge shaped rock block is resisted by the shearing resistance developed along the discontinuous planes. In the sandstone-shale formation, the most commonly seen wedge failures involve the sliding of sandstone blocks along the beddings of shale or joints of the sandstone.
