SETTLEMENT OF UNDERPINNED STRUCTURES IN SINGAPORE

by
H. Todo, R.N. Hwang and T. Hulme

Hiroaki Todo, Kiso-Jiban Consultants Co., Ltd., Tokyo
Richard Hwang, Moh and Associates, Taipei
Terry Hulme, Mass Rapid Transit Corporation, Singapore

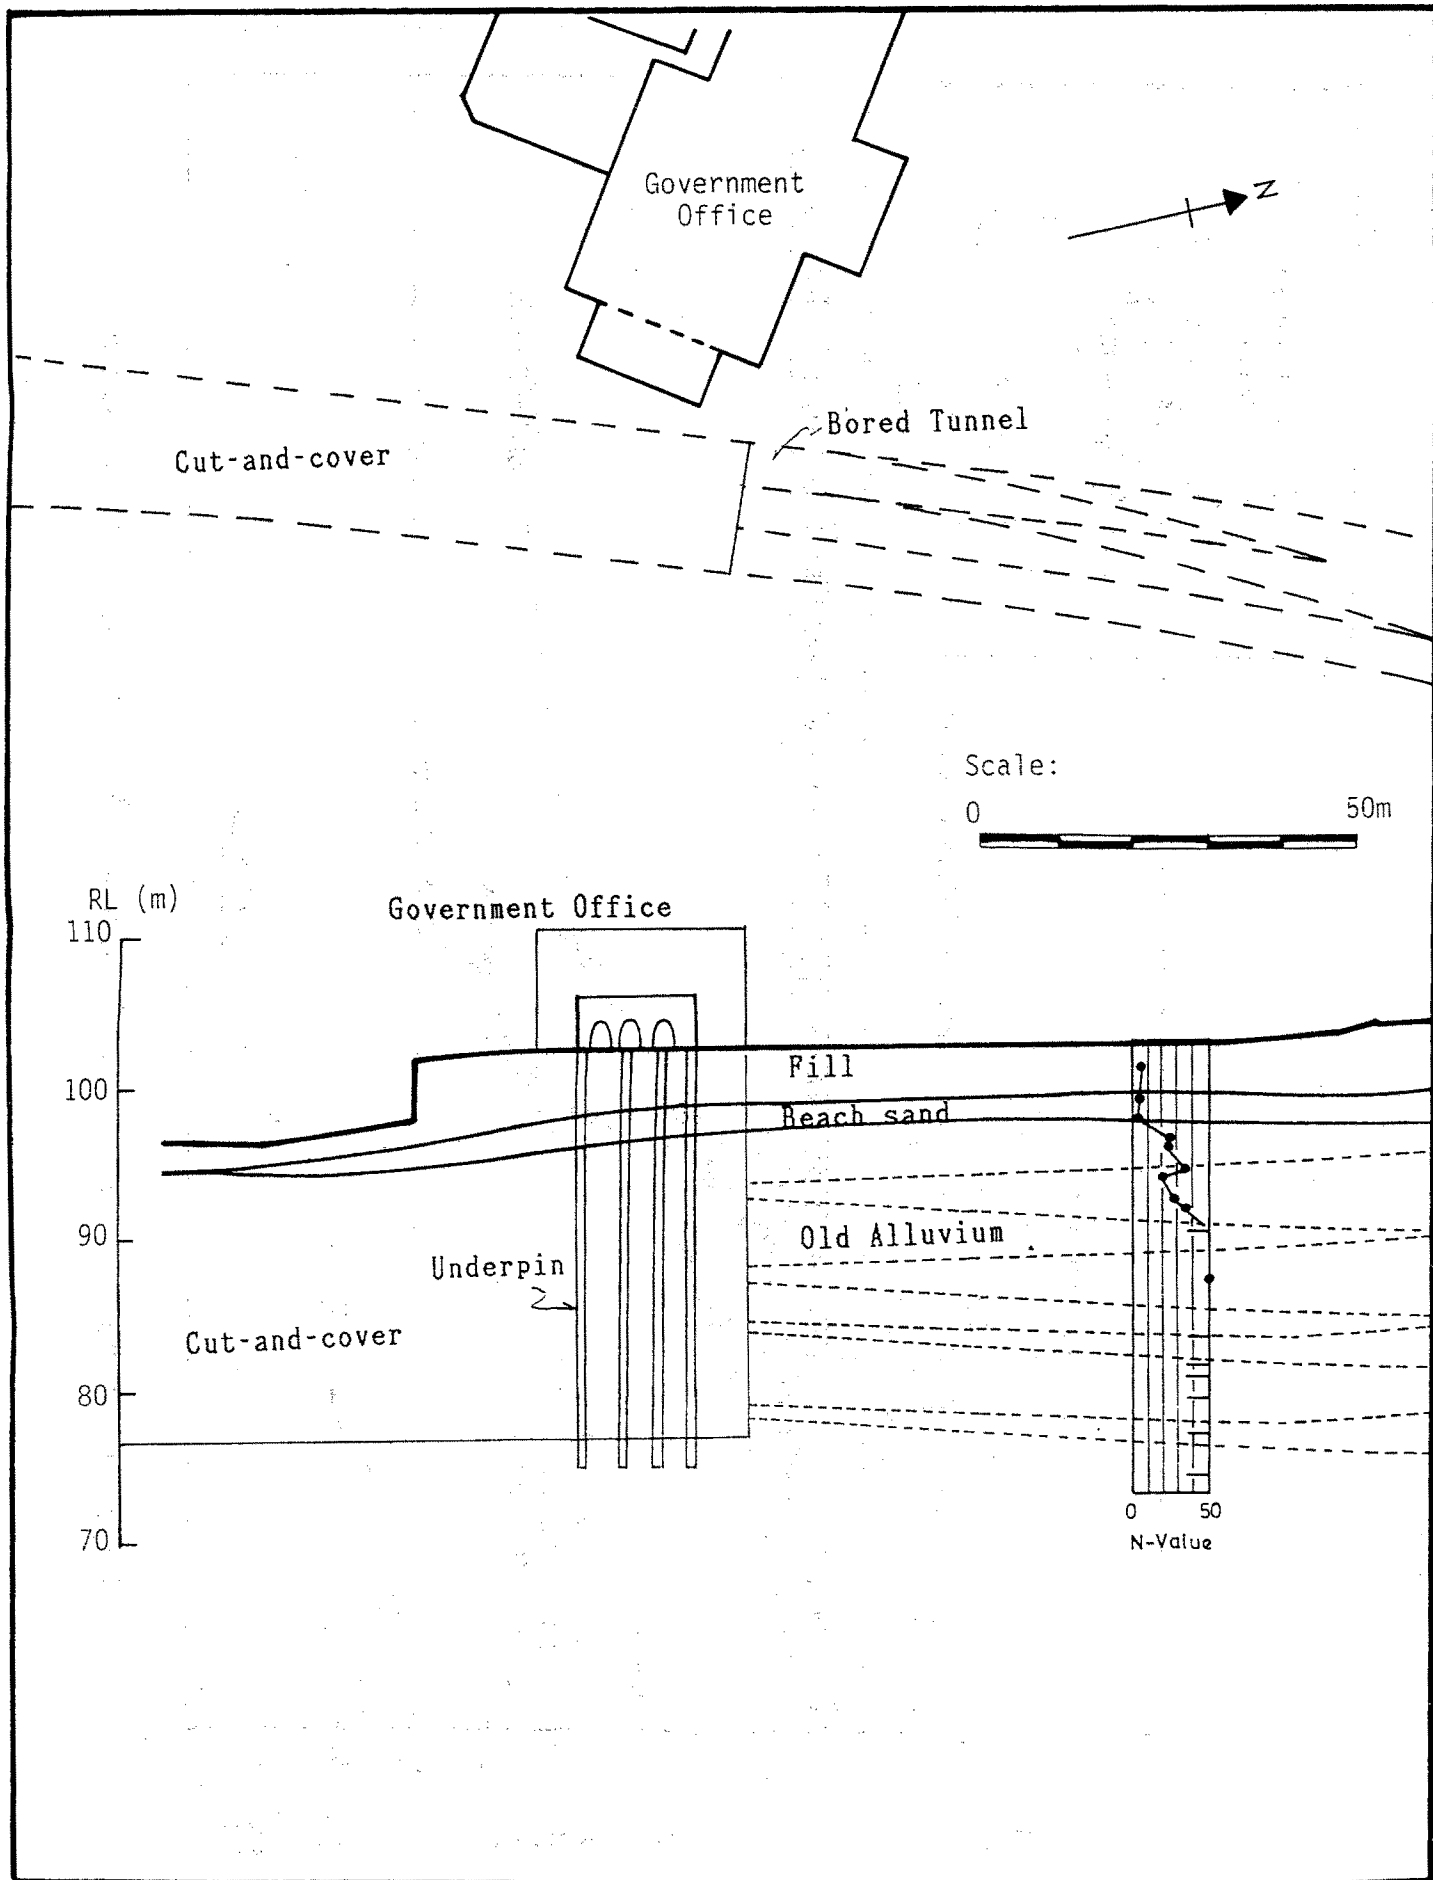
Figure 9 Plan and Soil Profile around Government Office

Figure 9 shows a plan of the building together with the area of the excavation for the cut-and-cover tunnel. Also shown in the lower part of the figure is a soil profile along the tunnel. The ground at the building is covered with a 3 m thick fill, which overlies a 2 to 3 m thick beach sand layer and then a very thick layer of Old Alluvium. The SPT N-value of the fill and beach sand layer is less than 5. The Old Alluvium is Pleistocene sediments consisting of stiff to hard clay layers and medium to dense, often cemented sand layers. The SPT N-value of the Old Alluvium at the site is greater than 50 except for the top 15 m where the N-values are 20 to 50.

Only the 4 columns in the front row facing the excavation were underpinned. The contractor used micro piles of a diameter of 107 mm for this. The piles were installed to depths of 26 to 28 m, which is 5m below the zone of influence as shown in Figure 8, but is approximately the same depth of the excavation. The micro pile consists of (1) a steel bar with a diameter of 38 mm and a yield stress of 465 N/mm² and (2) sand-cement-mix-grout with the compressive strength of 30 N/mm². The allowable load of the pile was 24 tons based on a factor of safety of 1.5 applied to the yield stress of the steel. The design considered the reduction of the cross sectional area of the steel bar at the thread. The allowable load of the micro piles does not include the strength of the grout.

their design load. Cracks became apparent at the building in early July when the excavation reached a depth of about 10 m with 3 levels of the struts in place. The excavation was then suspended until late September. The contractor shored the building as shown in Photo 4 in late July 1984 and underpinned the columns in the period between 10 and 23 August 1984.

The settlement of the front row columns started when the excavation began in late May 1984. Cracks of the building occurred when the settlement reached 5 mm. Further settlement of 6 mm occurred during the underpinning work. Major settlement started late September when the excavation restarted after the underpinning work. The ground settlement at the opposite side of the excavation and the settlement at the second row of the columns also progressed rapidly. The settlement almost stopped when the excavation reached the final level although a small amount of settlement still continued. The final recorded settlements at the front row of the columns were 37 to 51 mm, which are almost of the same order of the ground settlement as shown in Figure 10. The settlements at the second row of the columns were 30 to 36 mm.

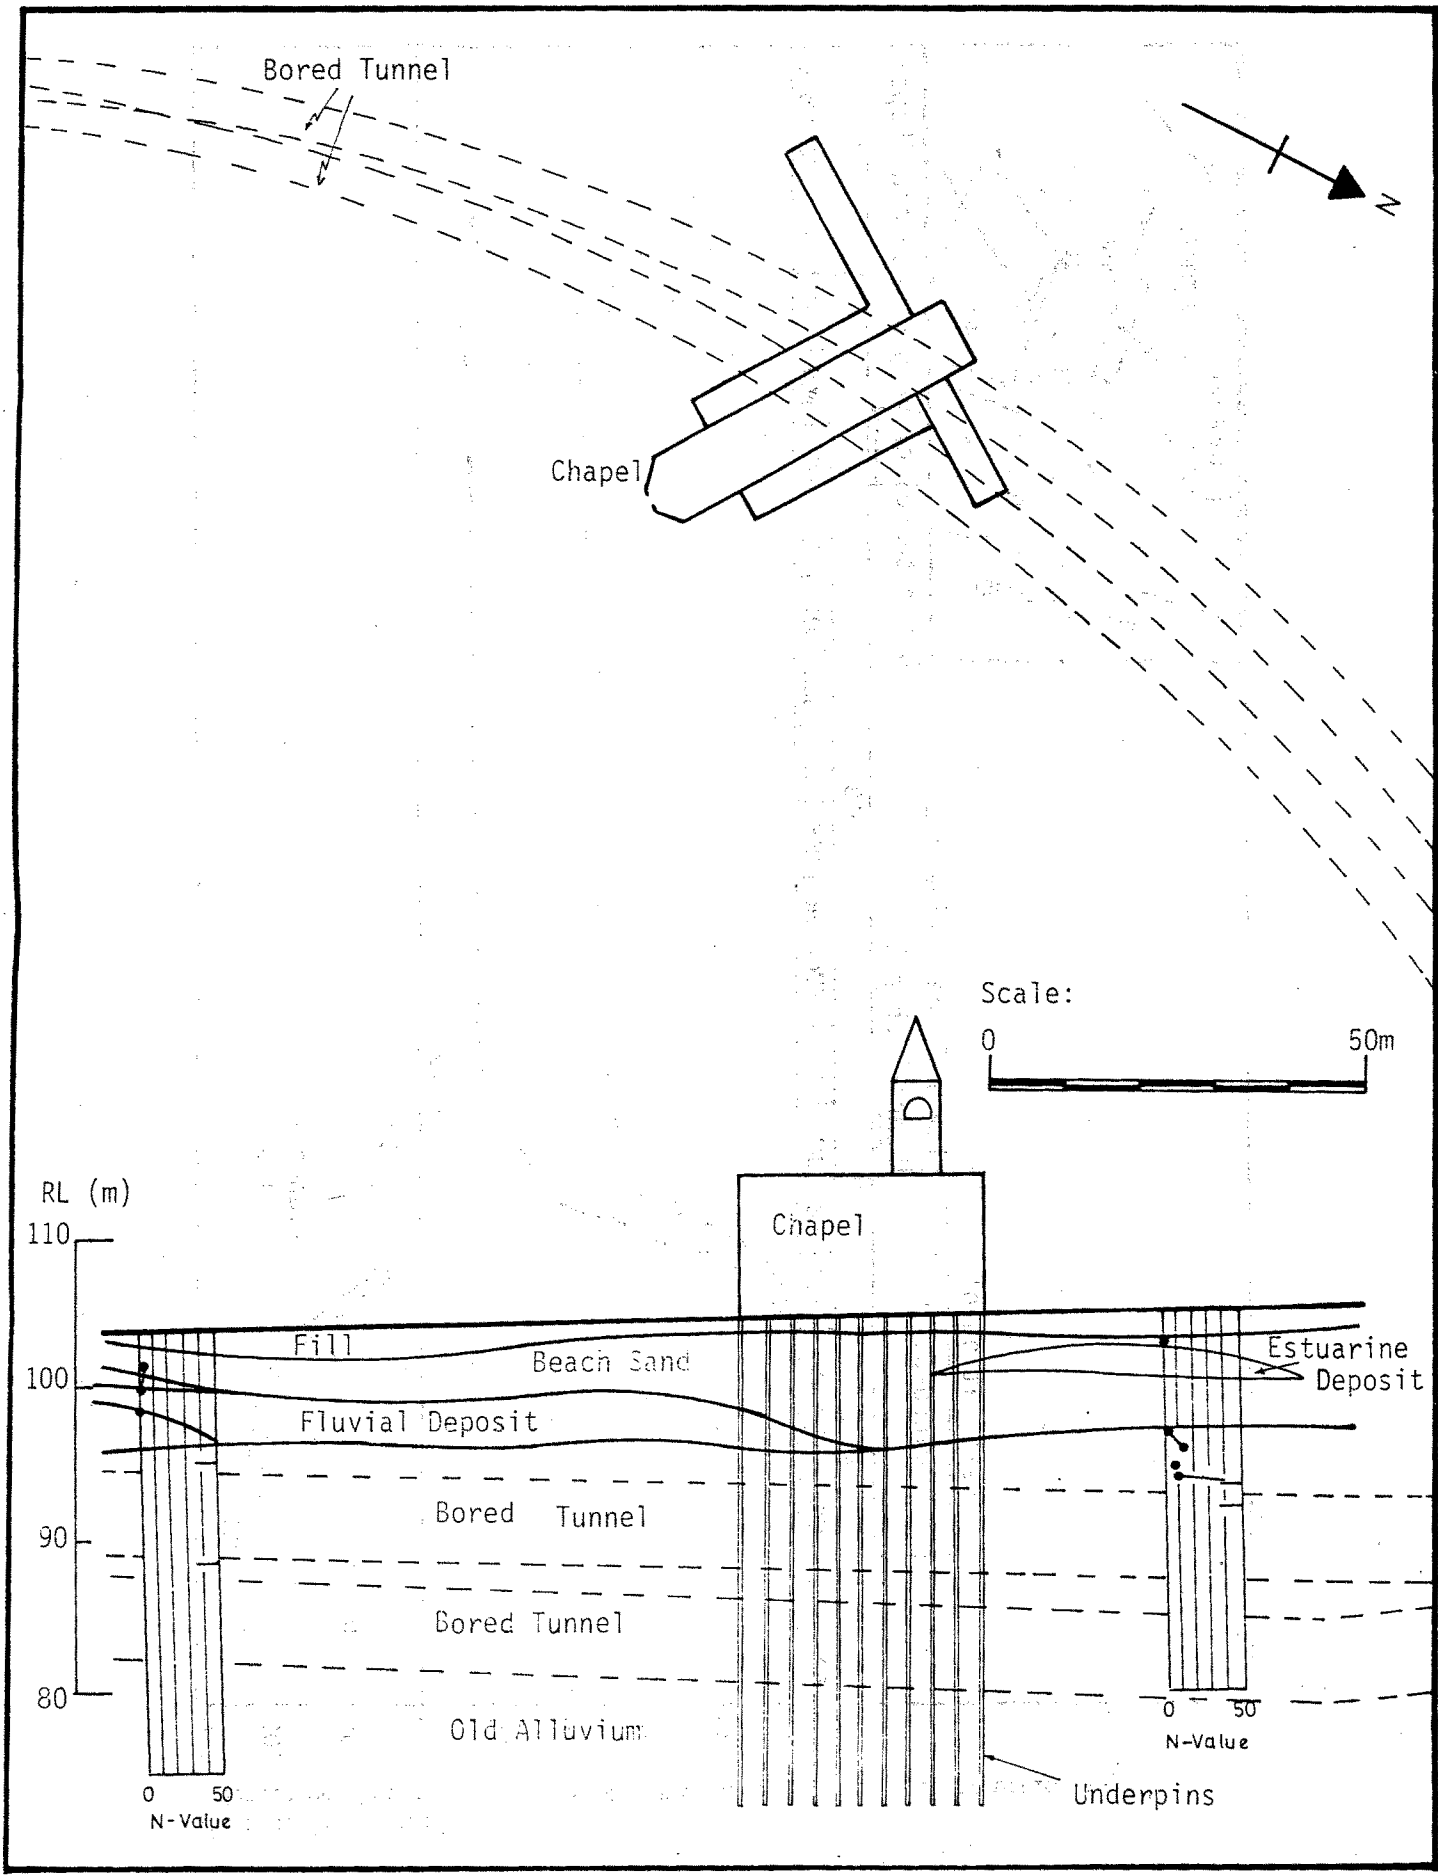
Figure 11 Plan and Soil Profile around Chapel

The chapel building of the Convent of the Holy Infant Jesus was built in 1854 with a 2-story main building and a 4-story tower constructed with bricks. The underpinning of the whole building was proposed because twin bored tunnels were to pass directly underneath. The convent was classified as a Preserved National Monument. No information was available on the foundation details of the building. Photo 5 shows the rear view of the building.

Figure 11 shows a plan of the building together with the tunnel alignment. Also shown in the lower part of the figure is a soil profile along the tunnels. The ground is covered with a layer of 7 to 9 m thick consisting of fill, beach sand and organic soil. The Old Alluvium (with SPT N-values of generally greater than 50) described for the Government Office underlies the surface layers. The twin bored tunnels of 6 m internal diameter pass under the building within the Old Alluvium. The cover of the Old Alluvium above the tunnels varies from 3.5 to 12 m.
