# **A RETROFITTING DESIGN OF YEN-FON BRIDGE IN CENTRAL TAIWAN AFTER CHI-CHI EARTHQUAKE**

## **Retrofit/Bridge Structure**

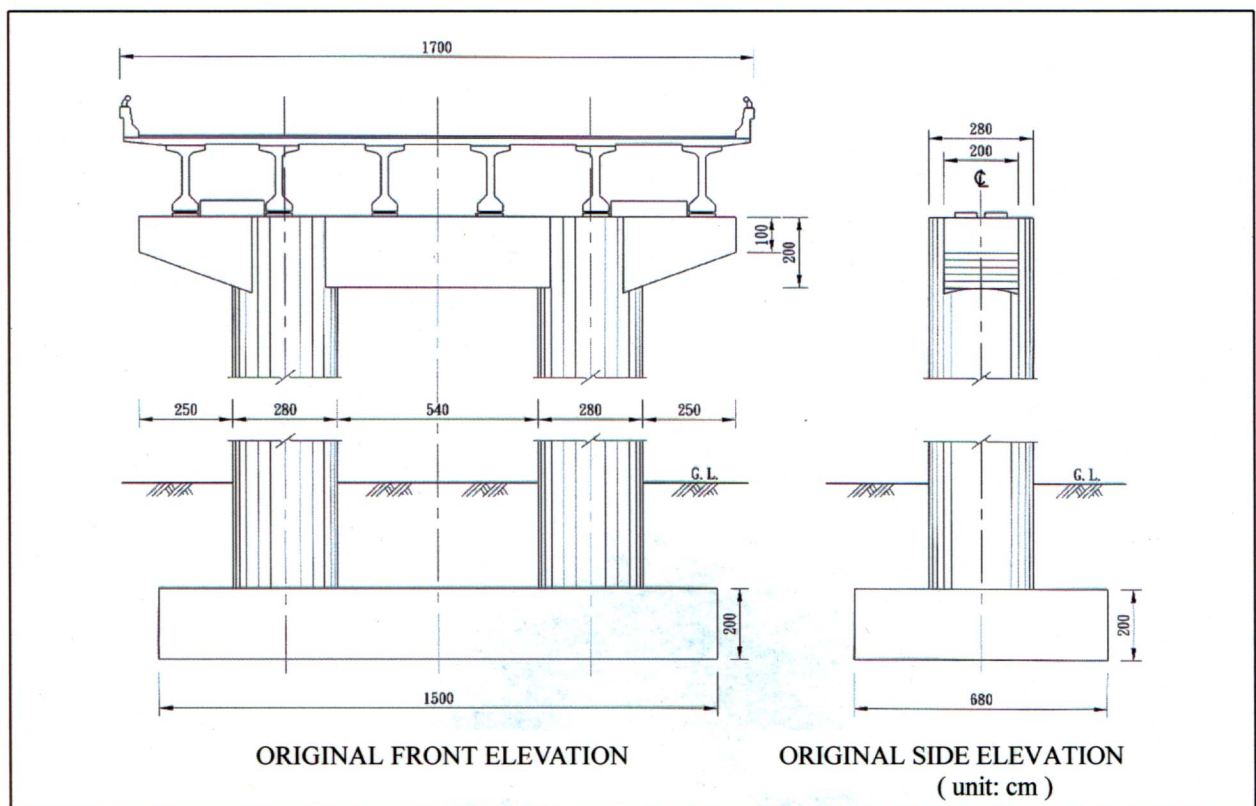
**Fig 1: Original Elevation**

Yen-Fon bridge, located at Nan-Tun Town of Nan-Tao county and crossing Wu-Si river, is the main bridge connecting Tsao-Tun town and Pu-Li town on Taiwan Provincial Highway No. 14. The bridge is at the east of Cher-Lung-Pu fault and located between Cher-Lung-Pu fault and Shuang-Dung fault. Built in 1984, the bridge has a length and width of 455 meters (13@35m) and 17 meters, respectively. The superstructure of the bridge is composed of six prestressed I girders at each span. The substructure is of two-column frame type on a foundation of combined footing found on rock (Fig. 1). The height of the pier is 11 meters.

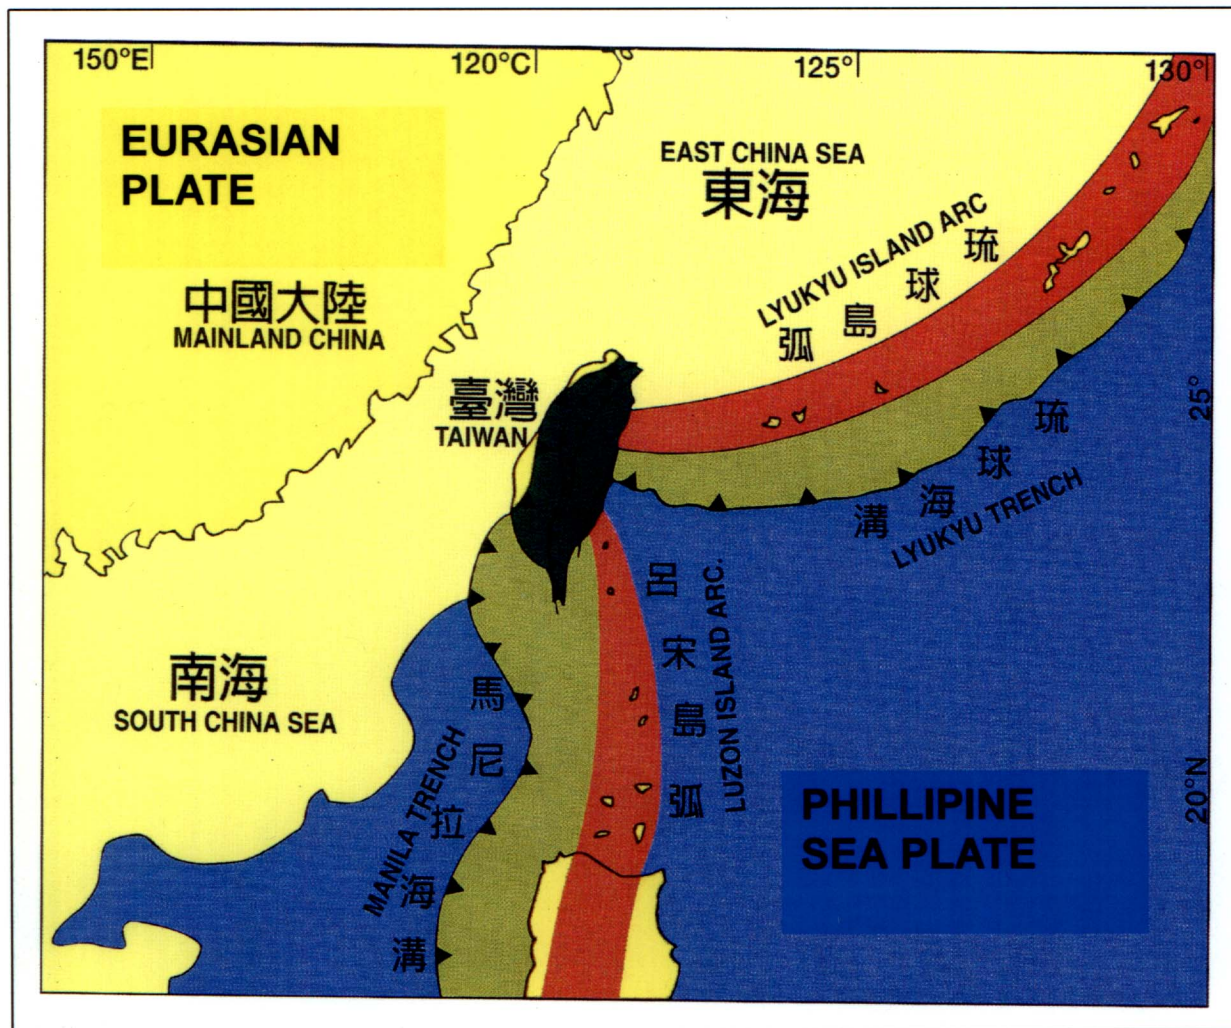
**Fig 5: Tectonic Structure Around TAIWAN (After Ho.1986)**

The island of Taiwan was formed during pliocene, due to the collision of Eurasian Plate and Phillipine Sea Plate (subdivision plate of Pacific Plate, Fig. 5 HO 1986). The latter is drifting from south-east at a rate of 7-8 cm/yr. And its Northern tip subducted underneath the Eurasian Plate along the east of Central Mountain Range of Taiwan. This thrust force

crushed the Tertiary sedimentary rocks of 10 km in thickness to form numerous faults and folds generally in the N-S direction, roughly the same as the axis of the island, and turns toward N-E at northern part of the Taiwan. The release of strain energy stored during the tectonic movement resulting in numerous inevitable earthquakes in Taiwan .
