Flooding of A Working Shaft during Construction of Taipei MRT

Za-Chieh Moh and Richard N. Hwang
Moh and Associates, Inc., Taipei

SYNOPSIS : A tunnel was seriously damaged when the portal was enlarged for the installation of the flexible joint. Water spurted at the invert and the flow soon became uncontrollable. The shaft had to be flooded to balance the groundwater pressure. A total of 23 segments of the tunnel lining were damaged and had to be replaced. Freezing was first carried out to seal off the opening so the water in the shaft could be drained and the shaft could be cleaned. Freezing was again carried out to form a tubular shelter to surround the damaged section of tunnel for the segments to be replaced subsequently.

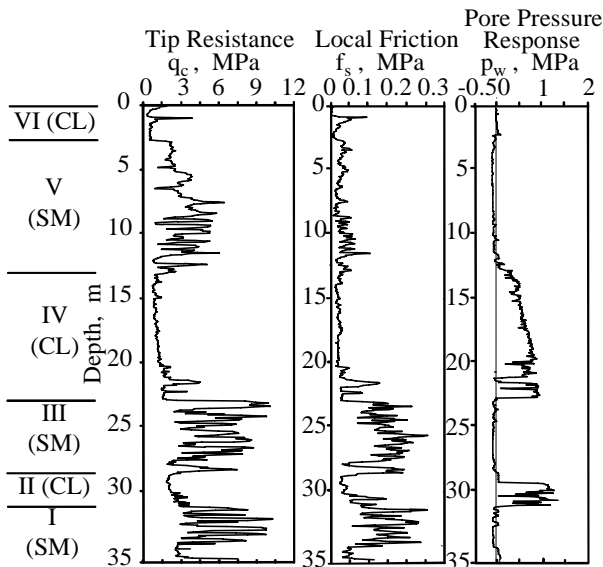
Fig. 3 Typical CPT profile in central Taipei City

Figure 2 shows the soil profile at this site. As can be noted that at the surface there exists a thick layer of Sungshan Formation which is underlain by the so-called Chingmei Gravels at a depth of 35m below the ground surface. A typical CPT (cone penetration test) profile for the central city area of Taipei is given in Fig. 3. There are six sublayers in the Sungshan Formation of which Sublayers VI, IV and II consist of soft silty clays (CL) while Sublayers V, III and I consist of loose to medium sands (SM). The stratigraphy at this site is quite similar to what is shown in Fig. 3 except that there exists a gravelly layer in Sublayer V. Representative properties of the subsoils in the Sungshan Formation are given in Table 1. The Chingmei Gravels underneath the Sungshan Formation contains gravels of various sizes and is extremely permeable. This gravelly layer was the main source of water supply of the City of Taipei till the 60's. Because of its ample storage capacity of groundwater and the extremely high permeability, this Chingmei Formation was responsible for several major failures during the underground construction of TRTS (Lin, Ju and
